Observations on Proportions of the Reinforced Concrete Buildings in Turkey

Santiago Pujol, Ayhan Irfanoglu, Mario Rodriguez,
Remy Lequesne, and
Chungwook Sim (University of Nebraska-Lincoln)

Deployed by ACI Committee 133 – Disaster Reconnaissance

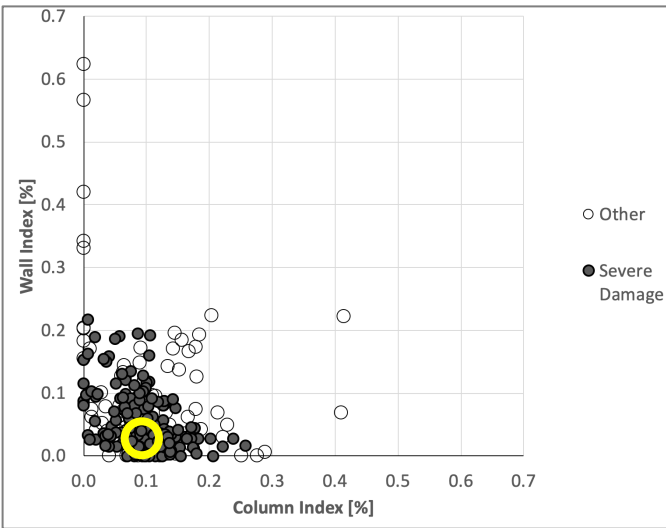
Location: Nurdagi
 PGV: 1.1 m/s
 WI: NS 0.06% EW 0.03%
 Cl: 0.1%

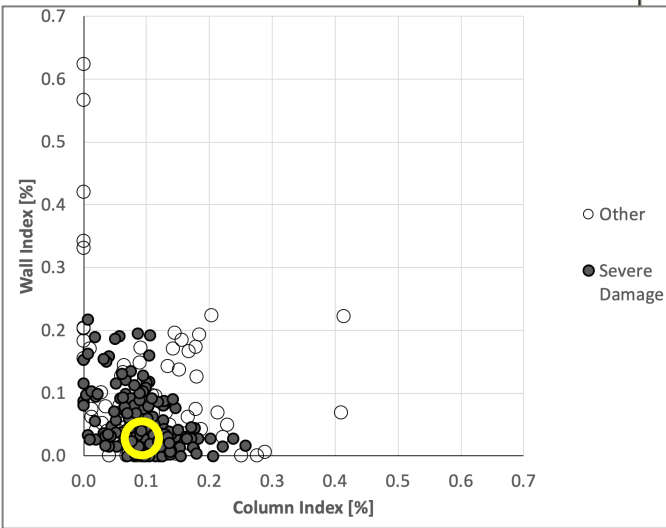
Location: Nurdagi
 PGV: 1.1 m/s

WI: NS 0.06% EW 0.03%
 CI: 0.1%

DAMAGE LEVEL
 RC Structure: M M. Walls: S

OBSERVATIONS
 - LESS OPENINGS THAN CS0
 - DIFFERENT DAMAGE LEVEL IN SHEAR WALL
 DUE TO HAVING ECCENTRICITY ONLY IN 1 (4-DI STY)

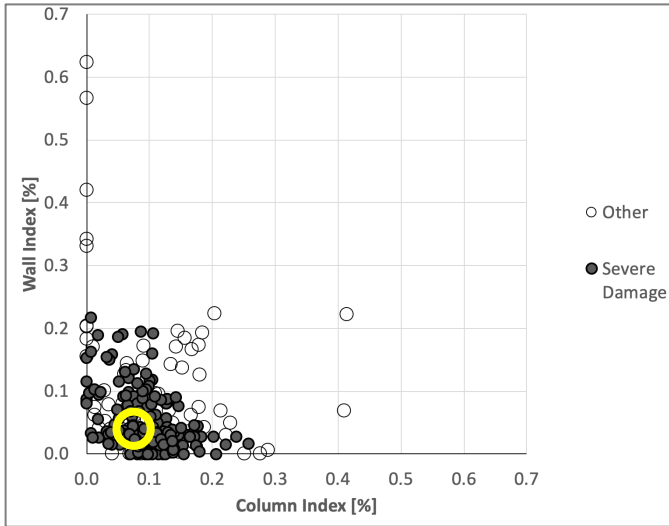
Location: Antakya

PGV: 1.9 m/s

WI: NS 0.09% EW 0.04%

CI: 0.07%

RC Structure: S M. Walls: S

- MANY OF THE BEAMS DAMAGED (SOME @ SPICE, SOME AS SEPARATE) LONGITUDINAL BAR BUCKLED! IN BEAMS,
- 1st FLOOR COLS. HAVE HOPE

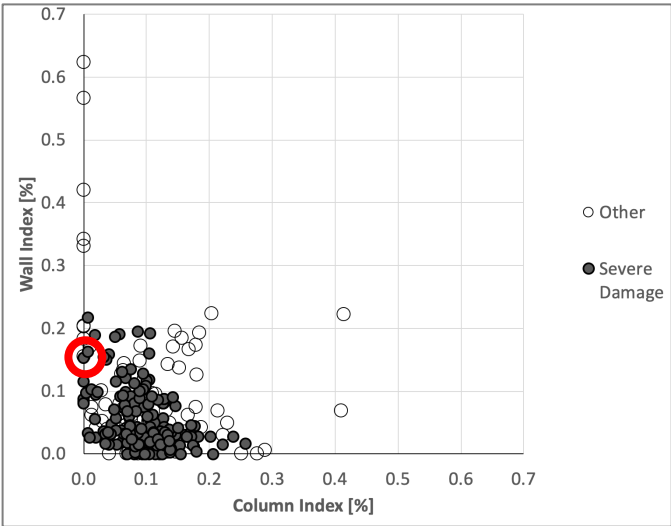
Location: Antakya
 PGV: 1.9 m/s
 WI: NS 0.15% EW 0.23%

STRUCTURE (descript.)	YEAR (construct.)
TUNNEL FORM RC SHEAR WALL	2013
No. STORIES ABOVE GROUND	16
HEIGHT	2.7m
PICTURE #S	
DAMAGE LEVEL	
RC Structure: S	M. Walls: S
PERMANENT DRIFT	
OBSERVATIONS	
- SHEAR WALL DAMAGE ON 1st & B	
- CAN SEE THROUGH MASONRY INFILL DAMAGE	
- ROOF (NON-STRUCTURAL) FELL DOWN DAMAGE

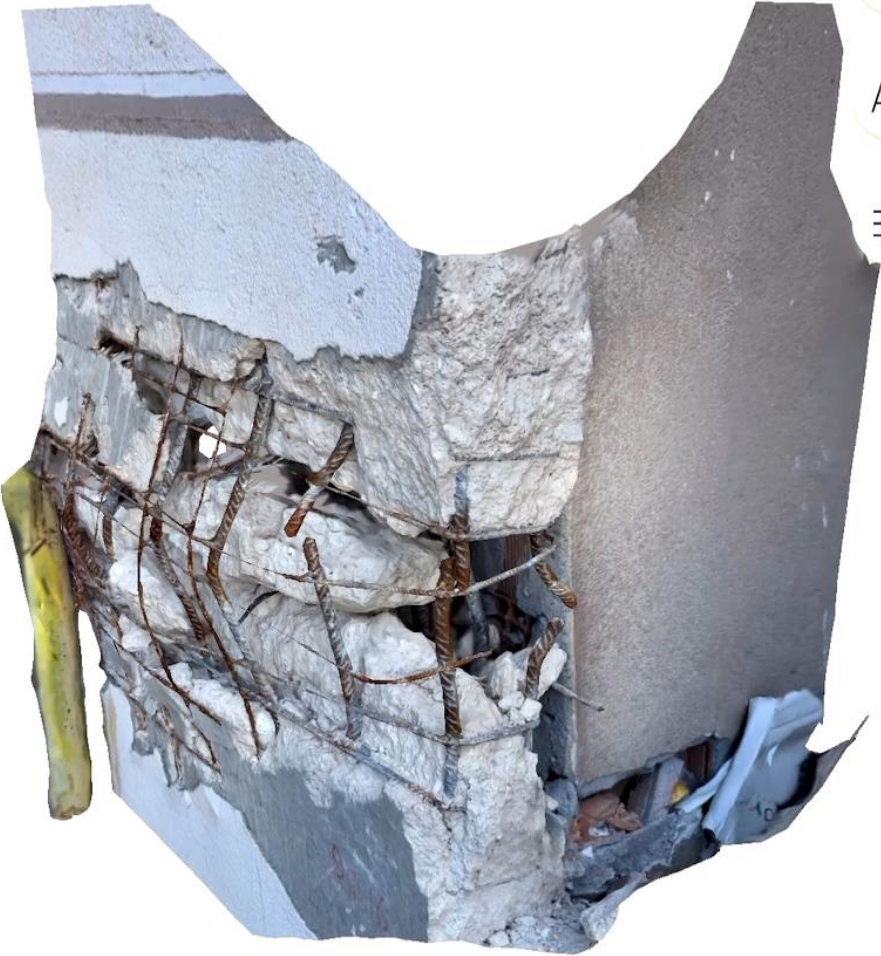
Location: Antakya
PGV: 1.3 m/s (avg.)

WI: 0.04%
Estimated Drift: 6%

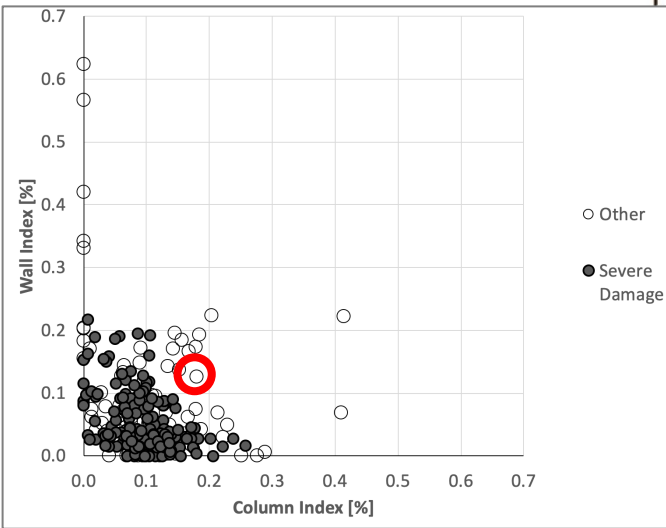
Location: Dulkadiroglu
 PGV: 1 m/s
 WI: NS 0.16% EW 0.12%
 CI: 0.18%

M.WALL W/ OPENING RC COL.
 M.SOLID INFILL WALL CAPTIVE
 RC WALL SEV. DMG

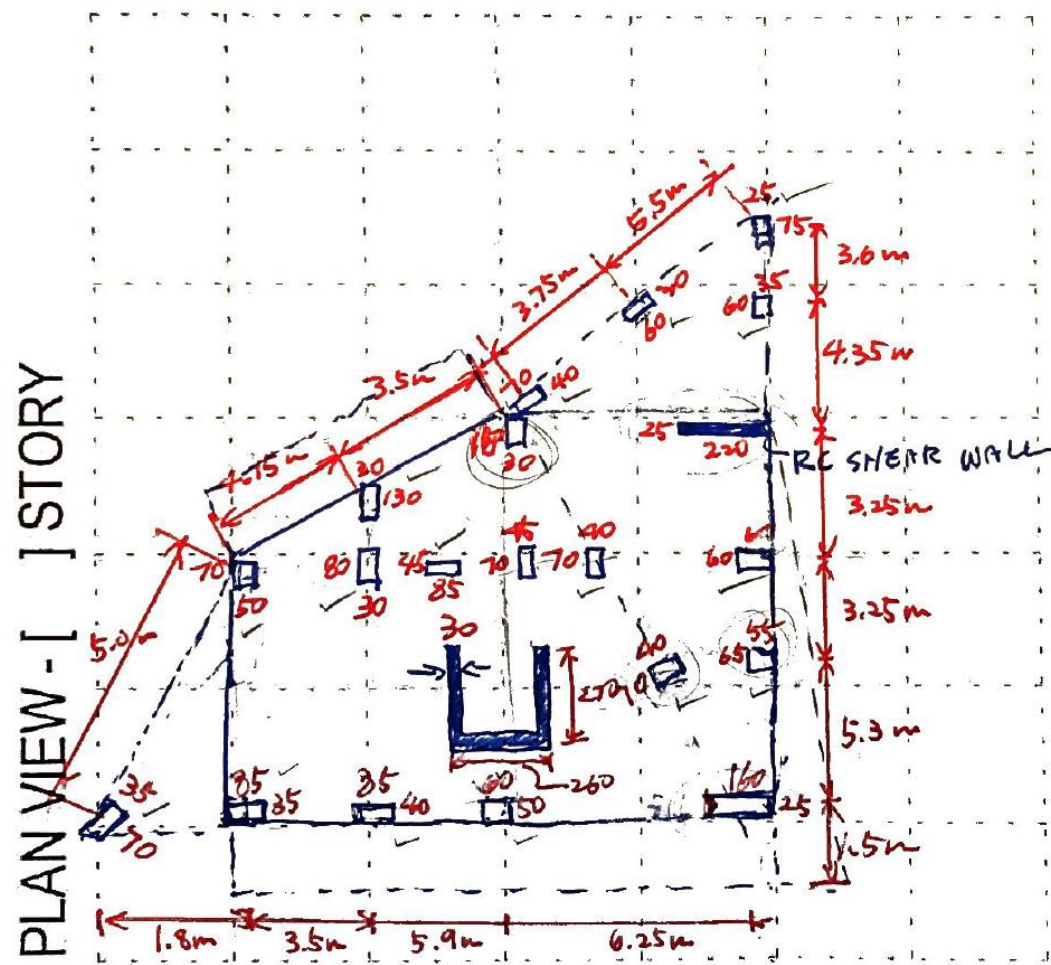
BUILDING (location)
 DULKADIROGLU
 ADA 1622
 PARSEL 10

DAMAGE LEVEL
 RC Structure: L M. Walls: S

- CORNER BLDG
- TRIANGULAR ATTACHMENTS TO BLDG
- TRAPEZOIDAL SHAPE
- DRAWINGS AVAILABLE
