Long Term Monitoring of Bridge Decks in Montana

Todd Nelson, P.E.

Wiss Janney Elstner Associates

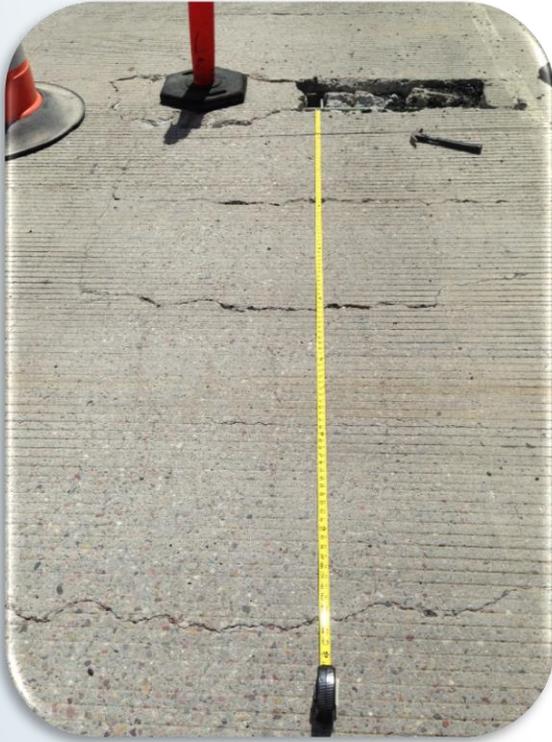
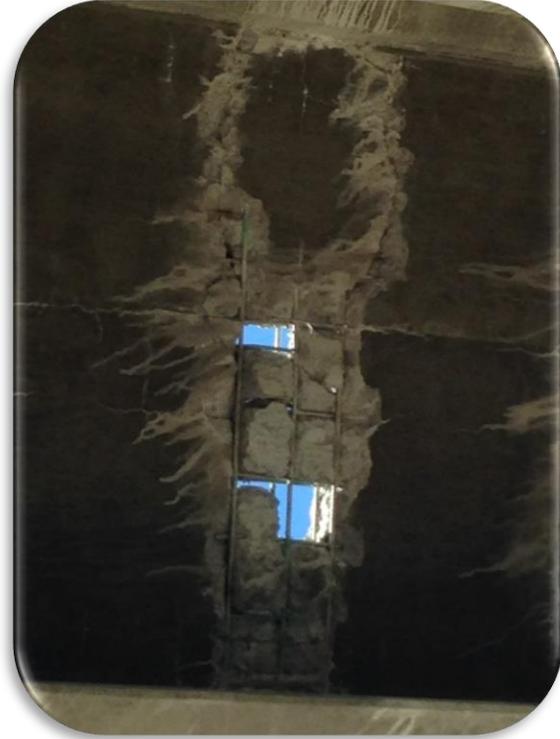
- Closely spaced transverse cracks on numerous bridges in western Montana
- In some cases, through deck penetrations developed
- Young bridge decks < 8 years
- Mostly in the alpine regions

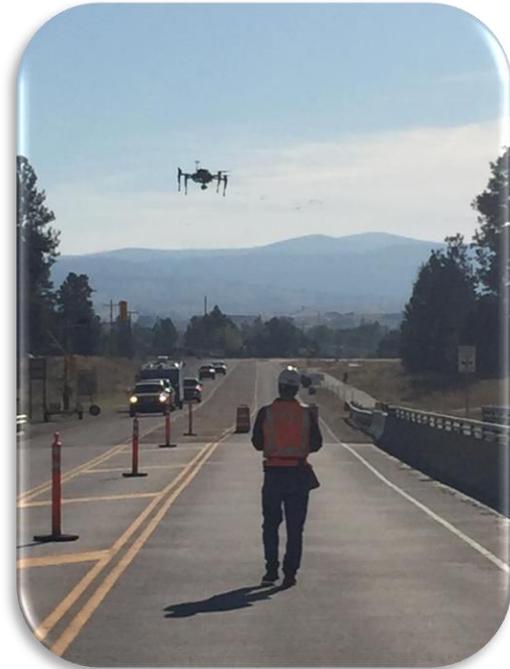
- Overall Visual Rating = 3
- Transverse cracks at 3 to 4 feet
- Crack width 20 to 30 mils

Crack density (ft/ft ²)	Crack Severity (mil*ft/ft ²)
0.19	3.87
0.14	2.45
0.17	3.15

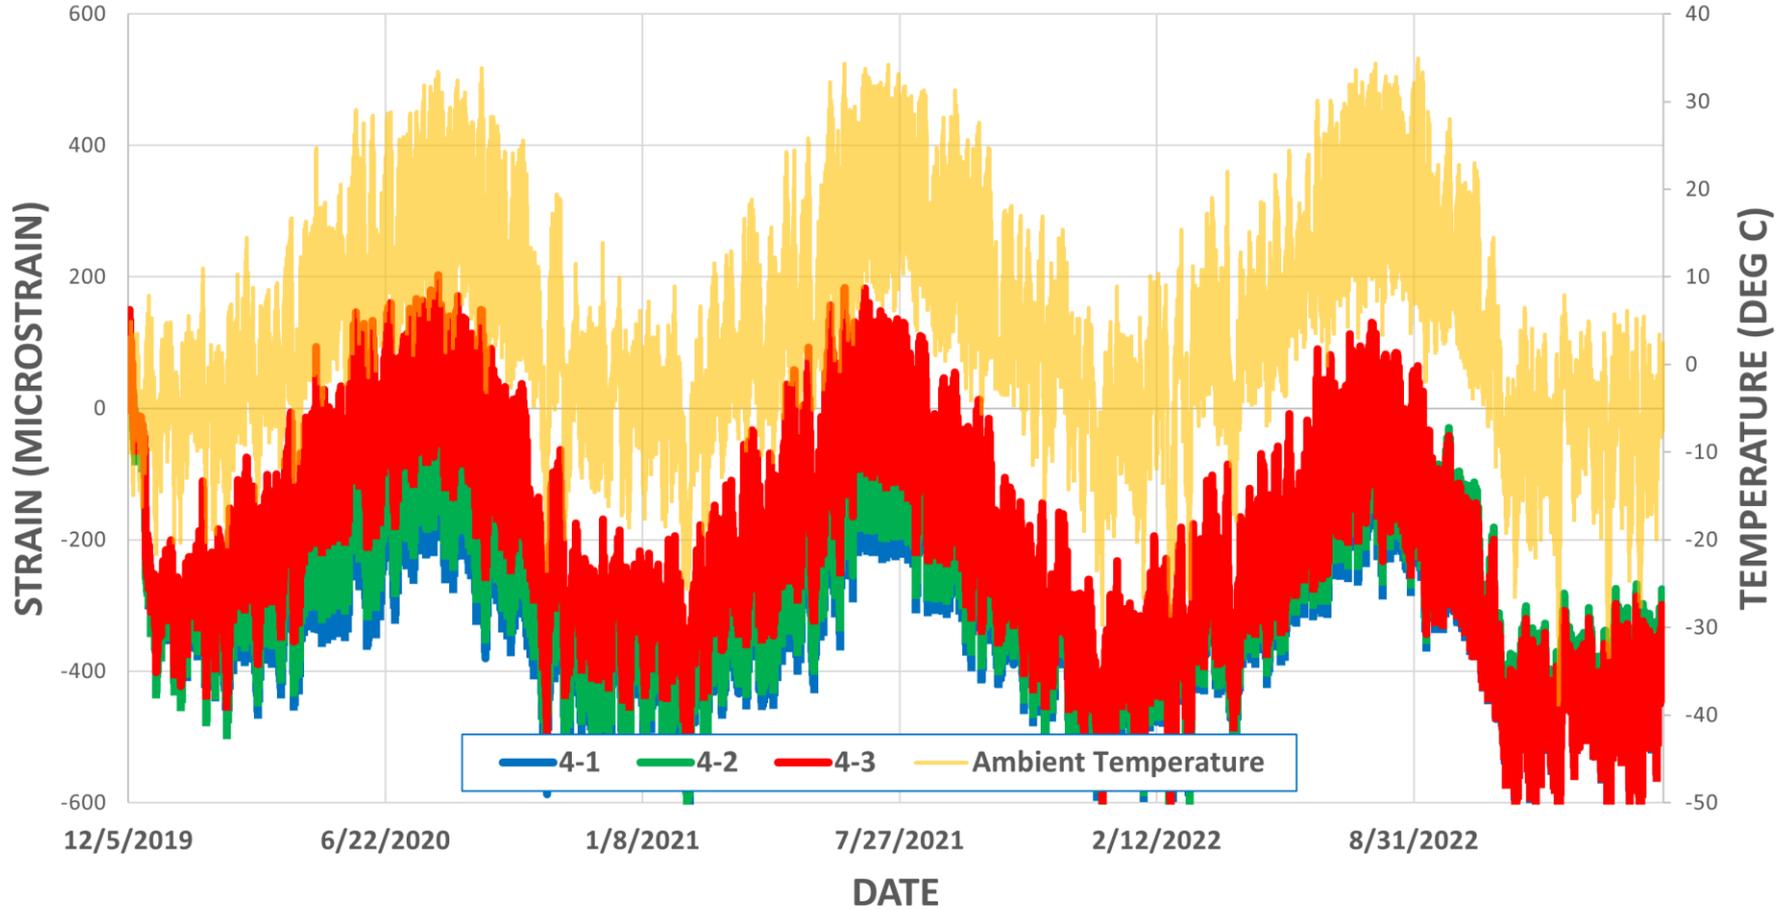
Strain - Location 4

- Compressive strain developed in deck after removal of insulation and heating

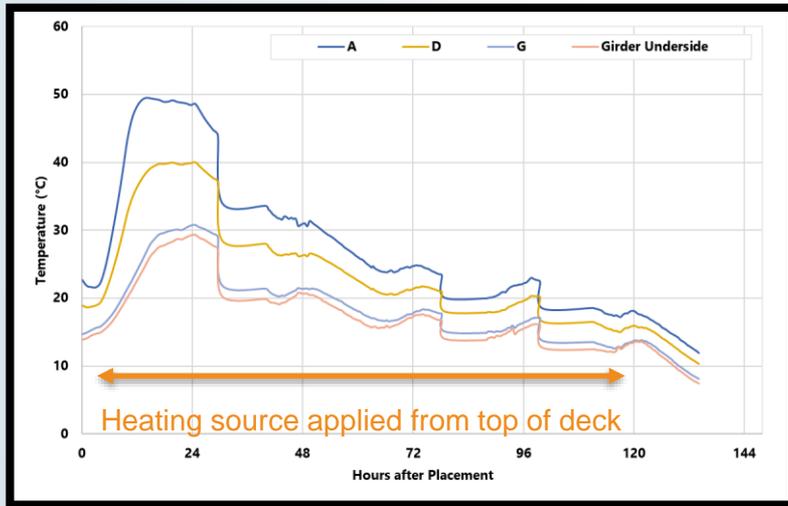
Heating from top of the deck

Winter placement temperature

Average Resultant Longitudinal Stress vs time

- Design and Construction Practices
 - Summer curing:
 - Installation of insulated blankets after peak hydration
 - Removal of insulation blankets after 4 to 5 days
 - Winter curing:
 - Heat cure from underside is preferable and provides additional pre-compression benefit
 - Reduction in moisture gradient - installation of thin-polymer overlays at later ages ~ 6 to 9 months after construction

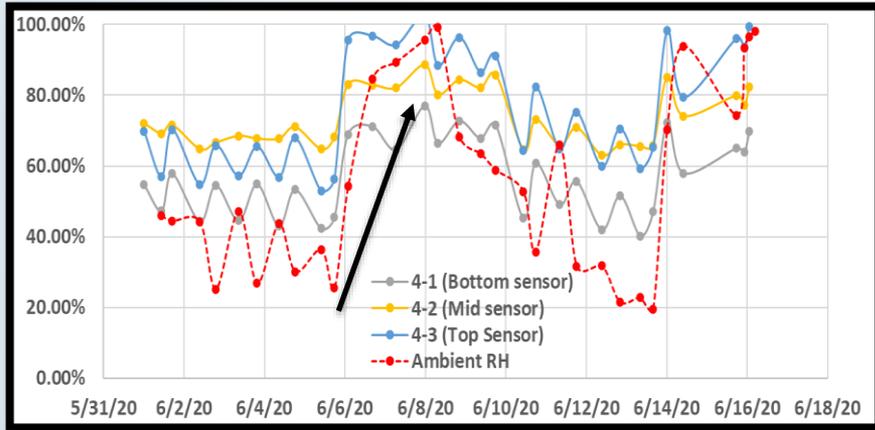
Stress vs time

- Drying shrinkage can contribute up to 300 psi in tensile stress
- Large temperature rises can create an increase in tensile stress by as much as 400 psi, underside of deck
- Large changes in relative humidity can create an increase in tensile stress by as much as 300 psi, underside of deck
- Winter curing, heating from below is preferred to heating from the top
