Lessons Learned from a Master in Concrete Repair – Tony Murray

Presentation by Gene Stevens – J. R. Harris & Company

Concrete Repair Session to Honor the contributions of Tony Murray

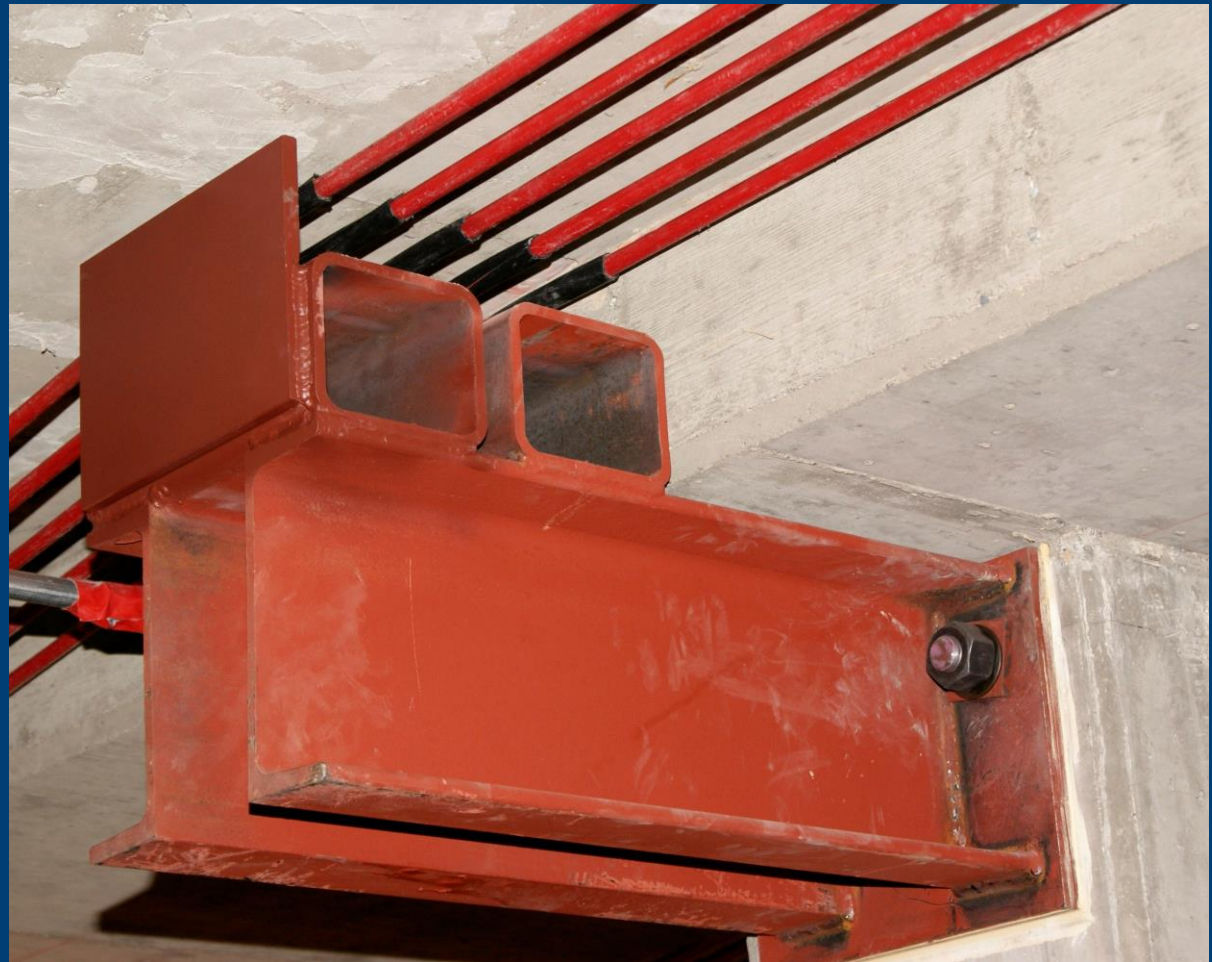
Construction Technique – bolt on corbels

Problem was exactly locating the column reinforcement and positioning the anchoring rods

& fitting of surfaces plate to (E) concrete
