Post-Earthquake Repairs, Part 1

ACI Spring 2012 Convention
March 18 – 21, Dallas, TX

**REPAIR OF CONCRETE BRIDGES
DAMAGED BY 02/27/2010 M8.8
CHILE EARTHQUAKE**

Daniel Ortiz, SE Univ. de Chile. CEO, TECNOAV S.A

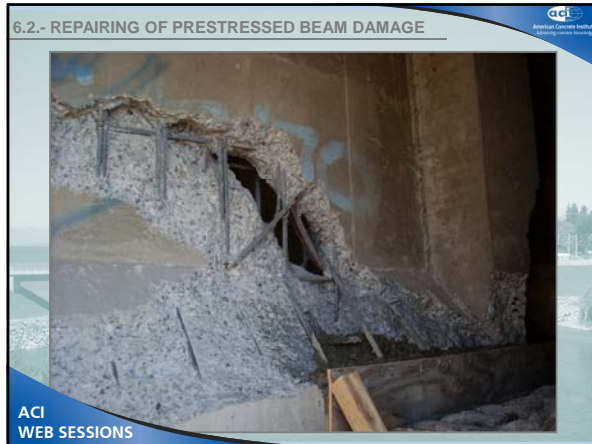
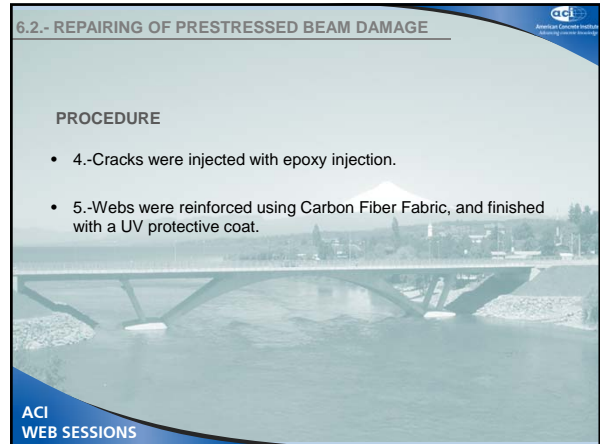
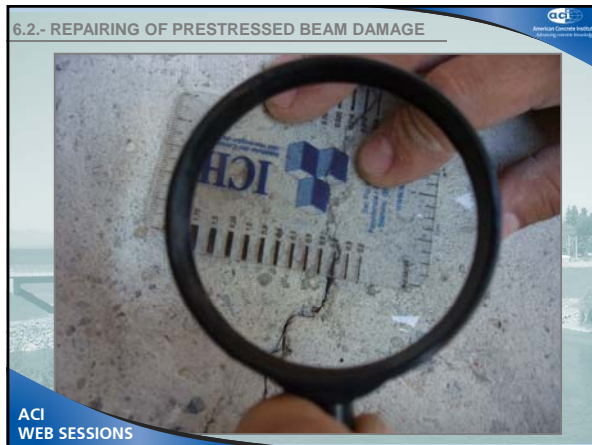
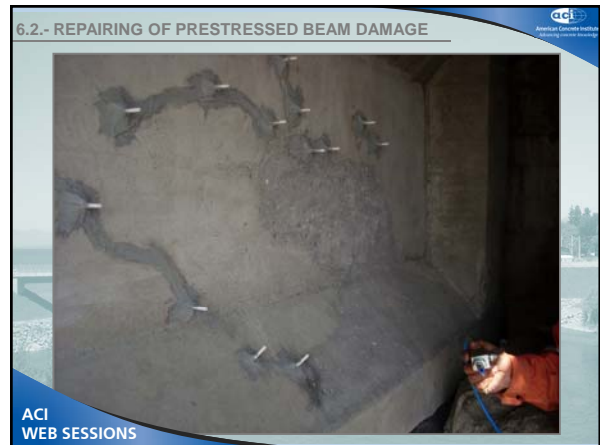
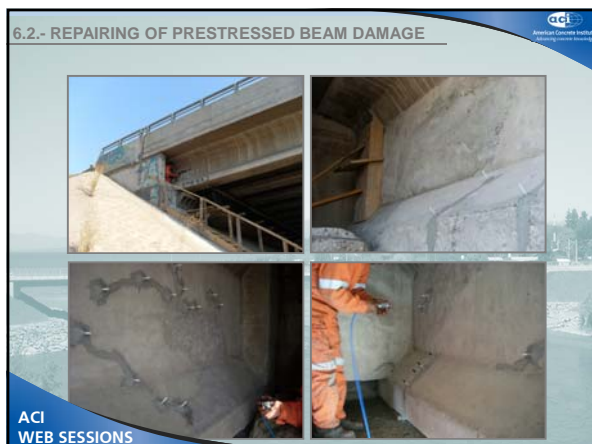
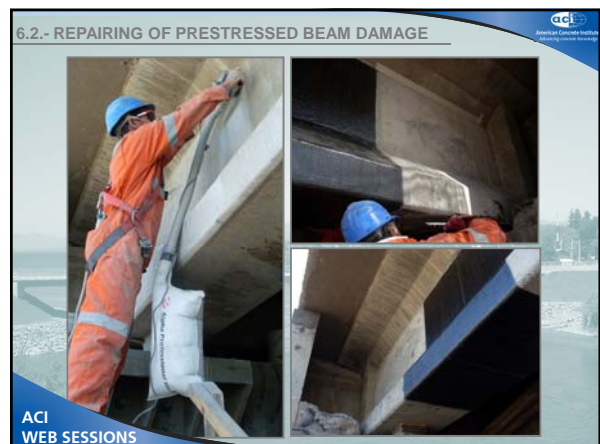
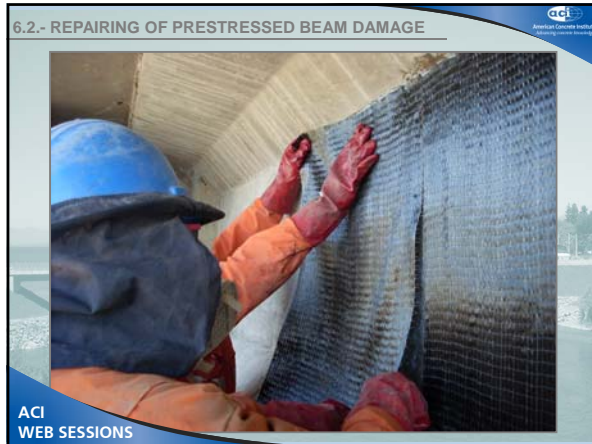
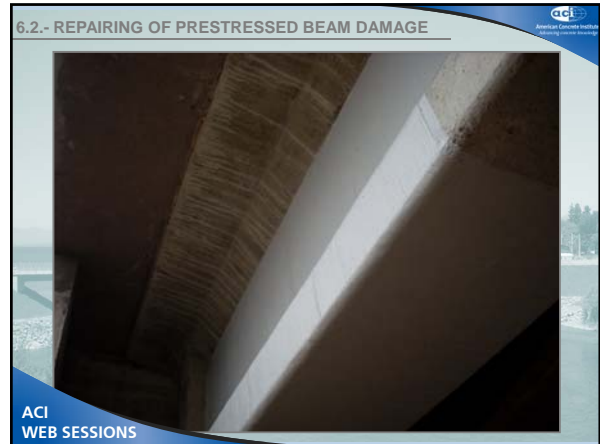
- During the earthquake, external prestressed beams hit against the horizontal concrete stoppers suffering damage in webs and bottom flanges close to their support, reducing their shear strength and affecting their support area.
- The idea was to repair them without having to replace them, reestablishing or improving their original properties without interrupting the traffic over the bridge.

- 1.-Installing a temporary vertical support to the beam as close as possible to the end of the beam.
- 2.-Removing all the concrete and rebars damaged by the distortions or failure and cleaning up all the surfaces.
- 3.-Web and bottom flange concrete repairing were executed using two kinds of concrete depending on the size of the damage:
- -Grout mortar mixed with 25% 10mm gravel, and repairing mortar with fiber for small volumes. In both cases a bonding agent was applied on the old concrete surface.
