Post-Earthquake Repairs, Part 2

Repair of R/C Buildings Damaged in Viña del Mar During the 27 February 2010 M_w 8.8 Maule Earthquake

Patricio Bonelli¹, Gilberto Leiva², José I. Restrepo³ and Jorge Federico Carvallo⁴

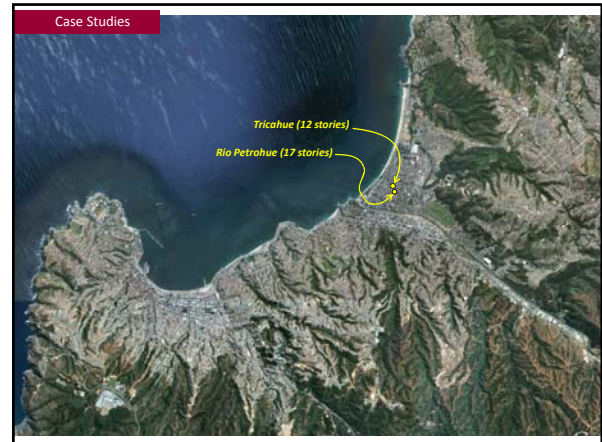
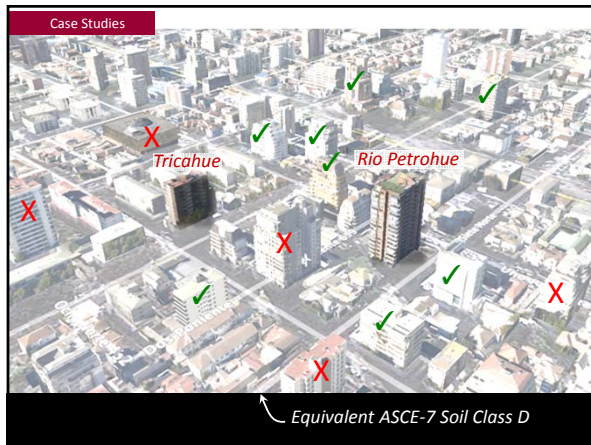
- Extensive crushing of the concrete in lower level walls
- Endemic buckling and fracture of the longitudinal reinforcement
- Closure of wall openings
- Increase wall thickness
- Additional walls
- Epoxy injection of small width cracks in walls and slabs
- Use of wet layoff carbon fiber strips
