THEORY VERSUS REALITY IN CONCRETE AIRFIELD PAVEMENT ENGINEERING

Presented for the Shiraz Tayabji Honorary ACI Session

Ray Rollings
Beaufort SC

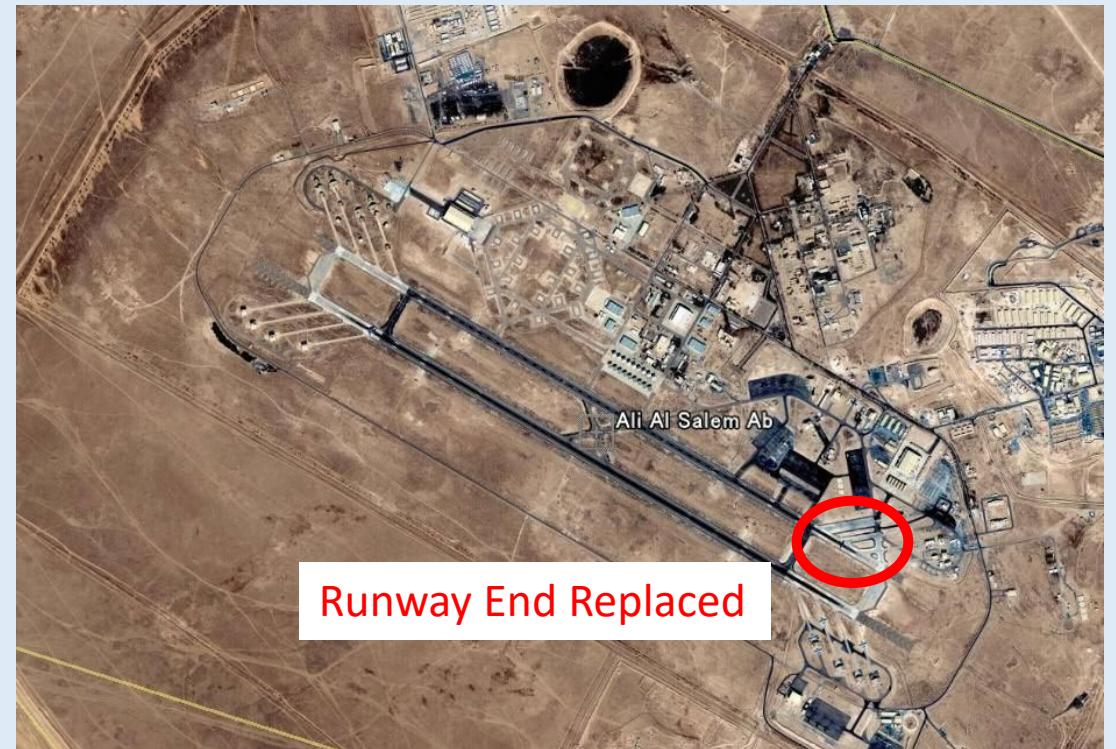
Ali Al Salem Airbase, Kuwait

- 1,000' keel of runway replaced
- 16" thick, conventional DOD design for medium load airfield
- Returned to operation 17 Dec. 2013; cracks appear Feb. 2014
- Claimed Failure Causes:
 - Military const. agent blames Gatch (local silty sandy soil w/evaporites) used as base & too weak
 - Contractor's AE blames faulty design

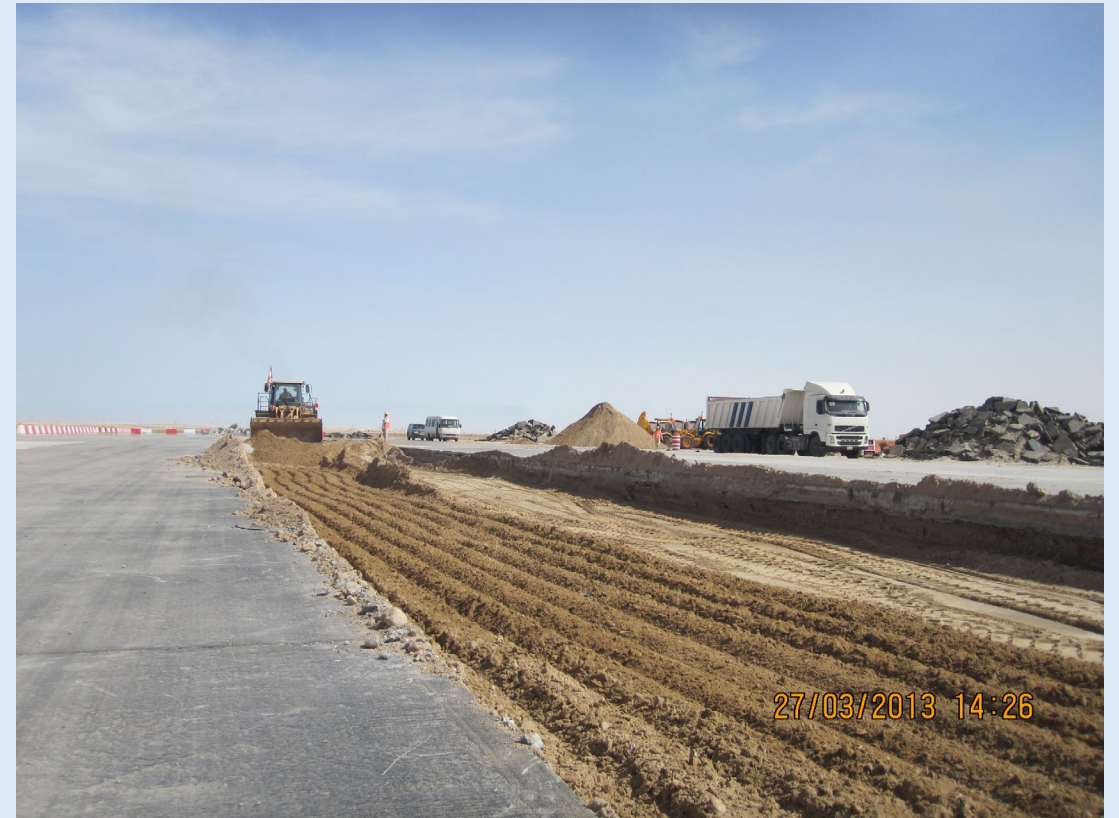
INEXPERIENCED CONTRACTOR

- Formed the job and placed by hand
- Placed in checkerboard pattern
- Doweled all construction joints
(i.e., all four sides)
- Government QA inspectors infrequently on site and inexperienced, i.e., the contractor has a free rein

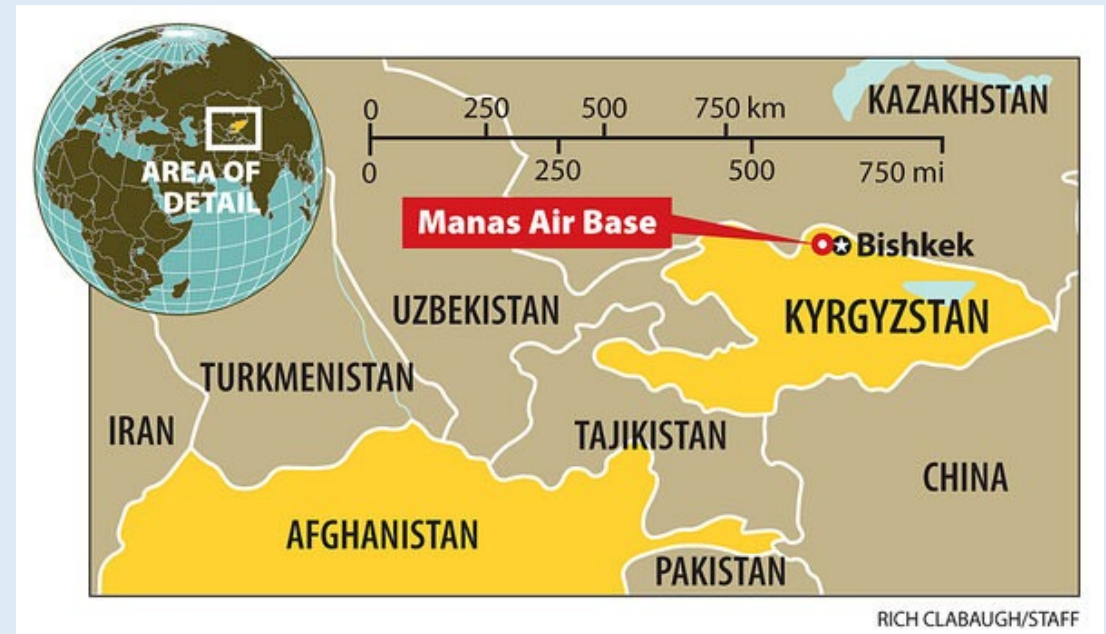
MANAS AIR BASE, KYRGYZSTAN

- Shared Runway with Int. Airport
- Primary USAF Mission
 - Logistical support to Afghanistan (C-17)
 - Refuel combat aircraft over Afghanistan (KC-135)
- Replace & extend 3,000 ft ends of runway with new concrete pavement
- To be built as two successive phases in subsequent years

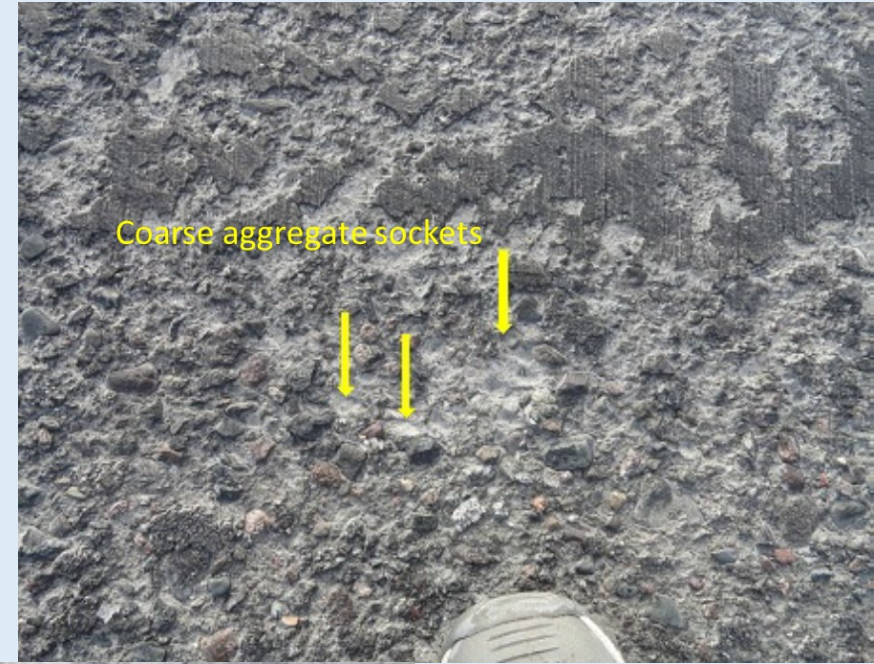
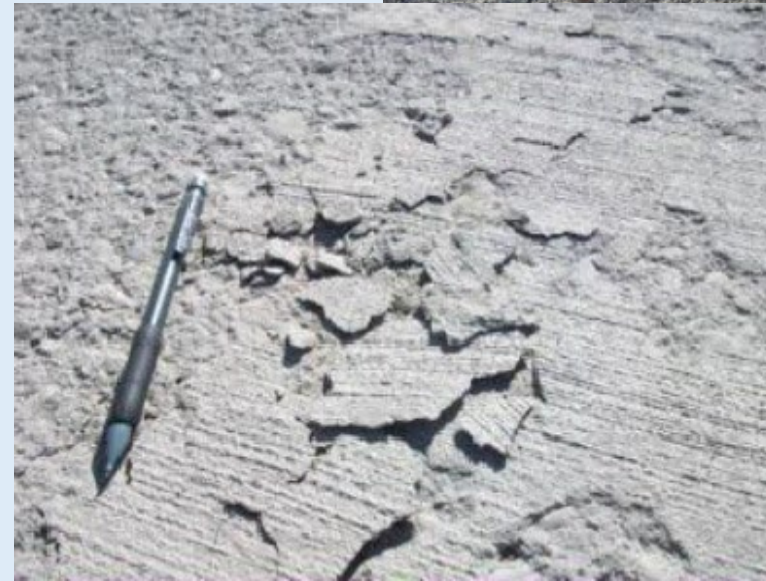
EXTENSIVE SCALING DEVELOPS ON PHASE I

- 18 Aug. 2012 – phase 1 runway end opened to traffic
- Immediately minor scaling appears in touchdown areas
- Worsens during 2012-2013 winter
- Appearing in both trafficked and untrafficked areas
- Traffic suspended from damaged areas (last 3,000 ft of runway) because of FOD hazard

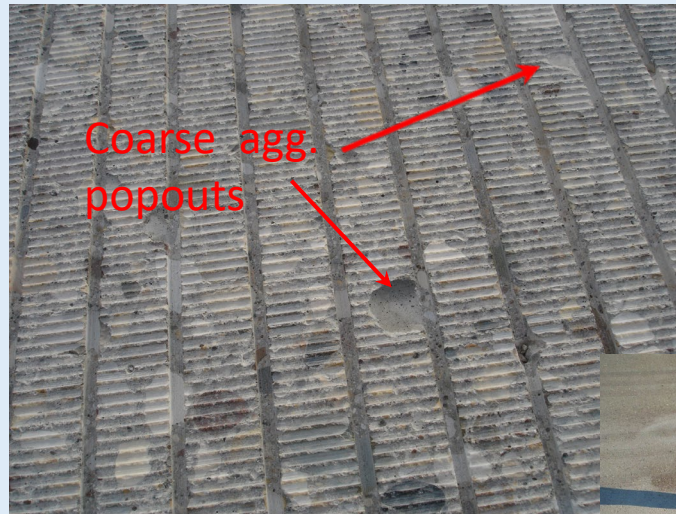
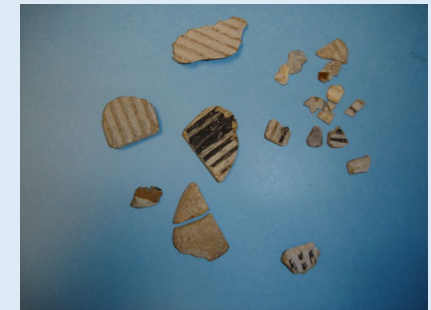
- Grind 6-mm from surface to remove failing surface paste
- US subcontractor brought in
 - Surface smoothness out
 - Some scaling areas missed
 - Some grinding > 20mm
 - Popouts appearing
 - Revealed widespread wood & clay balls
 - Same contaminants in sand stockpiles to be used in phase II

- Why we limit grinding to 6-mm

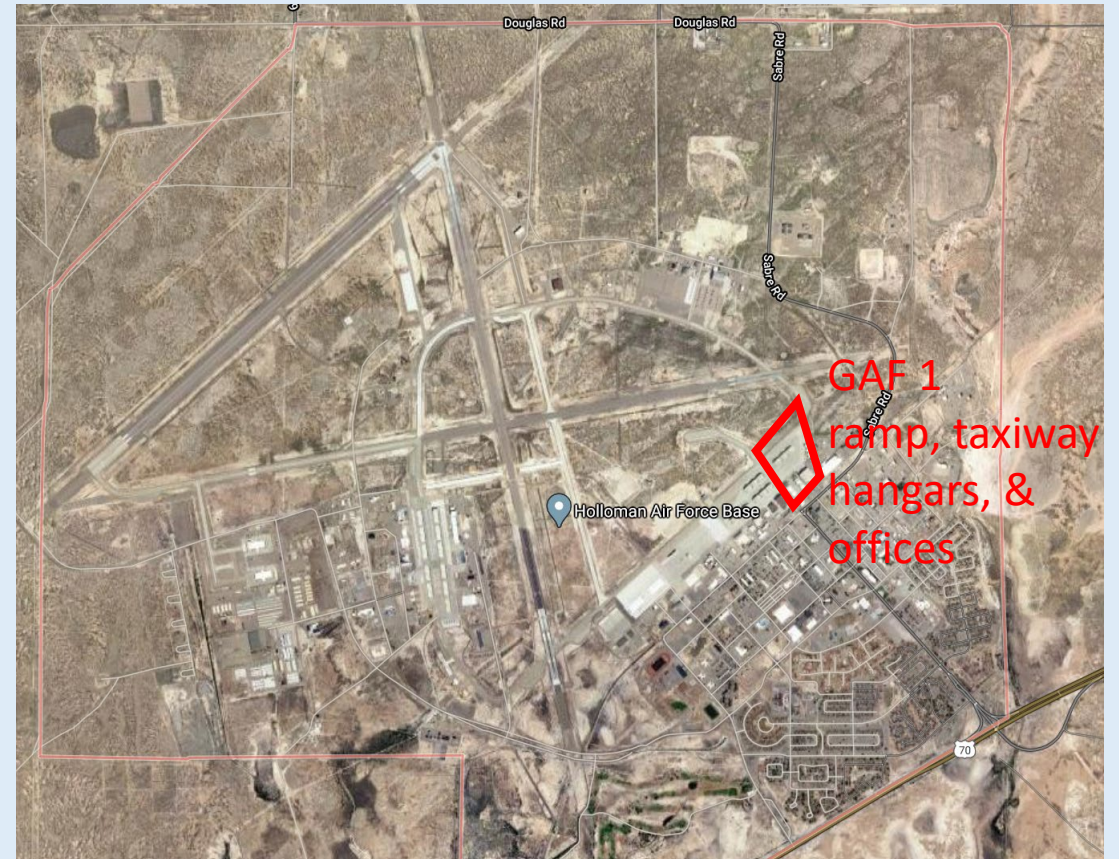
HOLLOMAN AFB, NM

- Site Conditions
 - Fluctuating high water table
 - High sulfate content soils & ground water
 - 24" fill and Type V cement standard requirement on base
- GAF 1 project: extend apron & add hanger
- Another project removing 5- to 38-year old concrete pavements on base
- Removed pavement structurally inadequate for new mission but in good shape and all made with Type V sulfate resistant cement
- Removed pavement crushed to base course gradation and placed 24- to 60-inches thick under all GAF 1 facilities
