Repaired Reinforced Concrete Wall Buildings in Chile After 2010 Earthquake

M. A. Hube¹, H Santa María¹, H.A. Gálvez², R. Jünemann³

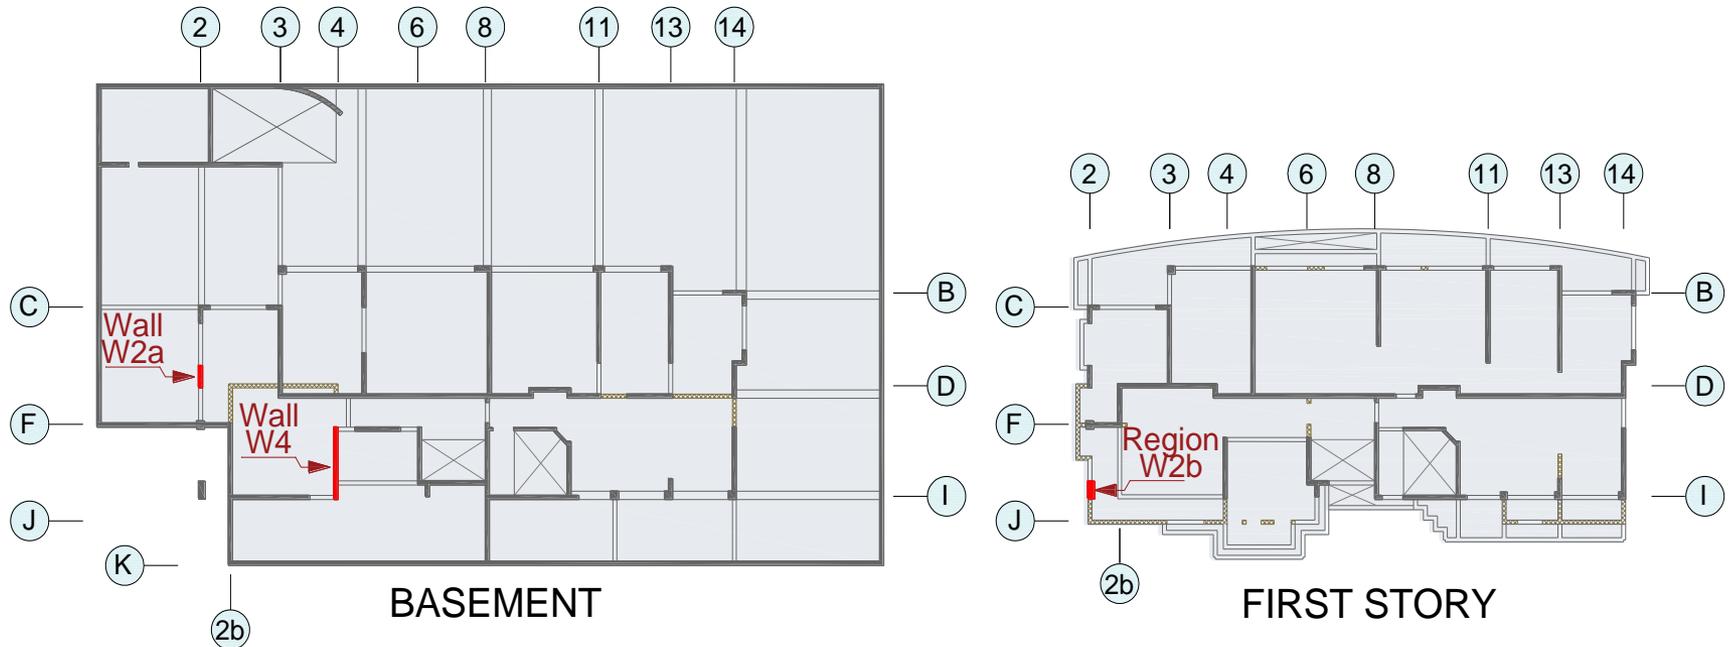
- Located in Viña del Mar
- Built in 1998
- 11 stories and one basement
- Damage concentrated mainly in two walls

- Flexural strength and deformation capacity of unconfined walls was improved by adding special boundary elements.

- Shear strength was improved by increasing the wall thickness or using FRP

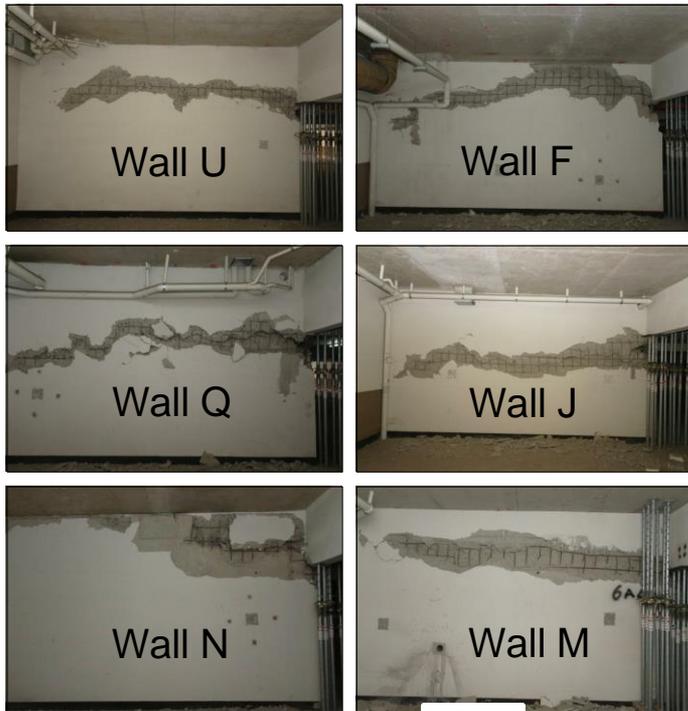
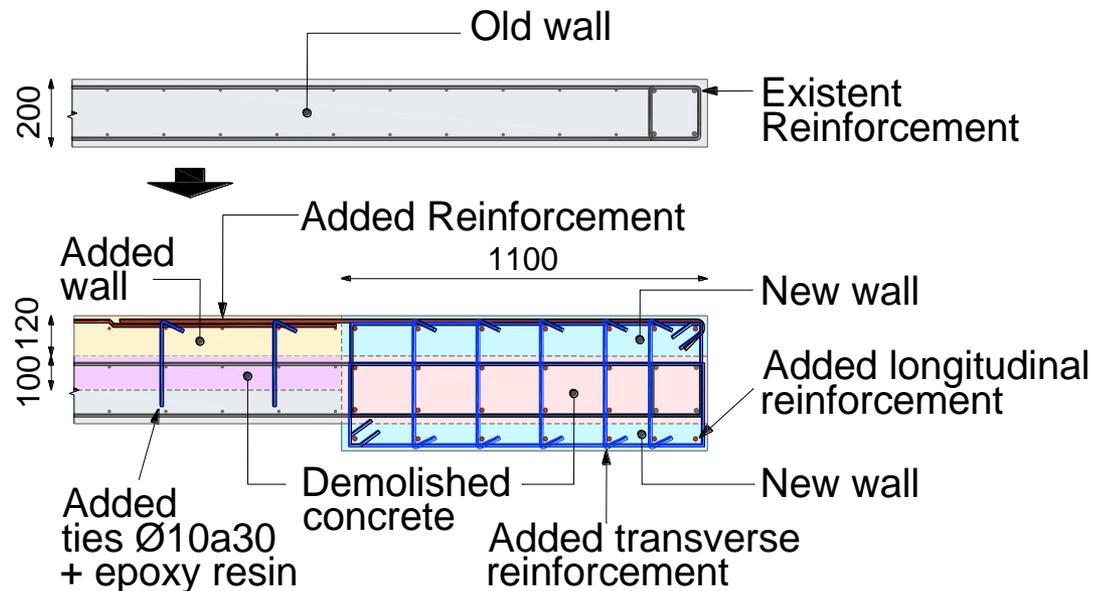
- Two towers of 18 stories and 2 basements
- Built in 2007
- Severe damage in walls

- Walls were repaired and strengthened by adding boundary elements and increasing the wall thickness
