Evaluation of Concrete Prior to Rehabilitation

John S. Lund, PE, FACI
Principal, Investigative Engineering

October 22, 2019

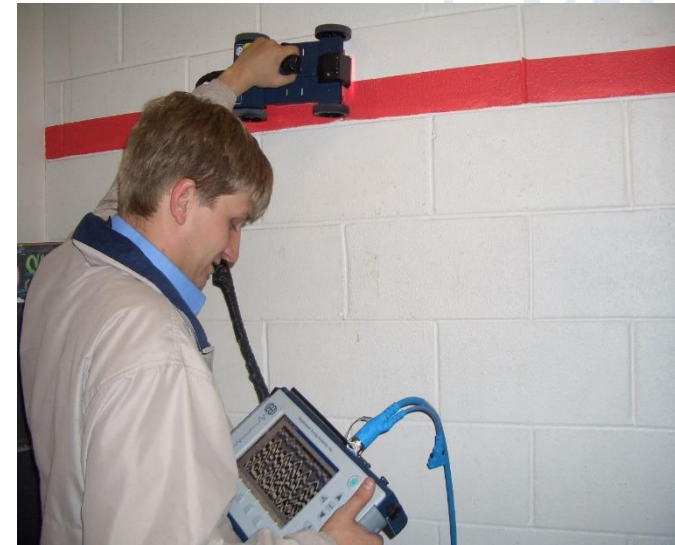
Ground-Penetrating Radar (GPR)

Not used because of mesh in tee legs

- Easy to Perform
- Immediate Results
- Limitations include:
 - Moisture in Concrete
 - Steel Fibers in Concrete
 - Excessive Reinforcing Congestion
 - Cannot Determine Exact Bar Size

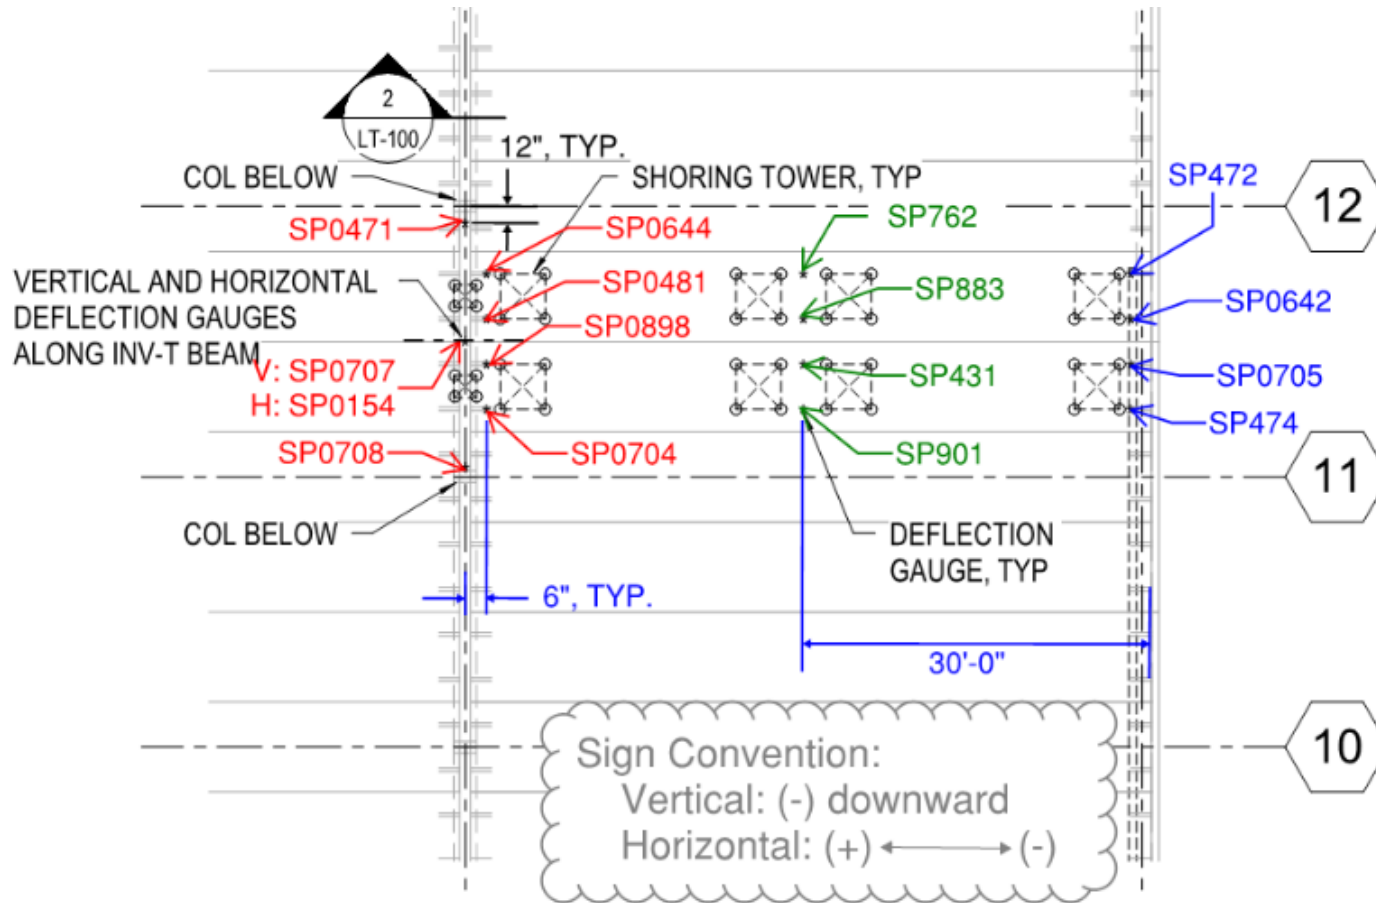
Locations of Deflection Gauges (LVDTs)
and Shoring Towers

Shoring was installed below the test area, and deflections were monitored at each of the load steps

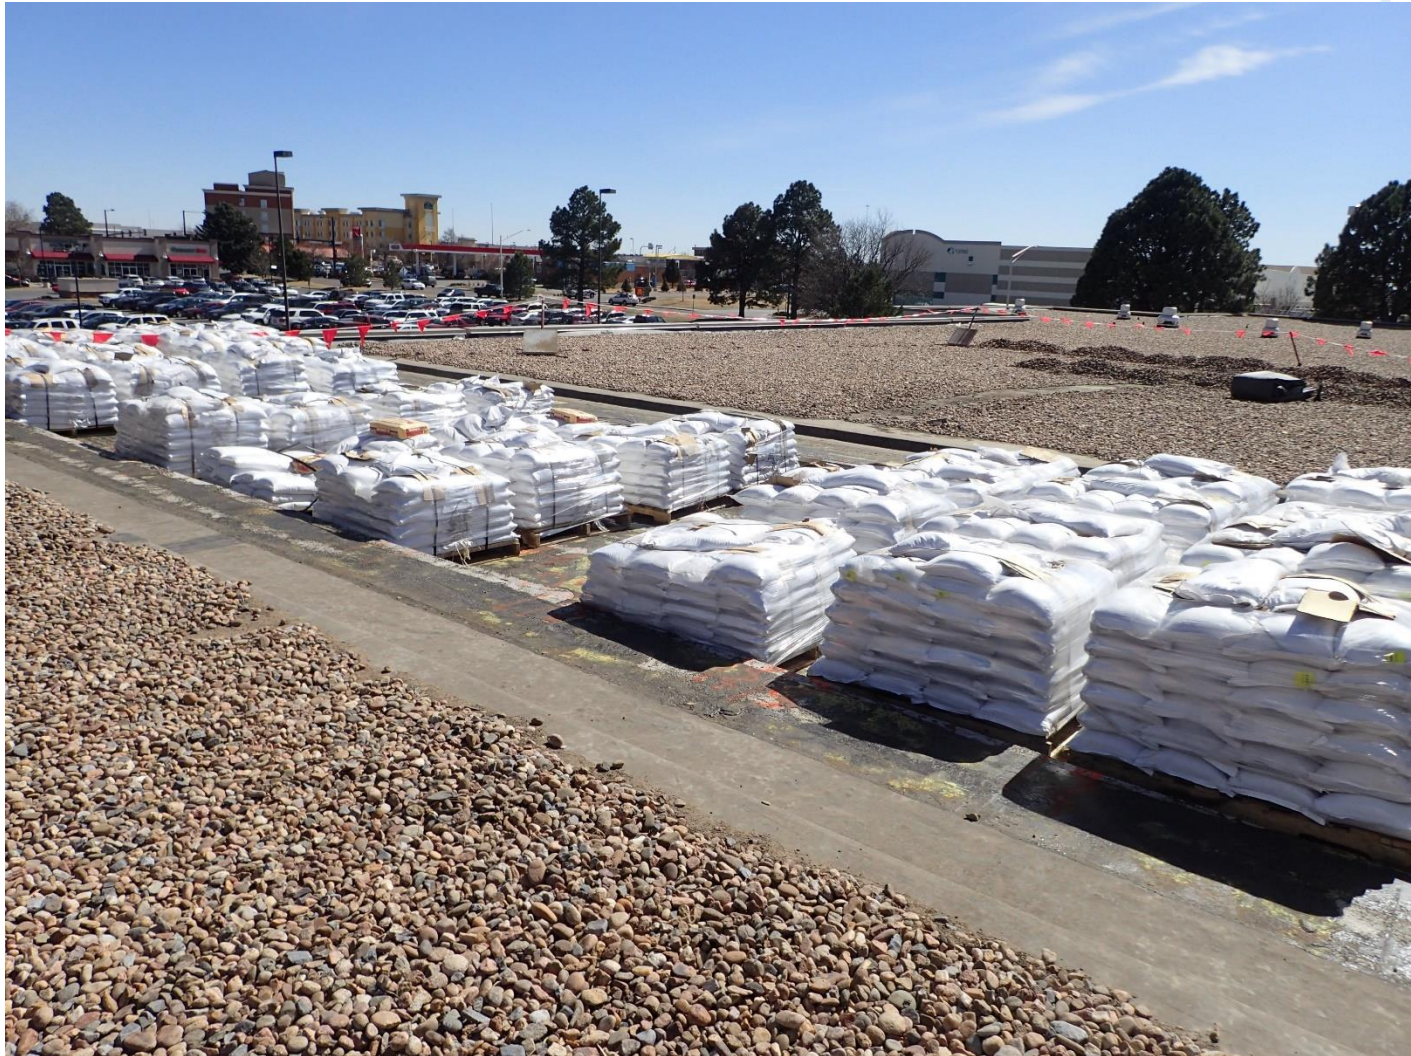
Load Testing in Progress

Loads were applied using pallets of sandbags with cranes from the adjacent parking lot

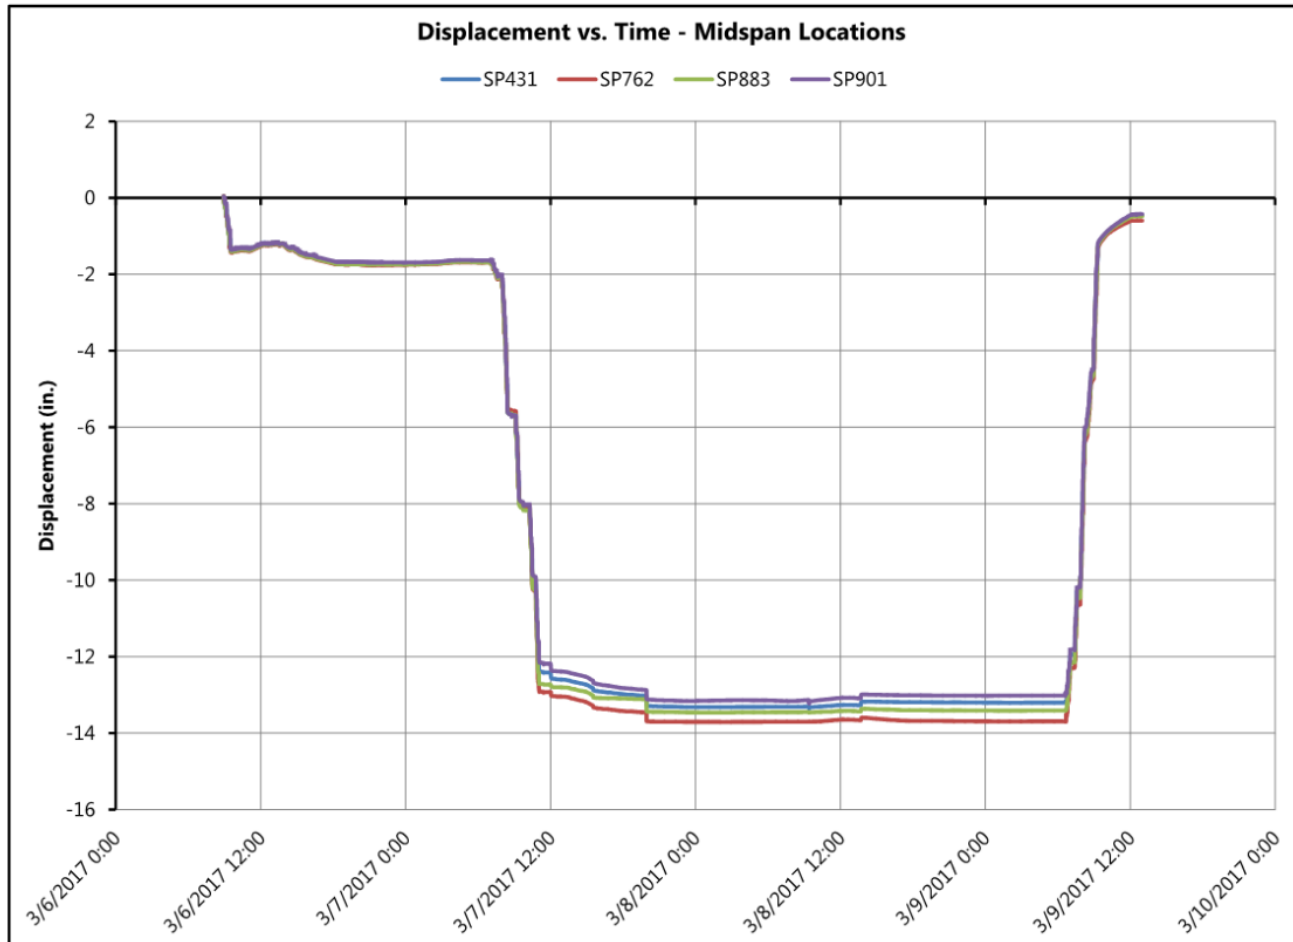
Results

Rebound within ACI Limits, Minor flexural cracking in Tees
No shear cracking in Tees or Inverted Tee Beams

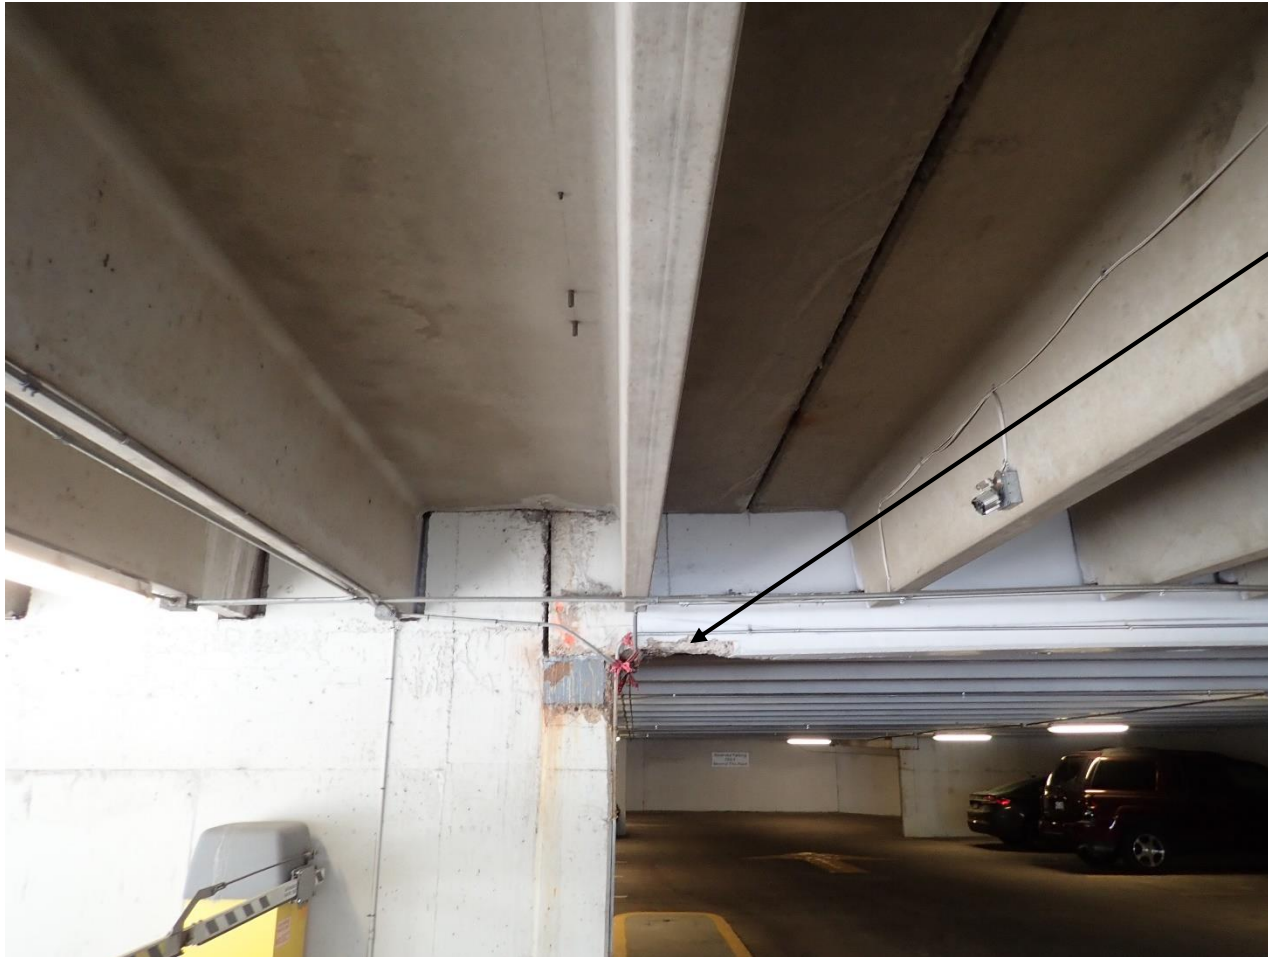
Location of
damage

Initial concrete removal revealed damage to bearing and
torsion reinforcement

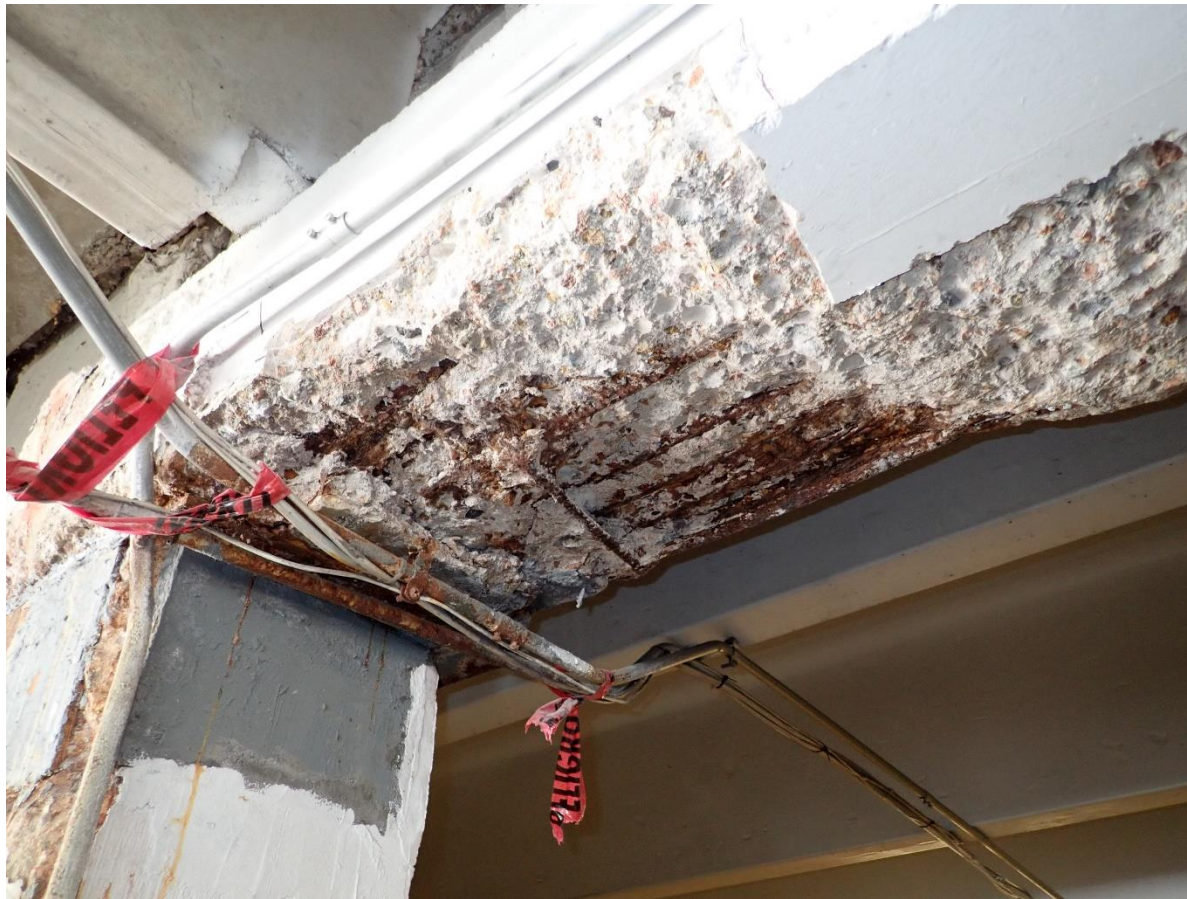
Initial concrete removal on the Ell beam revealed severely corroded prestressing steel, and potentially significant concrete deterioration in the beam bearing area.

At this time, we did not yet know extent of damage but installed shoring prior to any additional concrete removal. This work was part of a larger concrete repair project at the garage.

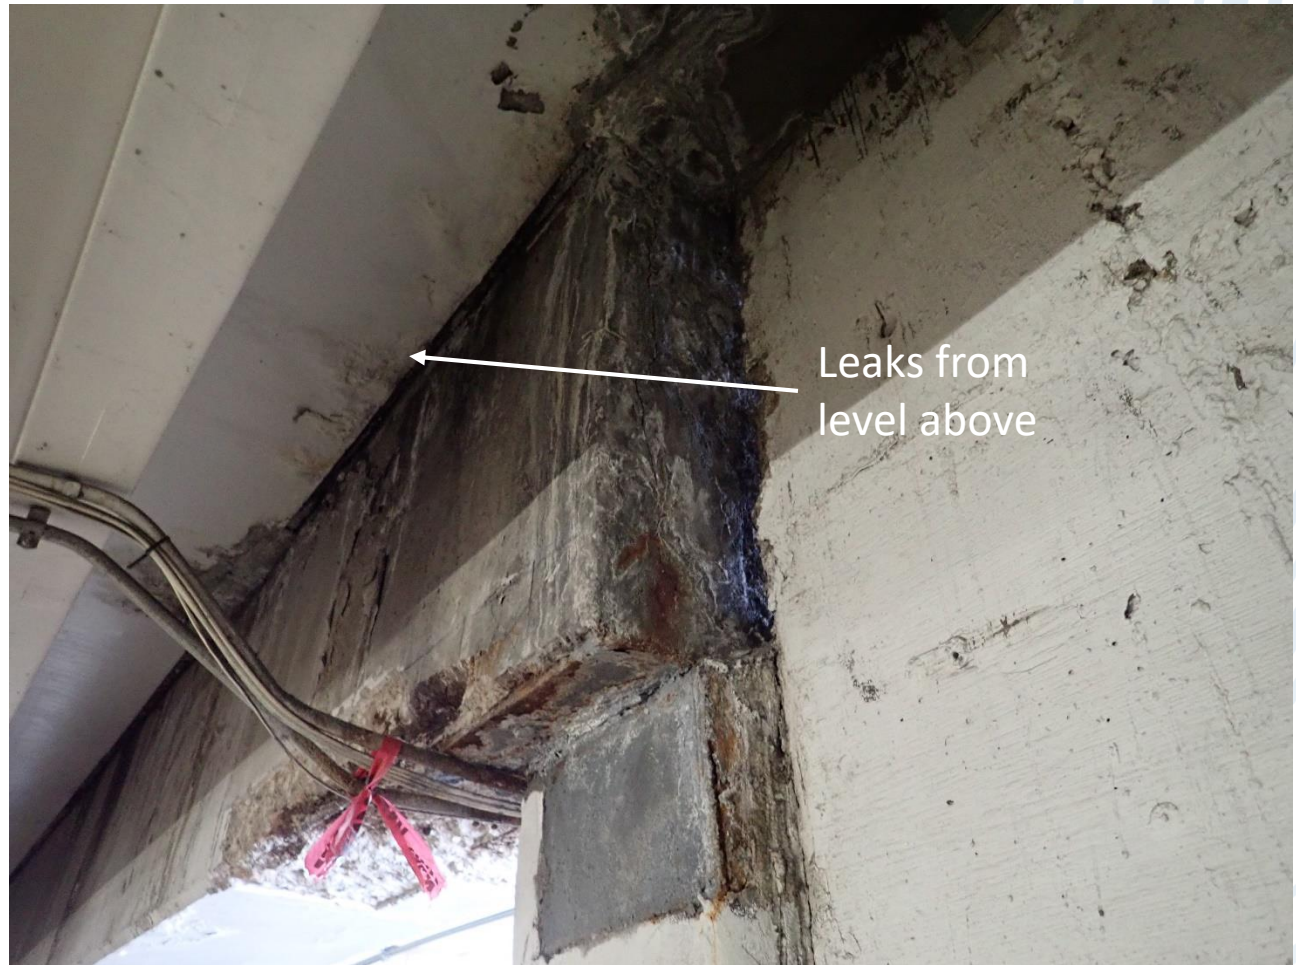
As additional concrete was removed, we discovered:

- Closed stirrups at the beam were corroded and broken in places.
- Extensive corrosion of prestressing tendons
- Large amount of concrete loss within development zone for the prestressing tendons

The cause of the corrosion was determined to be salt-laden water leaking from the level above, due to poor drainage and a failed sealant joint (Deferred Maintenance)

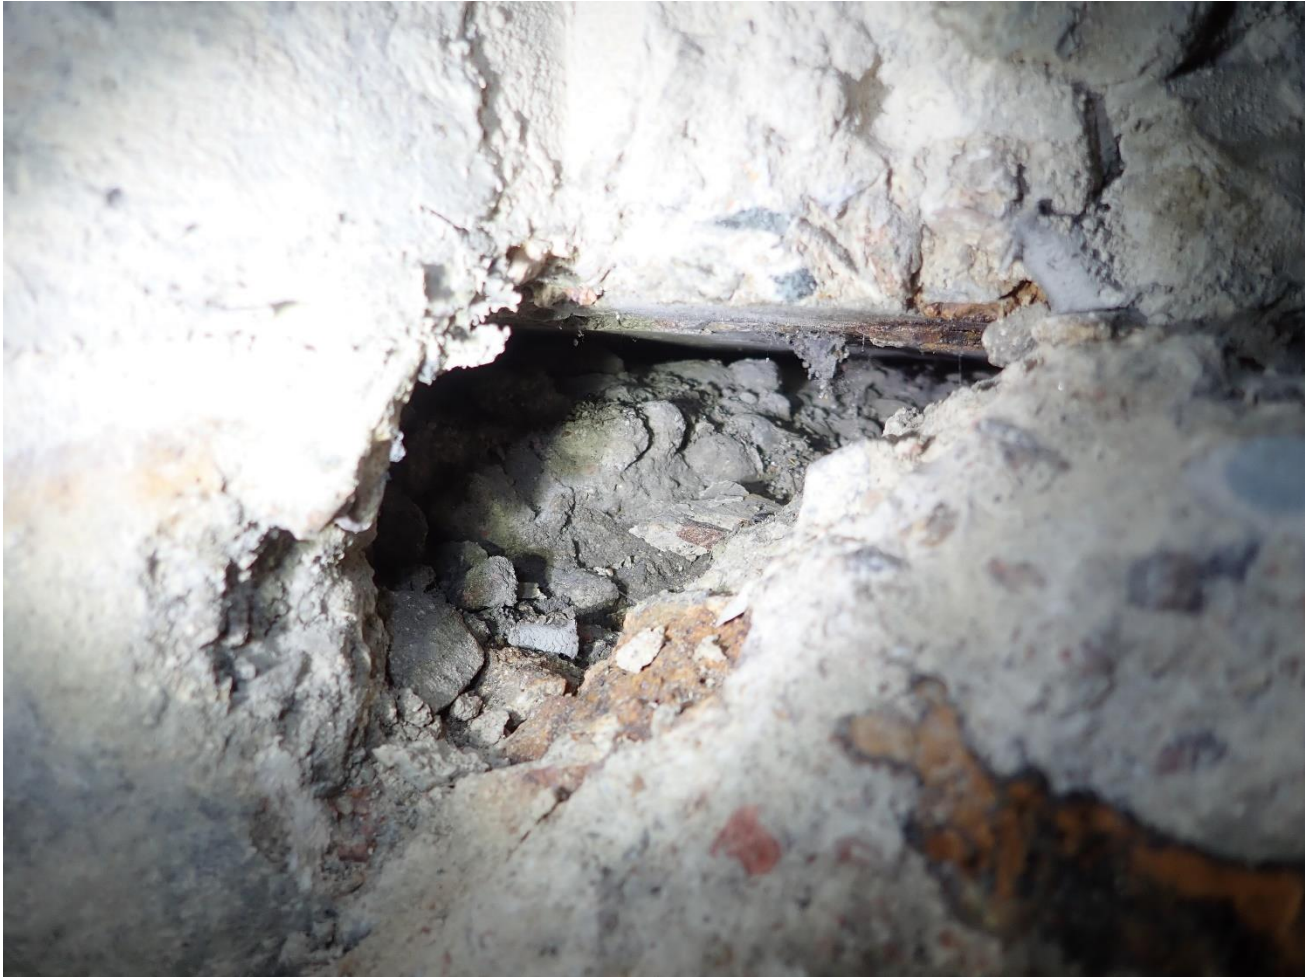
Void below Column

When removing deteriorated concrete from the level above, a void below the cast-in-place concrete column was identified.

Note that the column is cast integral with the adjacent CIP concrete wall

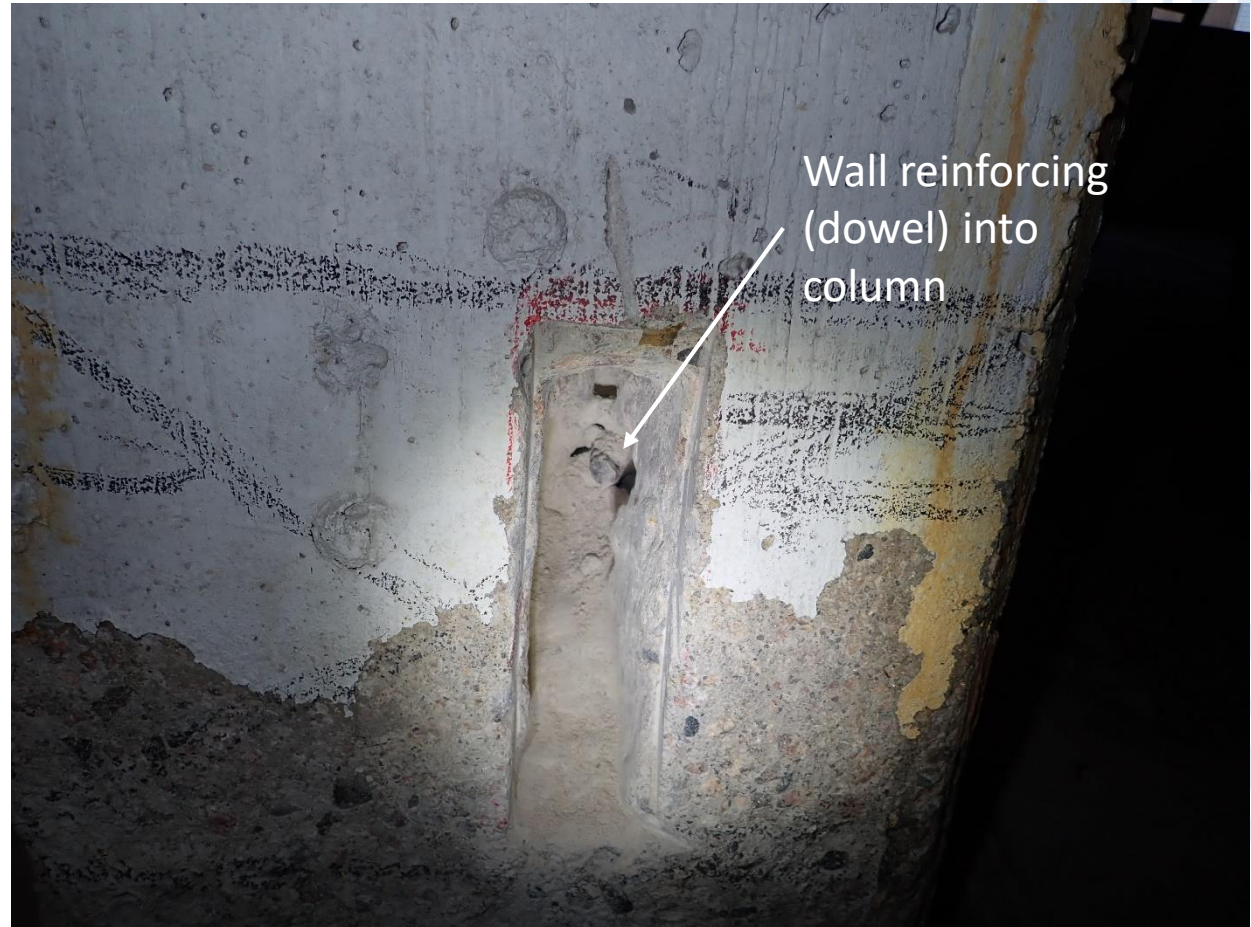
Wall reinforcing, acting as dowels, only extended approximately 6 inches from the wall into the column

In order to determine the presence of dowels, we performed GPR testing of the column, followed by selective demolition

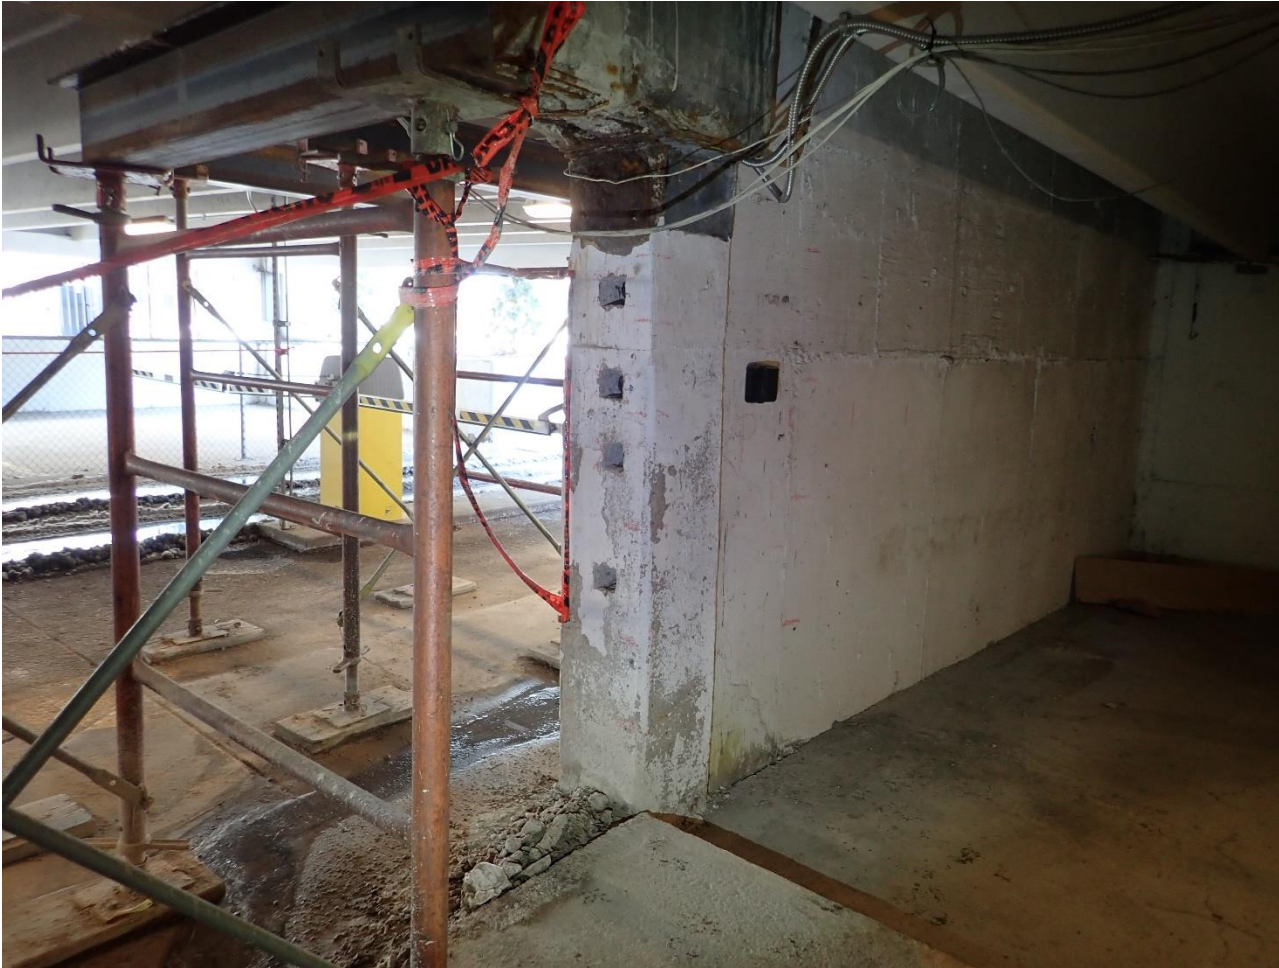
Dowels were installed with the structure shored

We performed an analysis of the wall to determine if it can take the column load, then designed a repair capable of transferring all the column load into the wall at each floor level

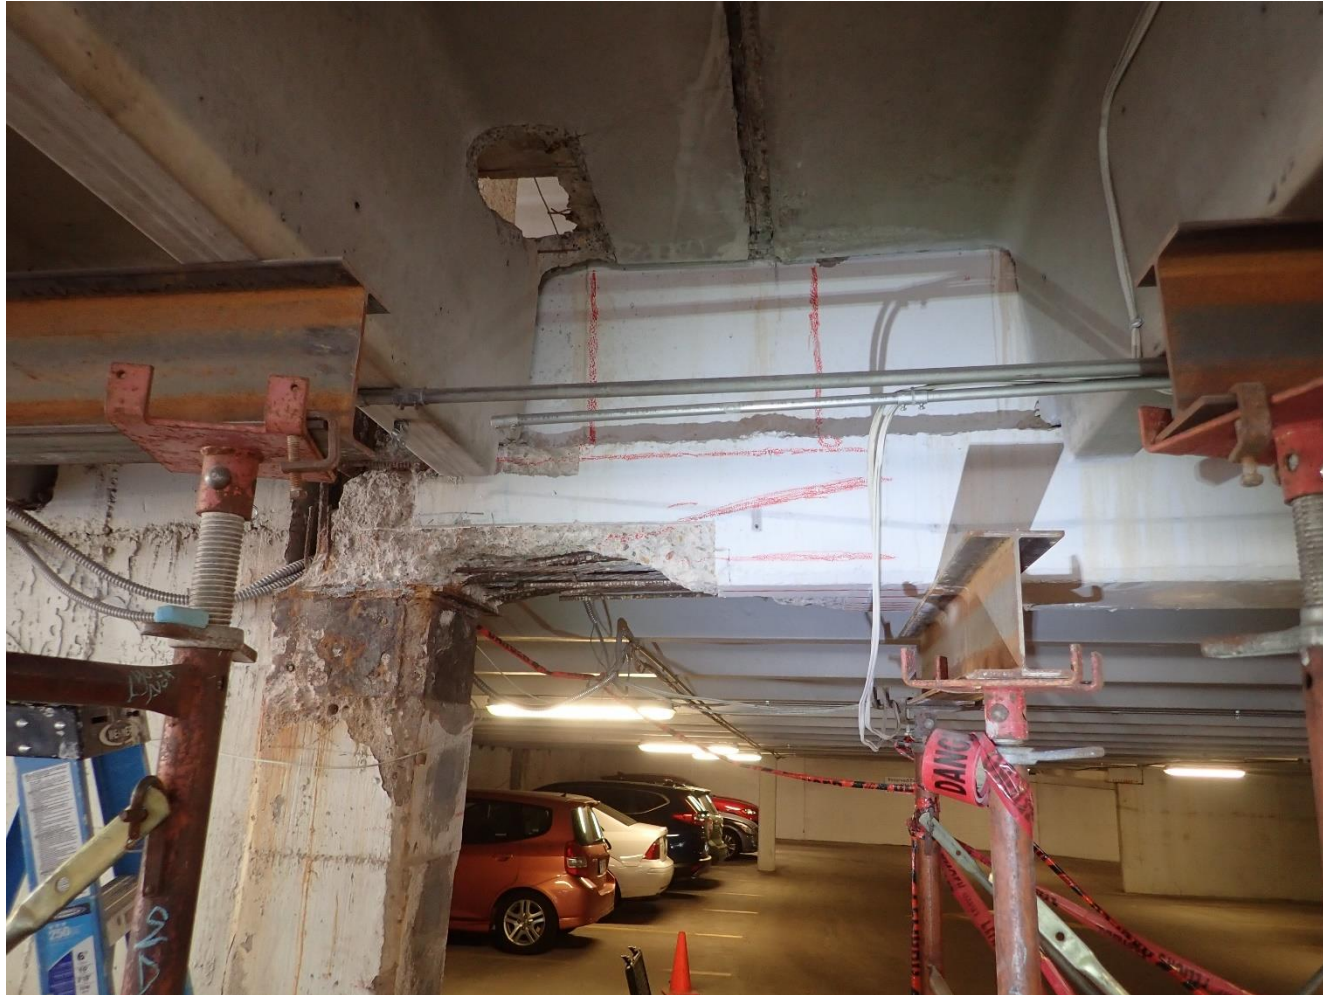
After dowels were installed, concrete removal continued to sound concrete and undamaged reinforcing

Note markings on Ell Beam from GPR Reinforcing Location

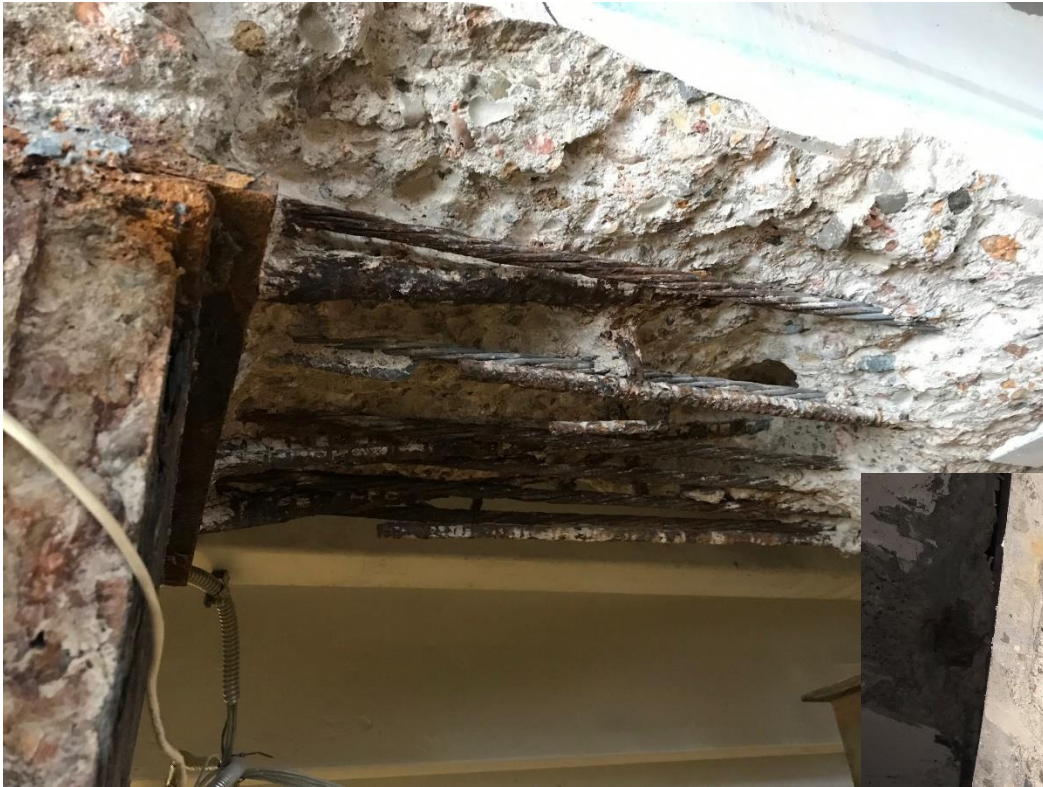
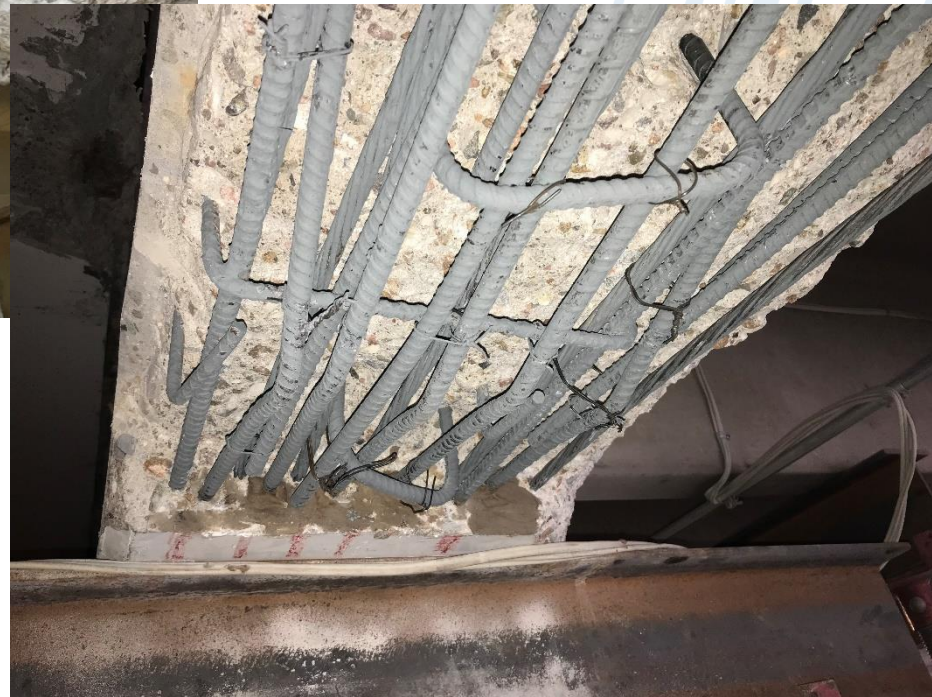
Reinforcing before and after repair
Supplemental reinforcing added

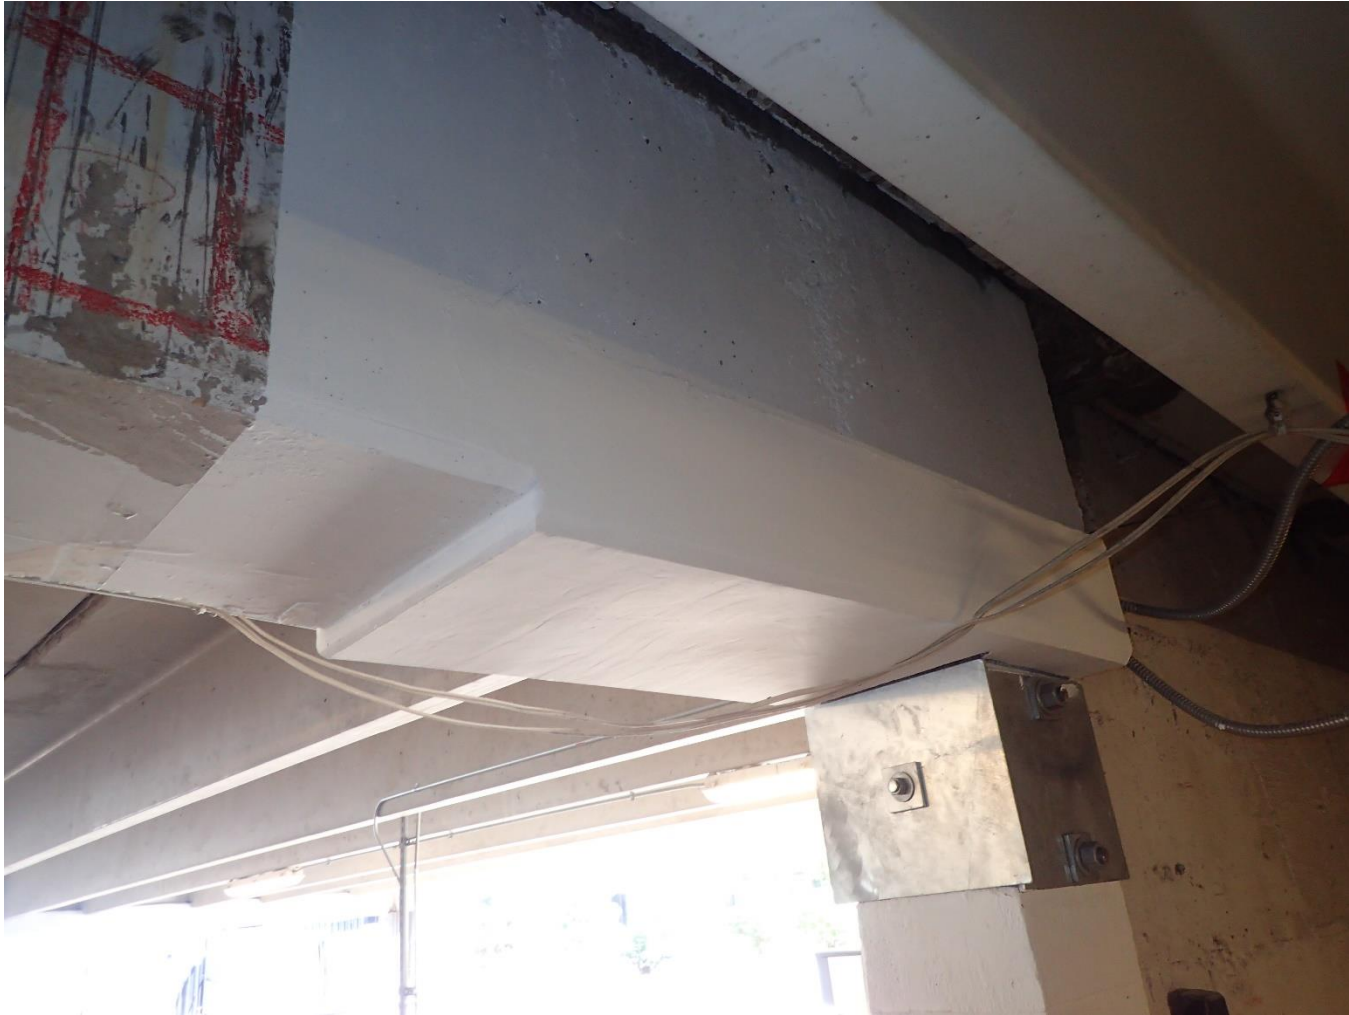
Completed Repair – Drop in beam soffit installed to provide additional cover for reinforcing (not in drive aisle)

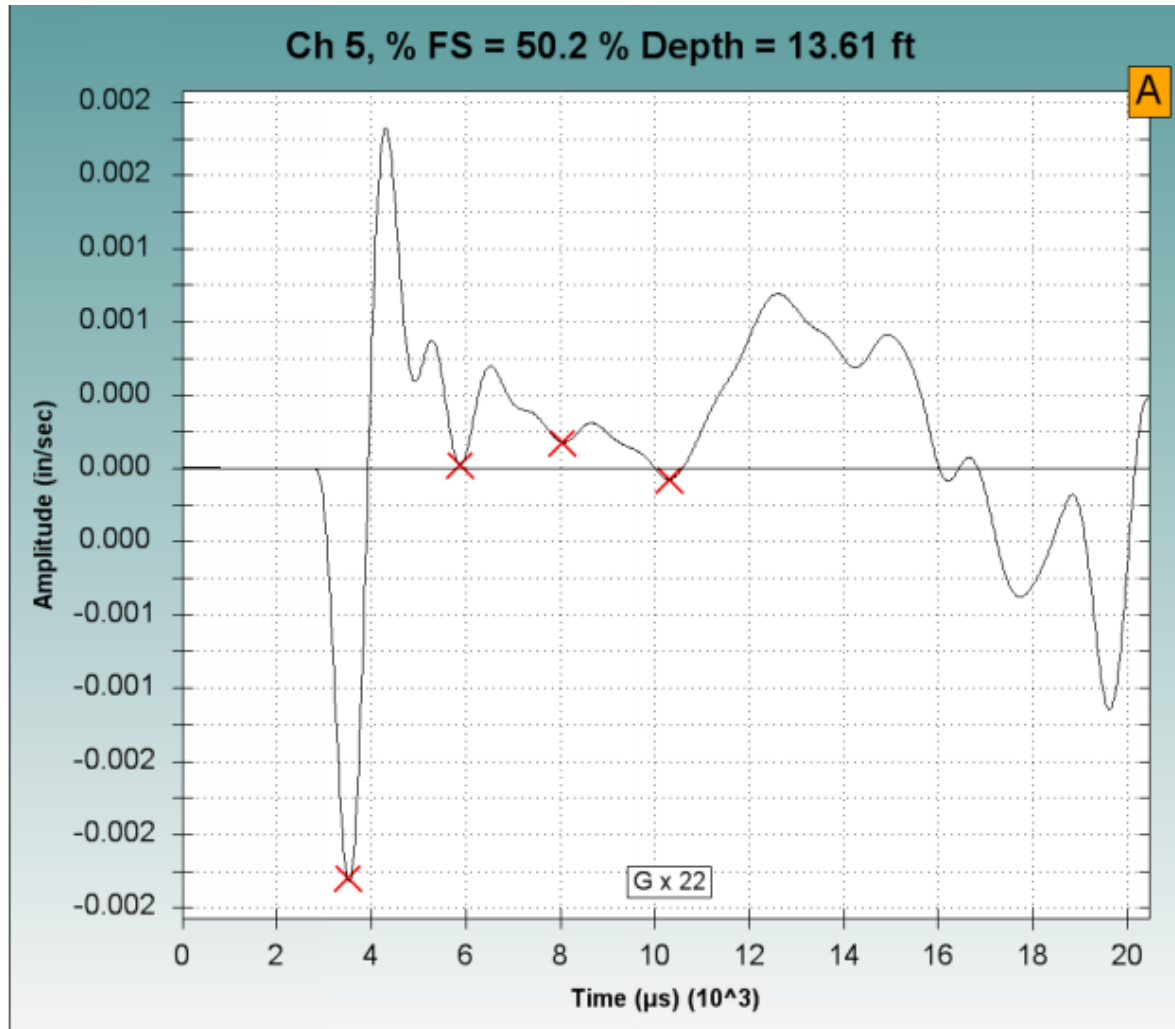
Defective Pier – Short, Broken or Cold Joint at a depth of 13.6 feet
Recommended replacement with a micropile
