# Experimental Study on Repairing and Strengthening Seismically Damaged RC Frames by Installing H-Shaped Steel

Seismic disaster investigations worldwide have revealed that a large number of reinforced concrete (RC) frame structures have been damaged or even collapsed. However, most of these buildings exhibit minor or moderate damage and can be repaired and strengthened. “Strong columns and weak beams, strong joints and weak components” is the concept of seismic design of buildings, and the failure of beam–column joints and columns is considered nonideal. For RC frame structures with damaged joints and columns, a method for repairing and strengthening damaged frames by installing *H*-shaped steel and pouring grout is proposed. By applying a pseudo static load, a frame structure specimen was damaged to simulate earthquake damage. After removing the crushed concrete, the damaged frame was repaired by pouring grout. Then, the structure was further strengthened by installing *H*-shaped steel on the columns using post-installed anchors. Through loading tests, seismic indices such as strength, deformation capacity, energy dissipation and failure mode of the frame before and after strengt

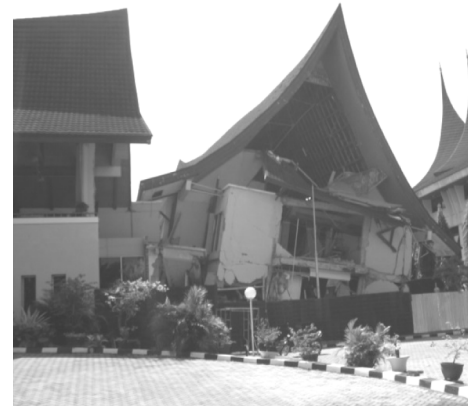
**Fig. 1** View and details of the target building

(a) View of the building and its damaged beam-column joint (Yasushi Sanada et al 2013)

(b) Dimensions and reinforcement details of the studied exterior joint (Sashima Y et al 2011)

Based on previous studies (Sashima et al., 2011, Sanada et al., 2013), a collapsed frame building in the 2009 Sumatra earthquake was taken as the prototype building to design the specimen. The building and details of the beam and column are shown in Fig. 1. In this building, severe damage, e.g., buckling of the column longitudinal reinforcement and core concrete crushing, was observed in the joints. The significant characteristics of the building are that instead of 135° hooks, the hoops in the beams and columns are 90° hooked, and the beam–column joint areas contain no hoops. A 1/2 scaled two-story, two-span specimen F is manufactured as shown in Fig. 2 (the frame

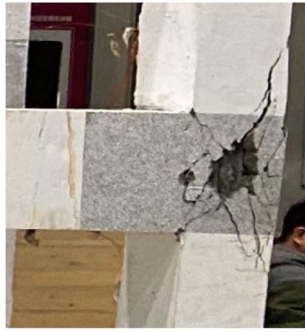
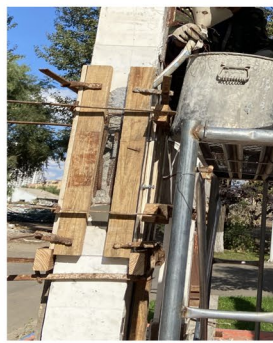
**Fig. 3** Repair and strengthening of the damaged of specimen F

(a) Damage to the exterior joint of specimen F

(b) Crushed concrete chipping

(c) Grout pouring

(d) Repair and strengthening process

After it was subjected to cyclic static loads, specimen F, which was used for simulating a seismically damaged existing frame structure, was severely damaged and then repaired and strengthened, forming specimen FR (retrofitted frame), as shown in Fig. 1. The severely crushed concrete in specimen F was repaired using grout, as shown in Fig. 3, with the following steps: chipping away the crushed concrete with an electric hammer, cleaning the surface where the concrete was chipped with an air pump, installing the formwork for grout, wetting the interface of the existing concrete, mixing and pouring the grout, and then removing the formwork after 24 h curing. The grout used is a kind of high-strength nonshrinkage grout with a compressive strength of 54.6 MPa. Then, the repaired specimen was further strengthened by installing *H*-shaped steel with a size of 200×200×8×12 next to the existing columns. At the top and bottom of the *H*-shaped steel, a steel plate was welded for connection with the beams. As shown in Fig. 2a, horizontal stiffeners were welded in pairs on some of the *H*-shaped steels, with one pair for each steel adjacent to the right columns and two pairs for each steel adjacent to the middle columns, to study the effectiveness of the stiffeners on the strengthening effect.

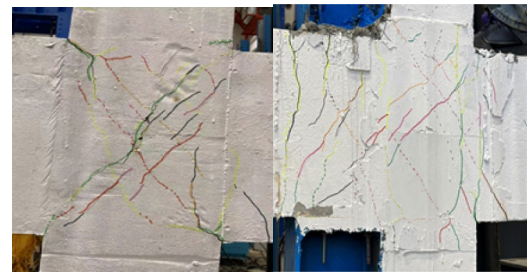
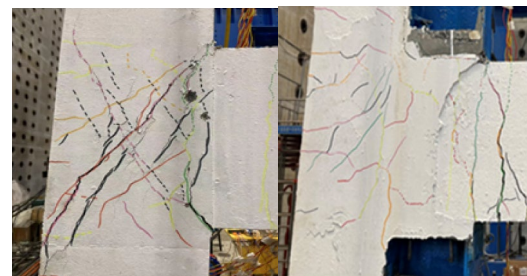
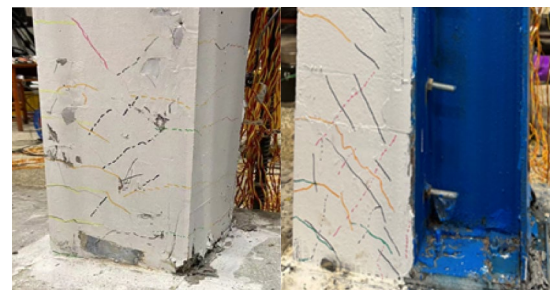
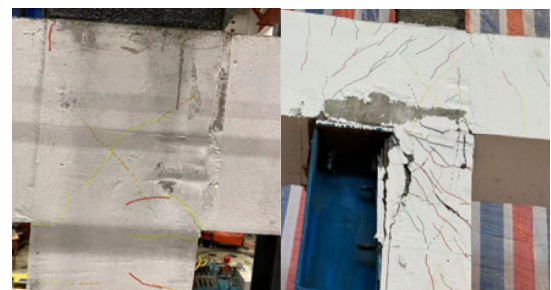
(a) Middle joint  
in specimen F

(b) Middle joint,  
in specimen FR

(c) Left joint  
in specimen F

(d) Left joint  
in specimen FR

(e) Left column bottom  
in specimen F

(f) Left column bottom  
in specimen FR

(g) middle column top  
in specimen F

(h) middle column top  
in specimen FR

**Fig. 6** Comparison of damage at each node of two specimens at maximum bearing capacity ( $R=3\%$ )

The crack patterns at the maximum strength ( $R=3\%$ ) of specimen F, which represents the seismically damaged frame, and specimen FR, which represents the repaired and strengthened frames, are shown in Fig. 6. The final crack patterns are shown in Fig. 7. The damage process is as follows.

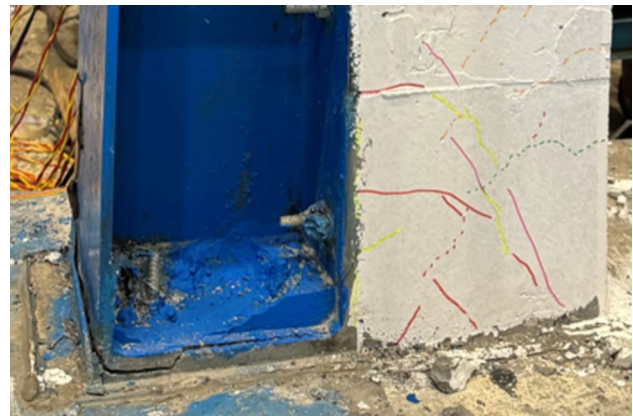
**Fig. 8** End plate of  $H$ -shaped steel warping ( $R=1.0\%$ )

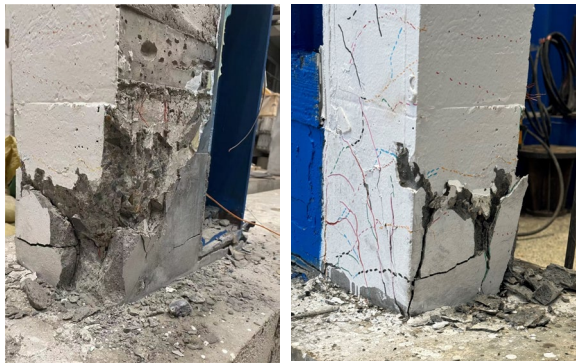
(a) Left column bottom (b) Right column bottom

**Fig. 21** Final damage to the bottom of the columns in specimen FR

Severe damage to the column bottom at the first floor of specimen FR was observed as shown in Fig. 21, with the concrete crushed and peeling off. However, the *H*-shaped steel did not yield as anticipated due to the warping of the bottom plate which was connected with the lower fixing stub as shown in Fig. 22. From the damage condition, it can be concluded that plastic hinges were formed at the column bottom of the first floor for the both specimens. All the joints at the first floor of specimen F were severely damaged by the formation of a joint hinge mechanism. After repair and strengthening, although many thin diagonal cracks appeared in the exterior joints of specimen FR, the main damage was concentrated in the beam ends, with concrete crushing, longitudinal reinforcement buckling, and the formation of plastic hinges at the beam ends. For the interior joint area, both the beam ends and the joint core area were severely damaged, but the joint damage was controlled considerably compared with that

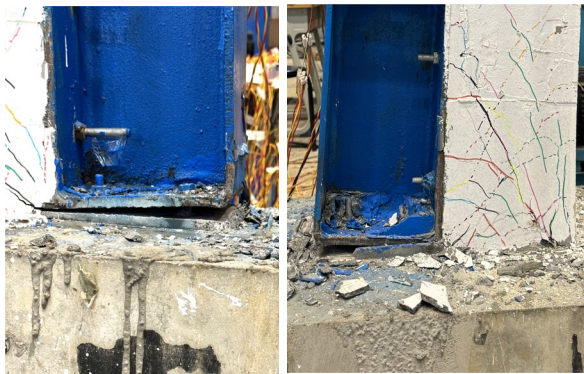
(a) Left column bottom, at negative loading (b) Right column bottom, at positive loading

**Fig. 22** *H*-steel warping at the bottom of the column at the first floor
