Performance Evaluation of Sprayed Ductile Fiber-Reinforced Mortar as a Repairing Material

Abstract: Most of existing repair materials have some shortcomings such as brittle fracture, imperfect interface bonding and marked difference in modulus of elasticity compared with the structures. These problems make their repair inefficient. Some researches on using a fiber-reinforced mortar as an alternative to enhance the efficiency have been carried out recently. This paper presents the results of an experimental study on the performance of sprayed PVA fiber-reinforced mortar as a repair material. We evaluated its mechanical properties, durability and strengthening effect. This study shows that the sprayed PVA fiber-reinforced mortar is remarkably effective as a repair material.

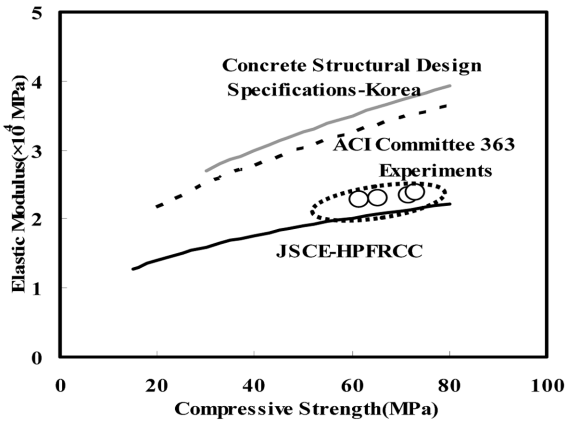
Fig. 4 Comparison of the elastic moduli of the sprayed fiber-reinforced mortar predicted by existing methods.

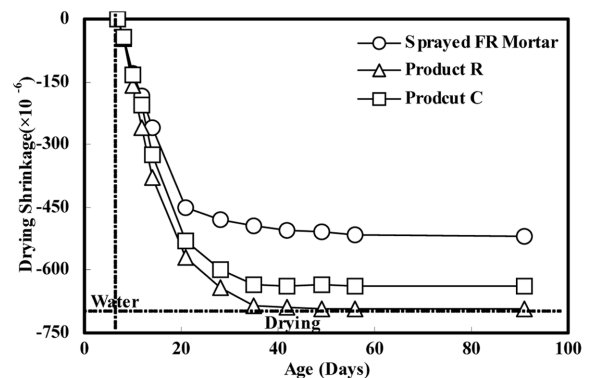
(a) Autogenous shrinkage

(b) Drying shrinkage

Fig. 7 Shrinkage characteristics according to the type of repair material.

Fig. 7 summarizes the results of the autogenous and drying shrinkage test. The autogenous and drying shrinkage strains, developed by the sprayed fiber-reinforced mortar, appear to be smaller by about 30~40% and 20%, respectively, compared to those of existing repair materials. The small shrinkage developed in the sprayed fiber-reinforced mortar is due to the use of shrinkage reducing agents and CSA-type expansion agents as well as the admixing of PVA fiber.

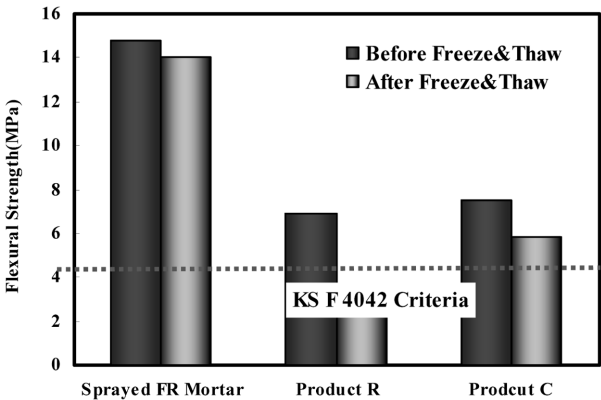
Fig. 12 Change in the flexural strength before and after freezing-thawing test.

Fig. 12 plots the variation of the flexural strength before and after the freezing-thawing test. Even if the existing products without the fiber reinforcement satisfied the criteria of KS F 4042 before the test, their flexural strength dropped below 6 MPa after the completion of the test. However, the sprayed fiber-reinforced

mortar showed an insignificant variation of the flexural strength before and after the freezing-thawing test, thus satisfying the KS standards. Consequently, the existing products exhibit degradation due to the action of freezing-thawing leading to the drop of the flexural strength below the KS criteria, which is likely to initiate cracking in the repair layer, while the sprayed fiber-reinforced mortar appears to be immune to the action of freezing and thawing.
