Guide to the Code for Assessment, Repair, and Rehabilitation of Existing Concrete Structures

A Companion to *ACI 562-19*

ACI MNL-3(20)

Third Edition

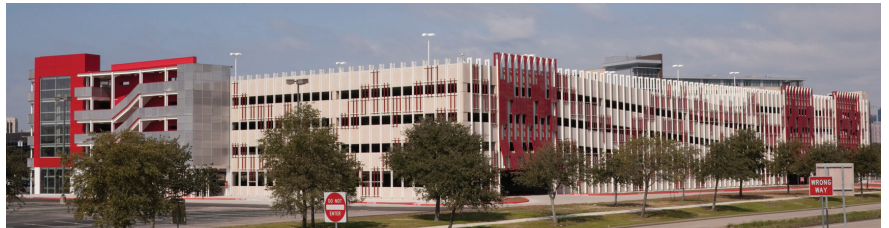
Fig. 1—University of Houston East Garage

The University of Houston’s 2006 Campus Framework Plan included the addition of parking spaces to accommodate the growing population of students. The East Garage was designed to meet the needs of students, faculty, visitors, and residents of the nearby campus lofts (Fig. 1). Utilizing a “double zero” ramp configuration, the garage was designed to have “nested” visitor parking with the capability to use the upper levels for overflow parking.

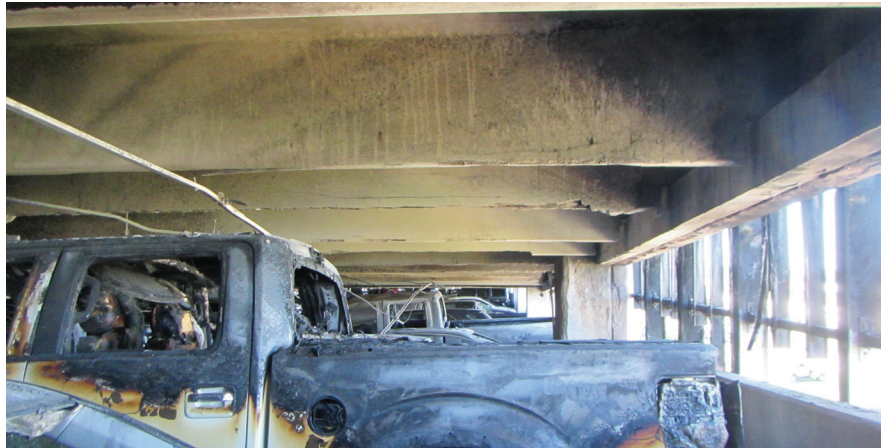
Fig. 2—Fire damage on Level 3 of parking garage

In April 2018, a multiple-vehicle fire occurred on the third level of the four-level University of Houston East Garage (Fig. 2). Significant structural damage occurred to two columns, the framing of the level above, and the exterior signage (Fig. 3). Before a survey of the damage could be completed, shoring was installed as a precaution to prevent the possible collapse of damaged members (Fig. 4).

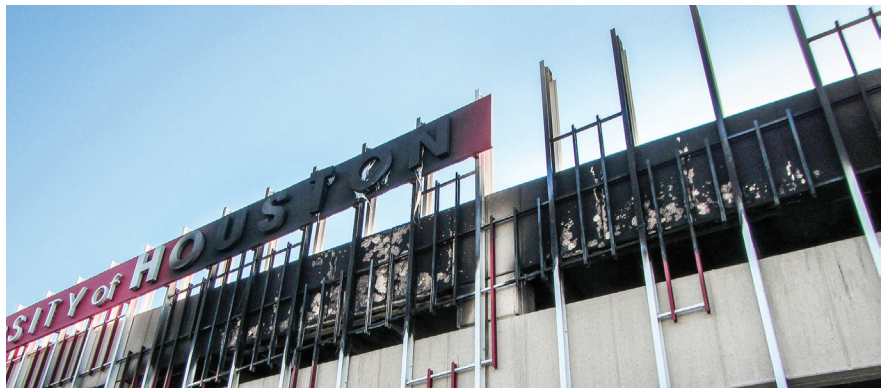
Fig. 3—Fire damage at exterior of garage

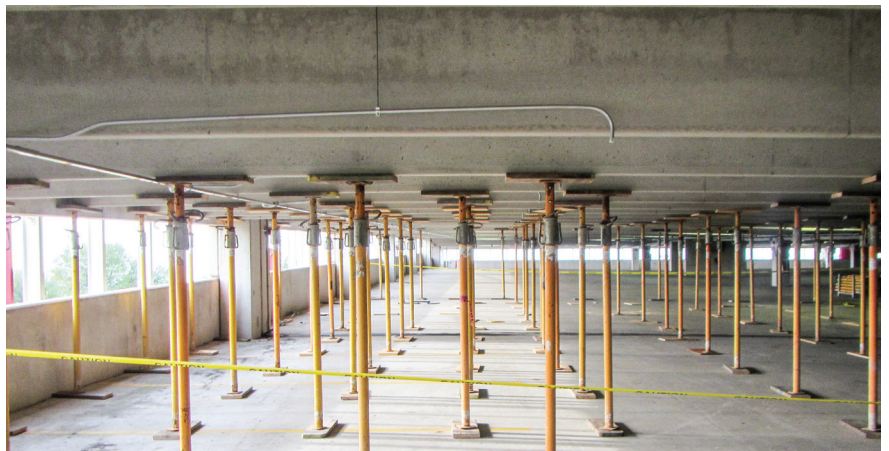
Fig. 4—Shoring installed in affected areas

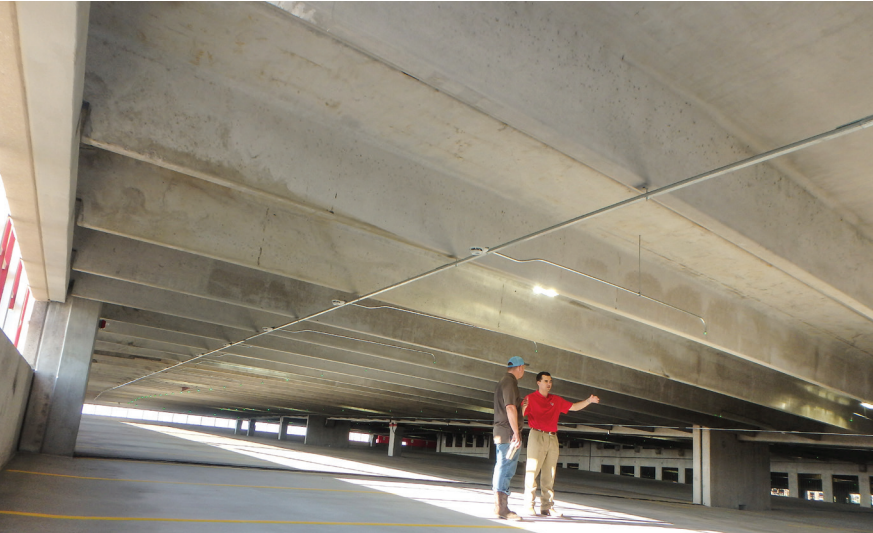
Fig. 8—New replacement double-tee beams at completion

reinstalled in their original position. Two spandrel beams were hoisted down, removed from the site, and replaced with new members (Fig. 7). New replacement double tees were hoisted into place for final repairs (Fig. 8).

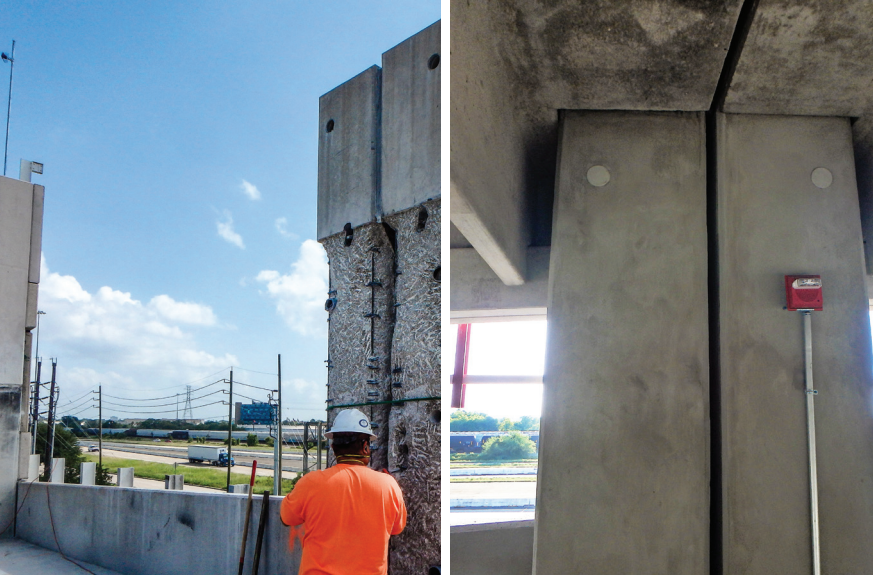
Fig. 9—Column during repair (left) and after repair (right)

Other repair works included the repair of concrete columns supporting Level 4 (Fig. 9), spandrel beams on Levels 3 and 4, double-tee members on Level 4, topping slab replacement on Level 3, and waterproofing installation on Levels 3 and 4. The damaged expansion joint system on Level 3 was replaced and a new expansion joint system was installed on Level 4. Joints were tooled in the topping slab and sealed above the double-tee flange-to-flange joints, and construction joints were routed and sealed. Cove sealant was installed at the perimeter bumper wall and columns.
