## Performance of Hybrid Moment-Resisting Precast Beam-Column Concrete Connections Subjected to Cyclic Loading

by William C. Stone, Geraldine S. Cheek, and John F. Stanton

*ACI Structural Journal*, V. 91, No. 2, March-April 1995.

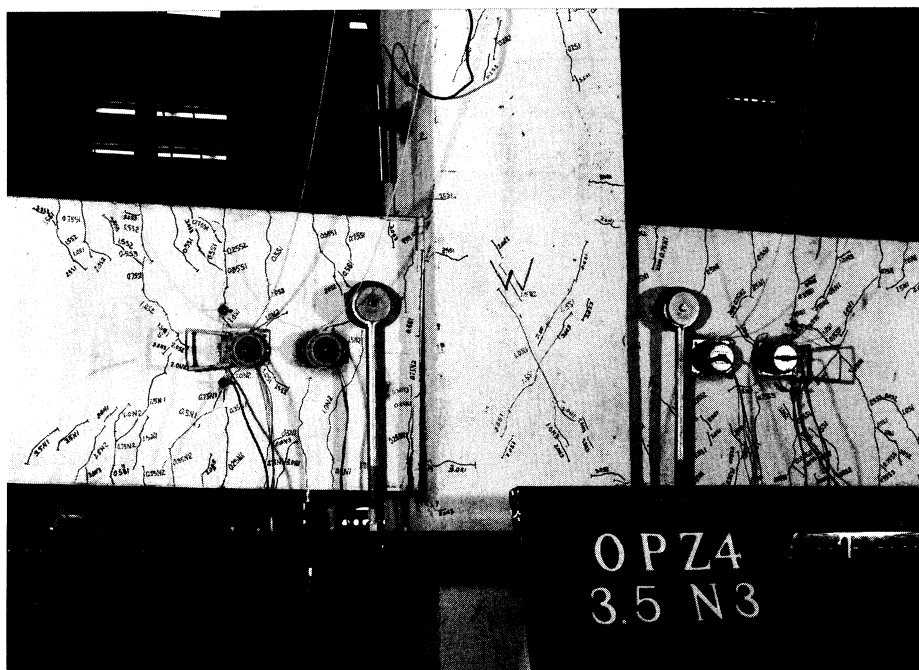
Fig. 23—O-P-Z4 at failure (3.4 percent story drift)

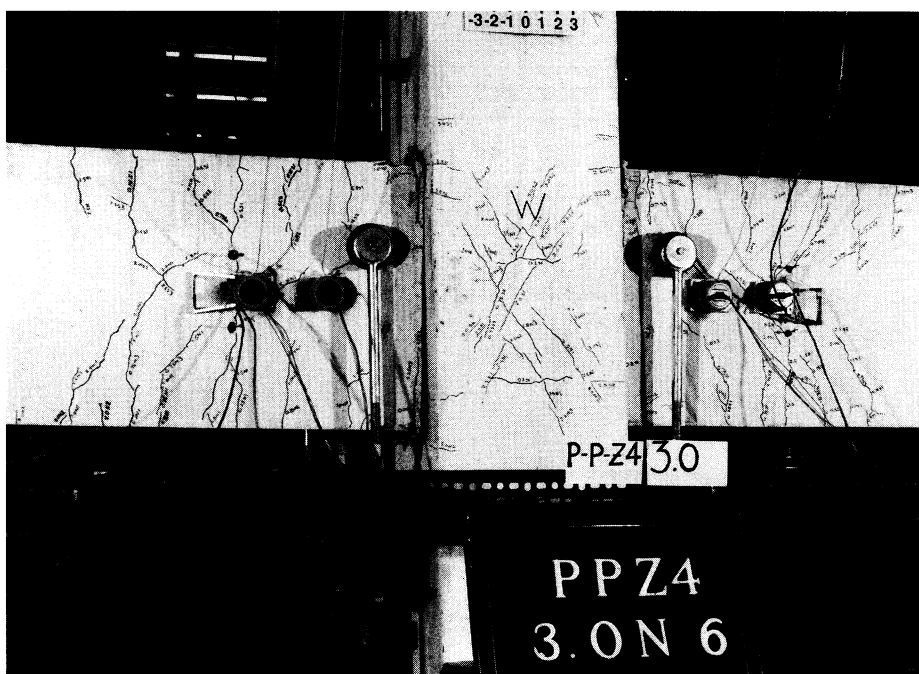
Fig. 24—P-P-Z4 at failure (2.9 percent story drift in aftershock)

percent drift and continued until bars fractured between 2 and 3 percent drift. Nominal failure occurred at 2.9 percent drift. Fig. 24 shows Specimen P-P-Z4 at failure.
