QuakeCoRE
NZ Centre for Earthquake Resilience

Damage to Concrete Buildings with Precast Floors in the 2016 Kaikoura Earthquake

Rick Henry and Ken Elwood
University of Auckland
New Zealand

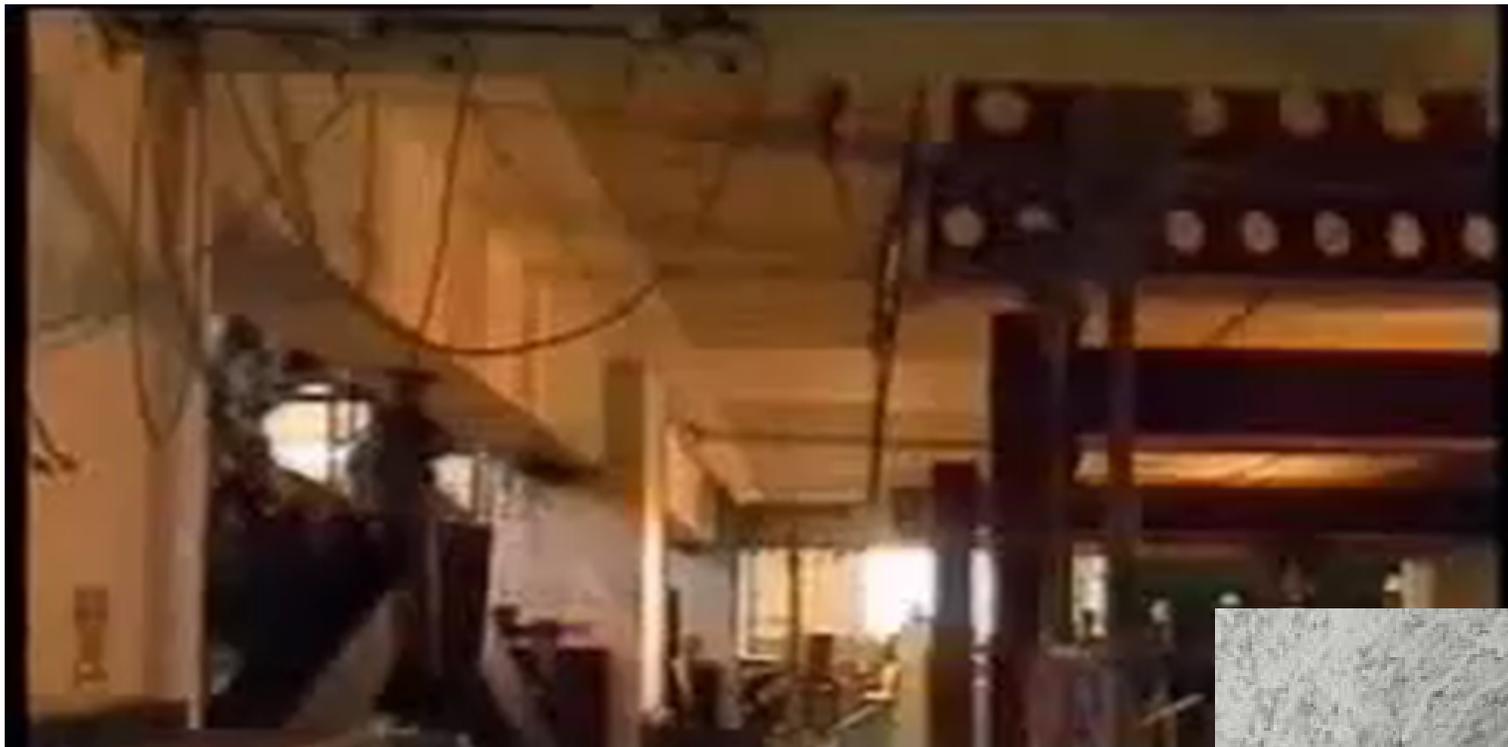
UoC test –
Matthews
(2004)

2.5% drift

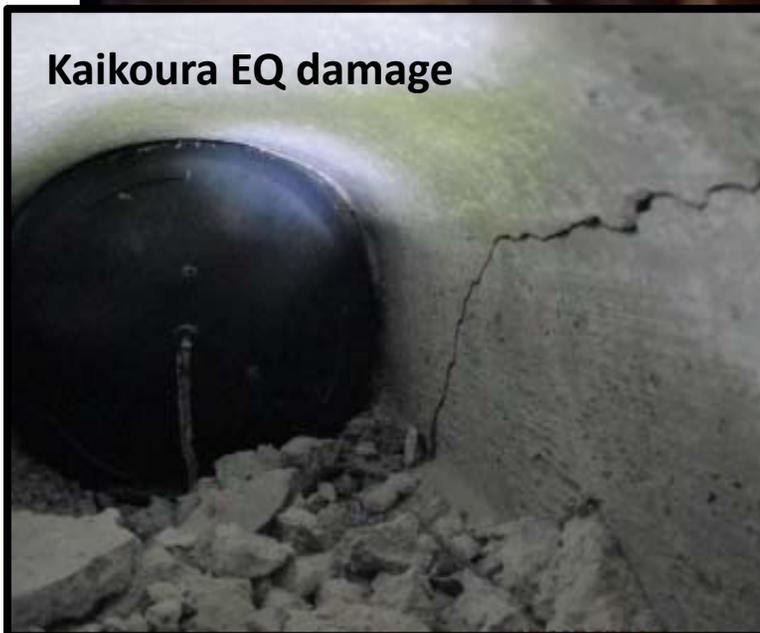
Incompatible displacements

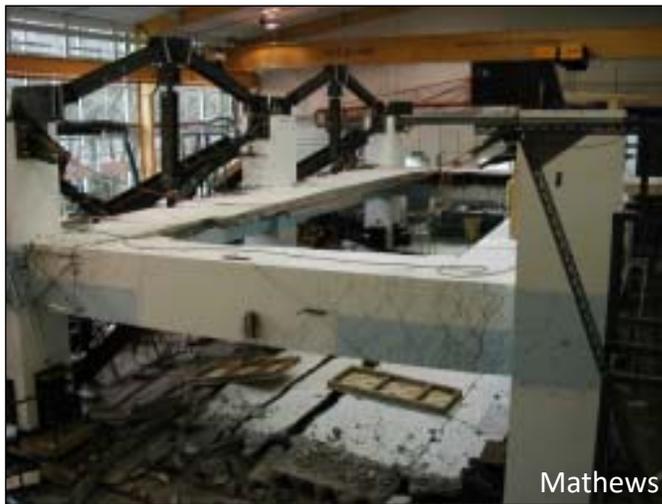
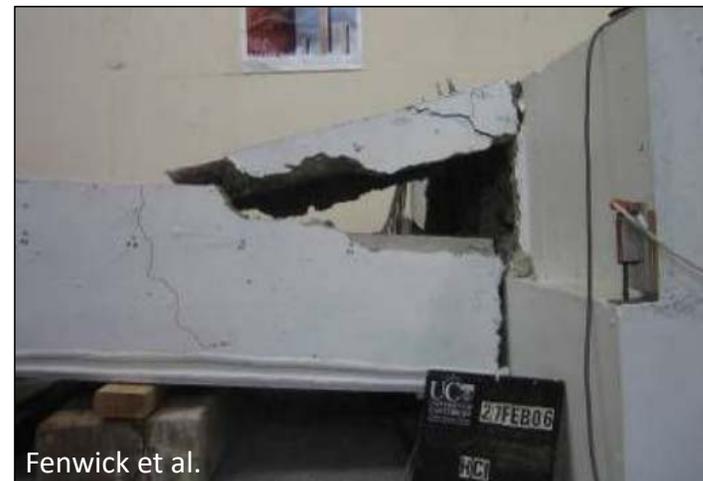
- Past research (Fenwick and Bull) highlighted effects of elongation and poor precast support detailing

Transverse cracks at end of hollowcore

- Ends trapped or weak section at end of starters
- No reinforcement (long or trans)
- Prestressed strand not fully developed
- Positive or negative moment failure

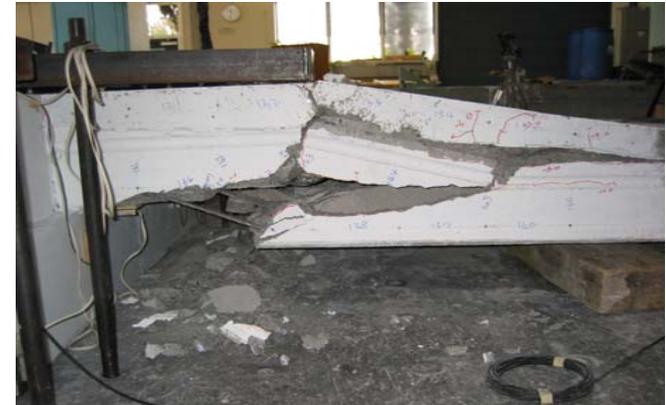
Negative Moment Failure (NMF)

Retrofit support:

- *Effectively same as shorter starters!*
