BUILDING PRESERVATION
— MATERIAL TECHNOLOGIES —
RESTORING THE PAST, BUILDING THE FUTURE

***Structural and Architectural Restoration of the
Puerto Rico Capital Dome***

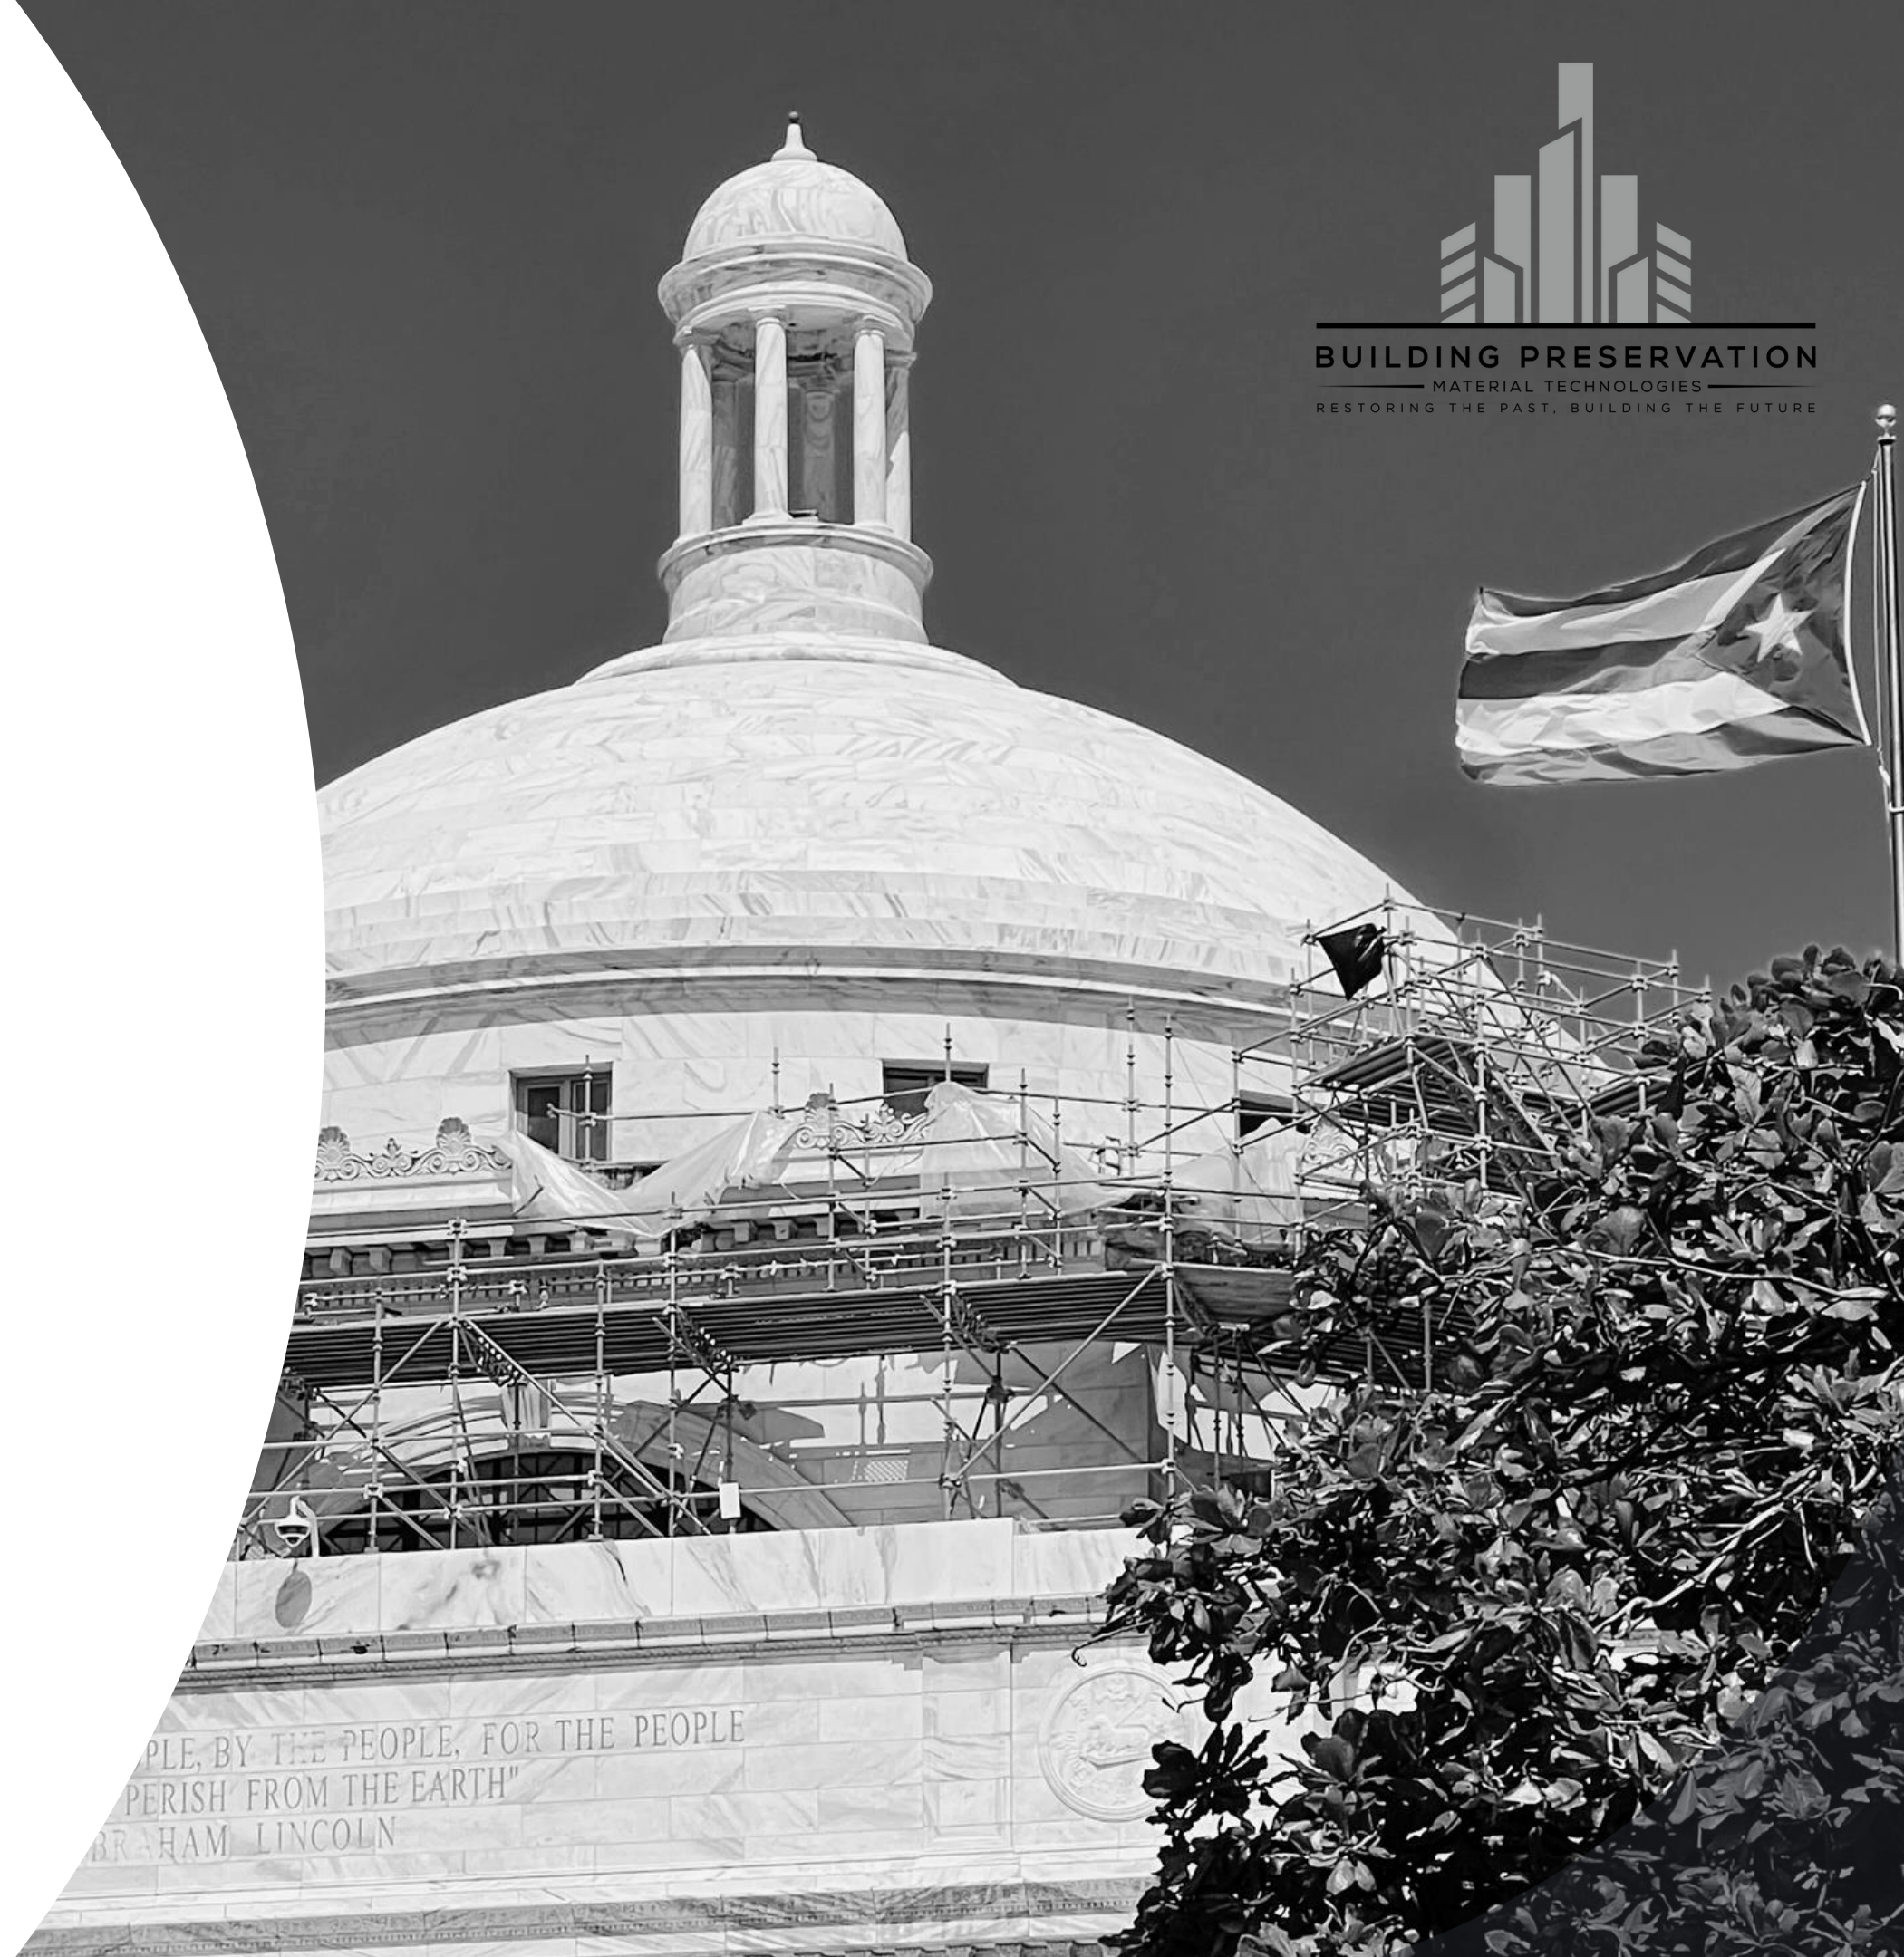
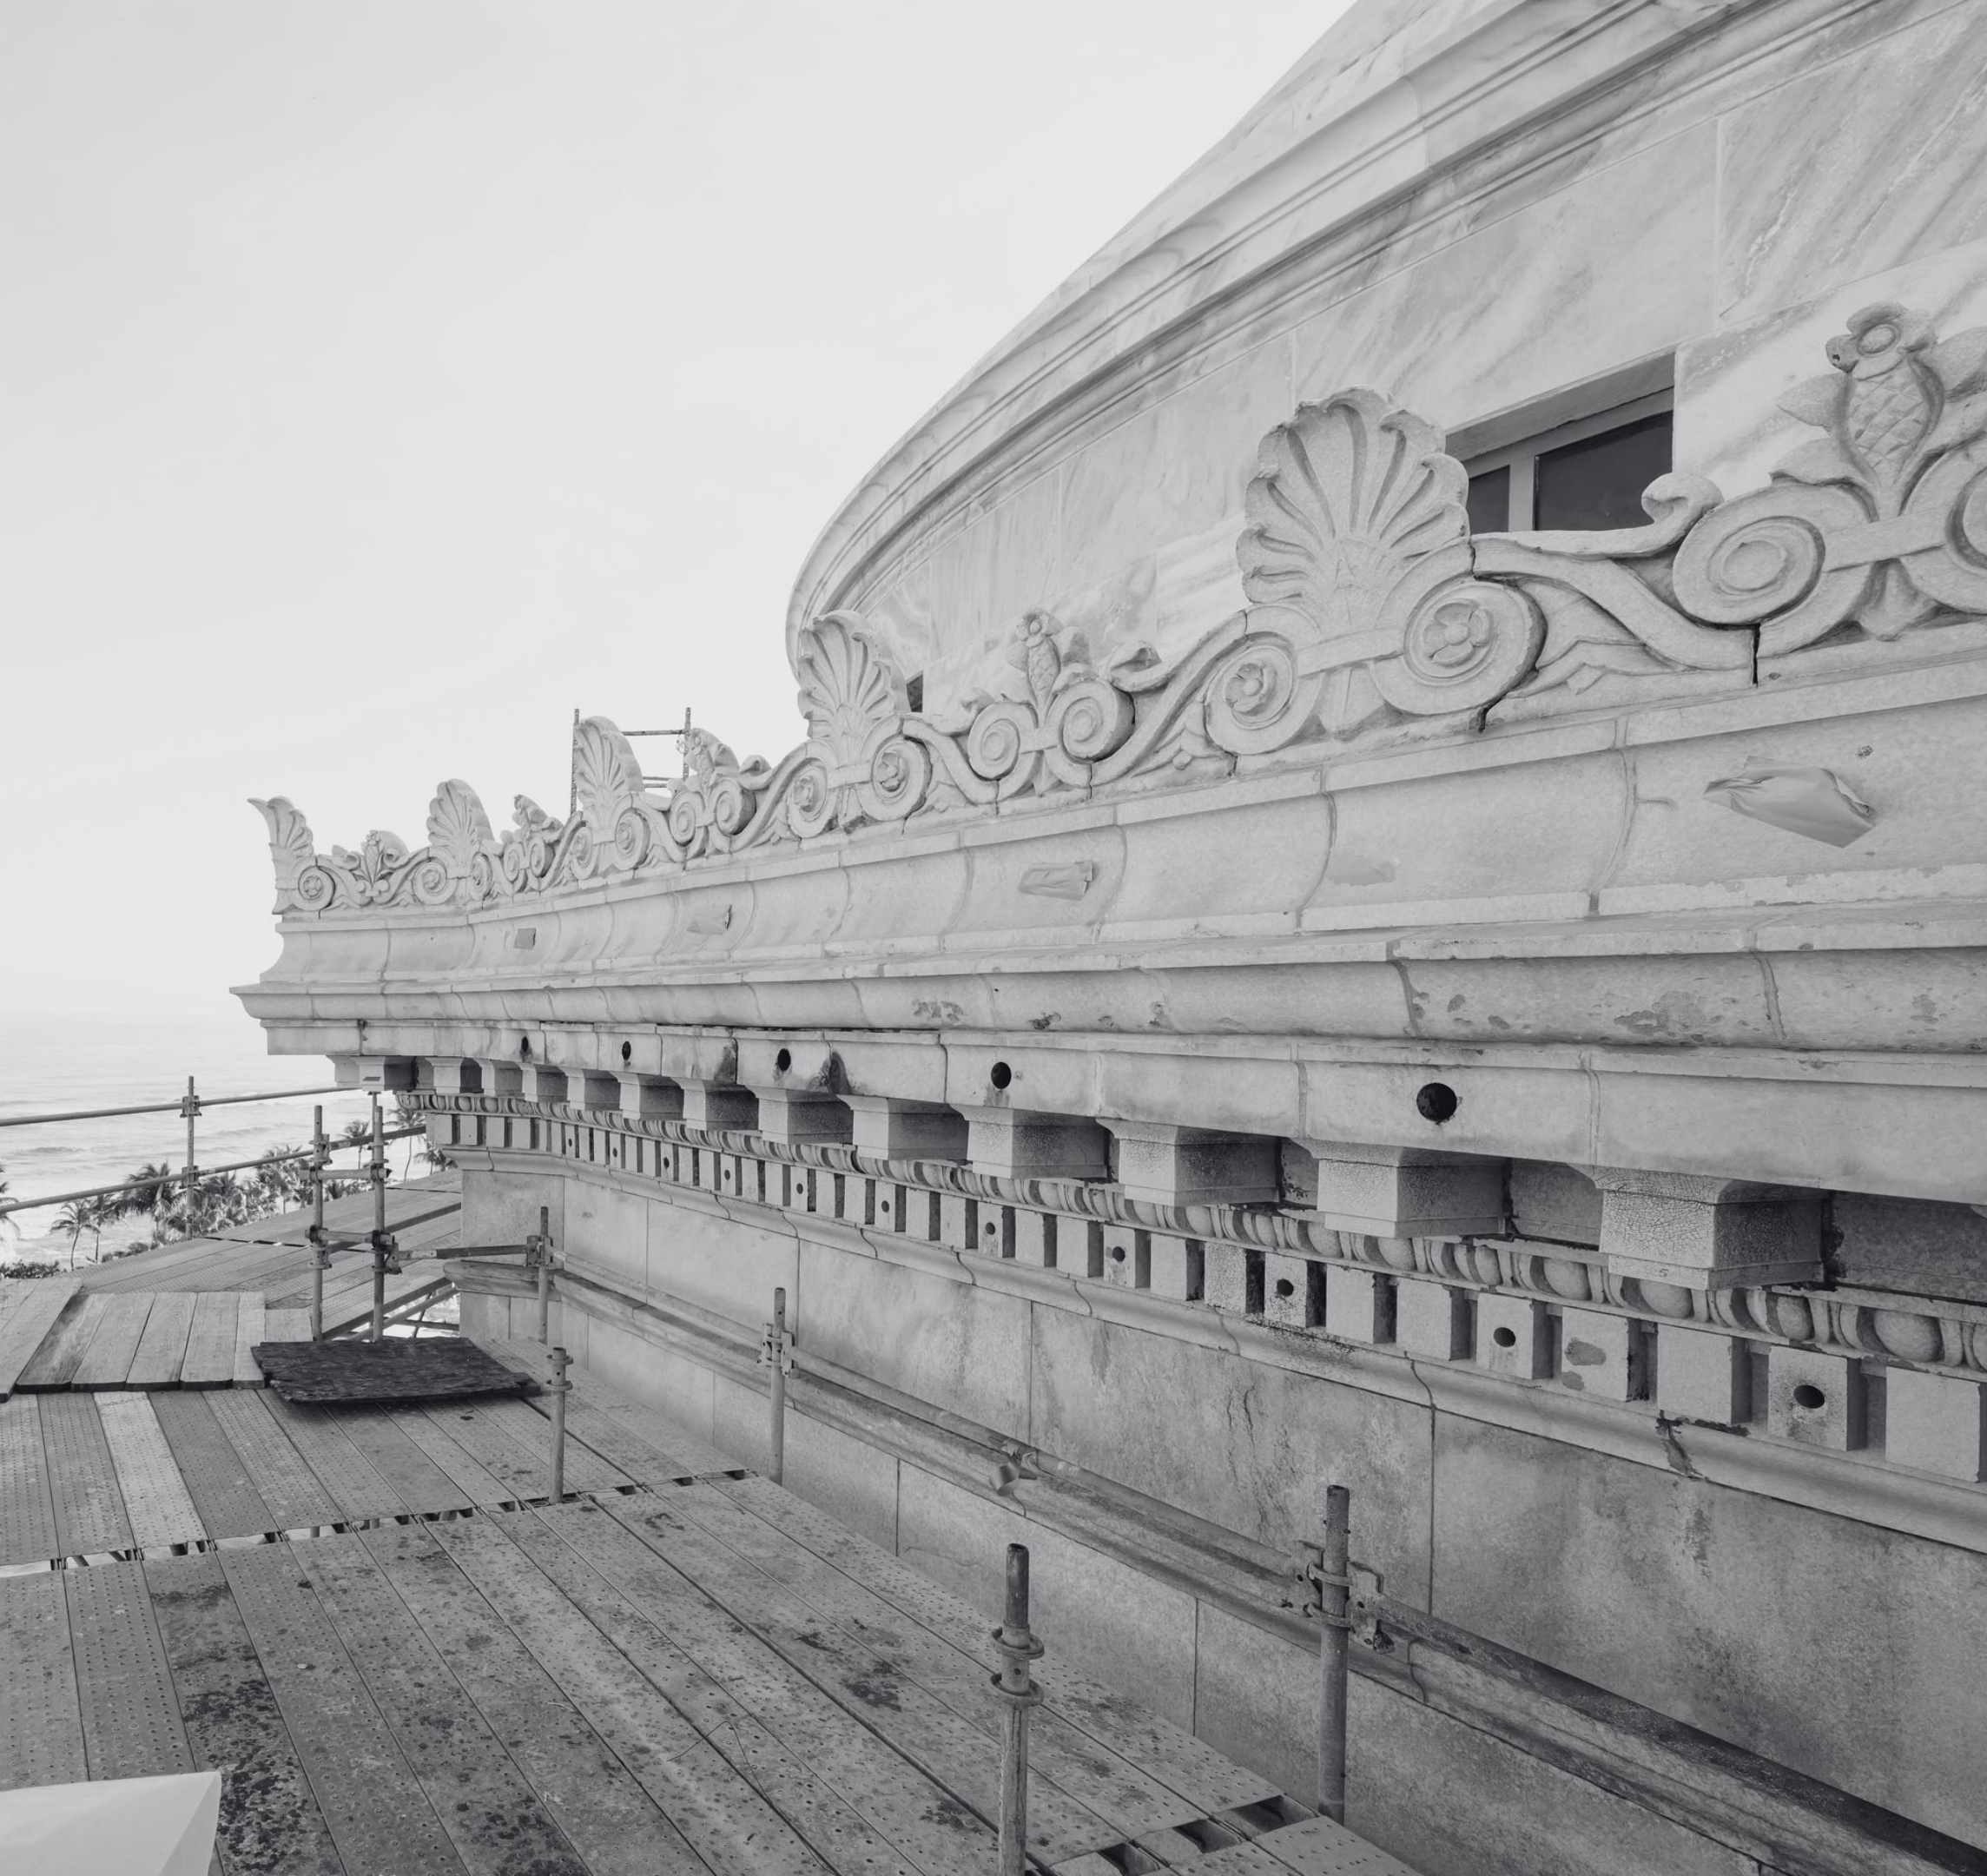
¿Why Rehabilitate?

Key Elements:

- *Concrete
Segregation of
Exterior Dome*
- *Concrete
Delamination*
- *Terracotta
Façade Distress*

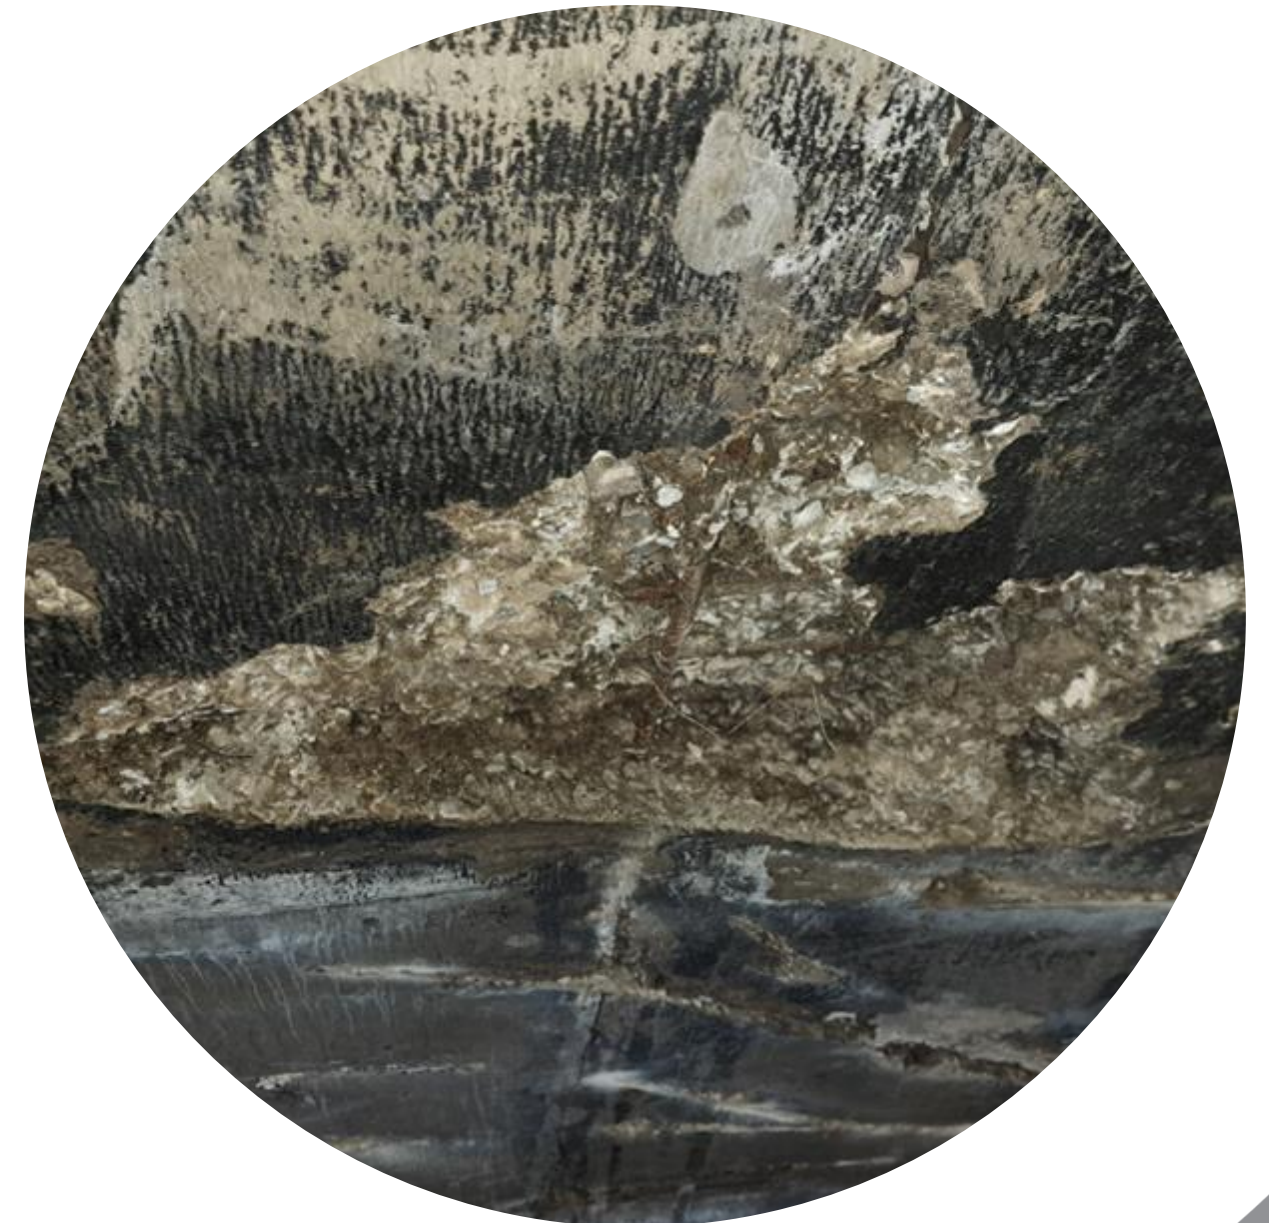
Existing Conditions of Interior

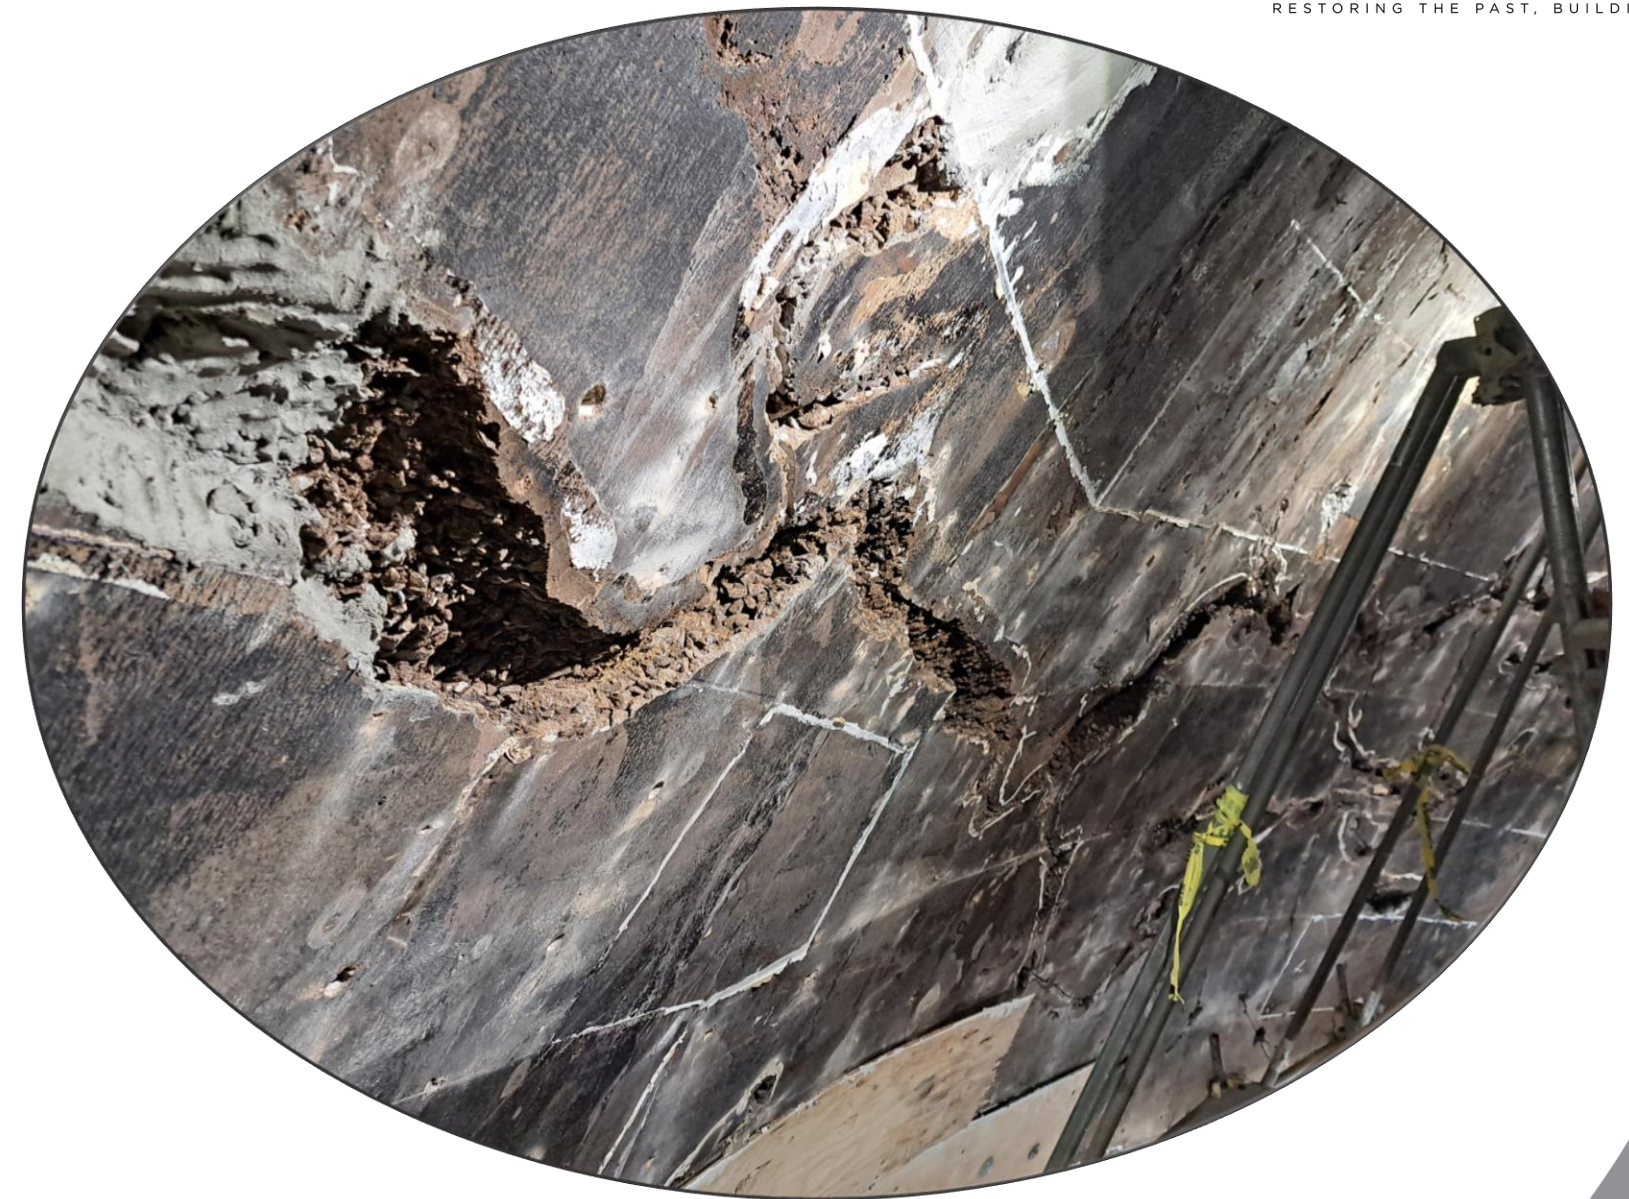
Existing Conditions of Interior

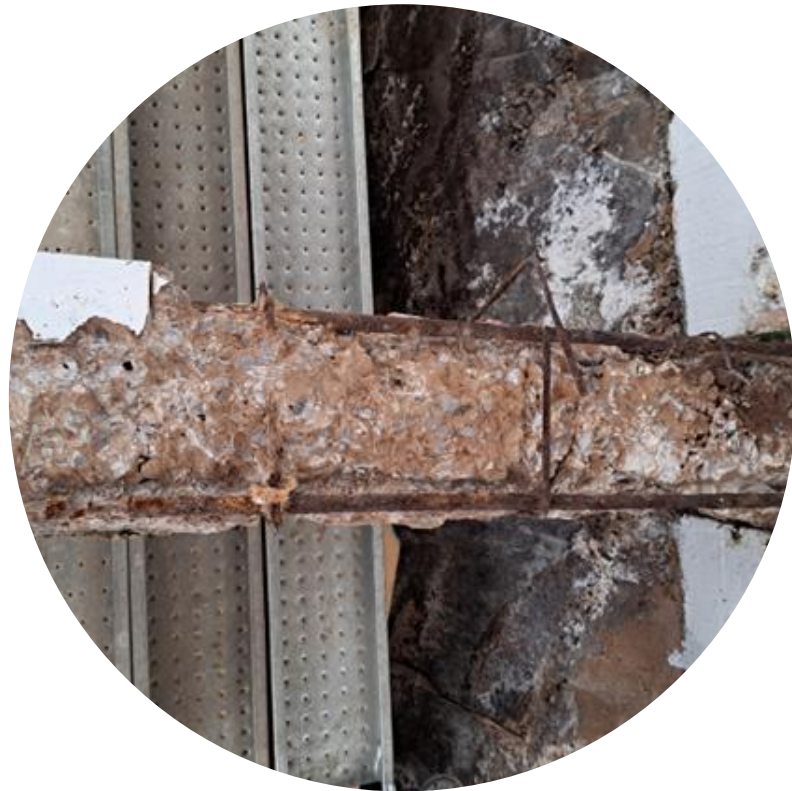
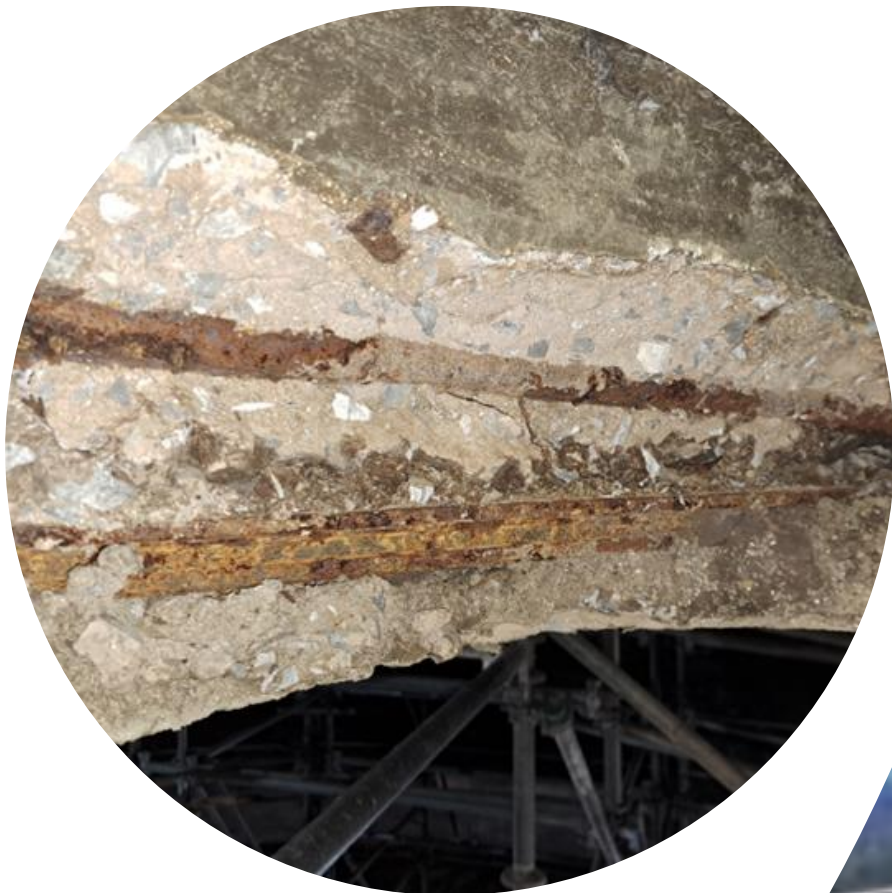
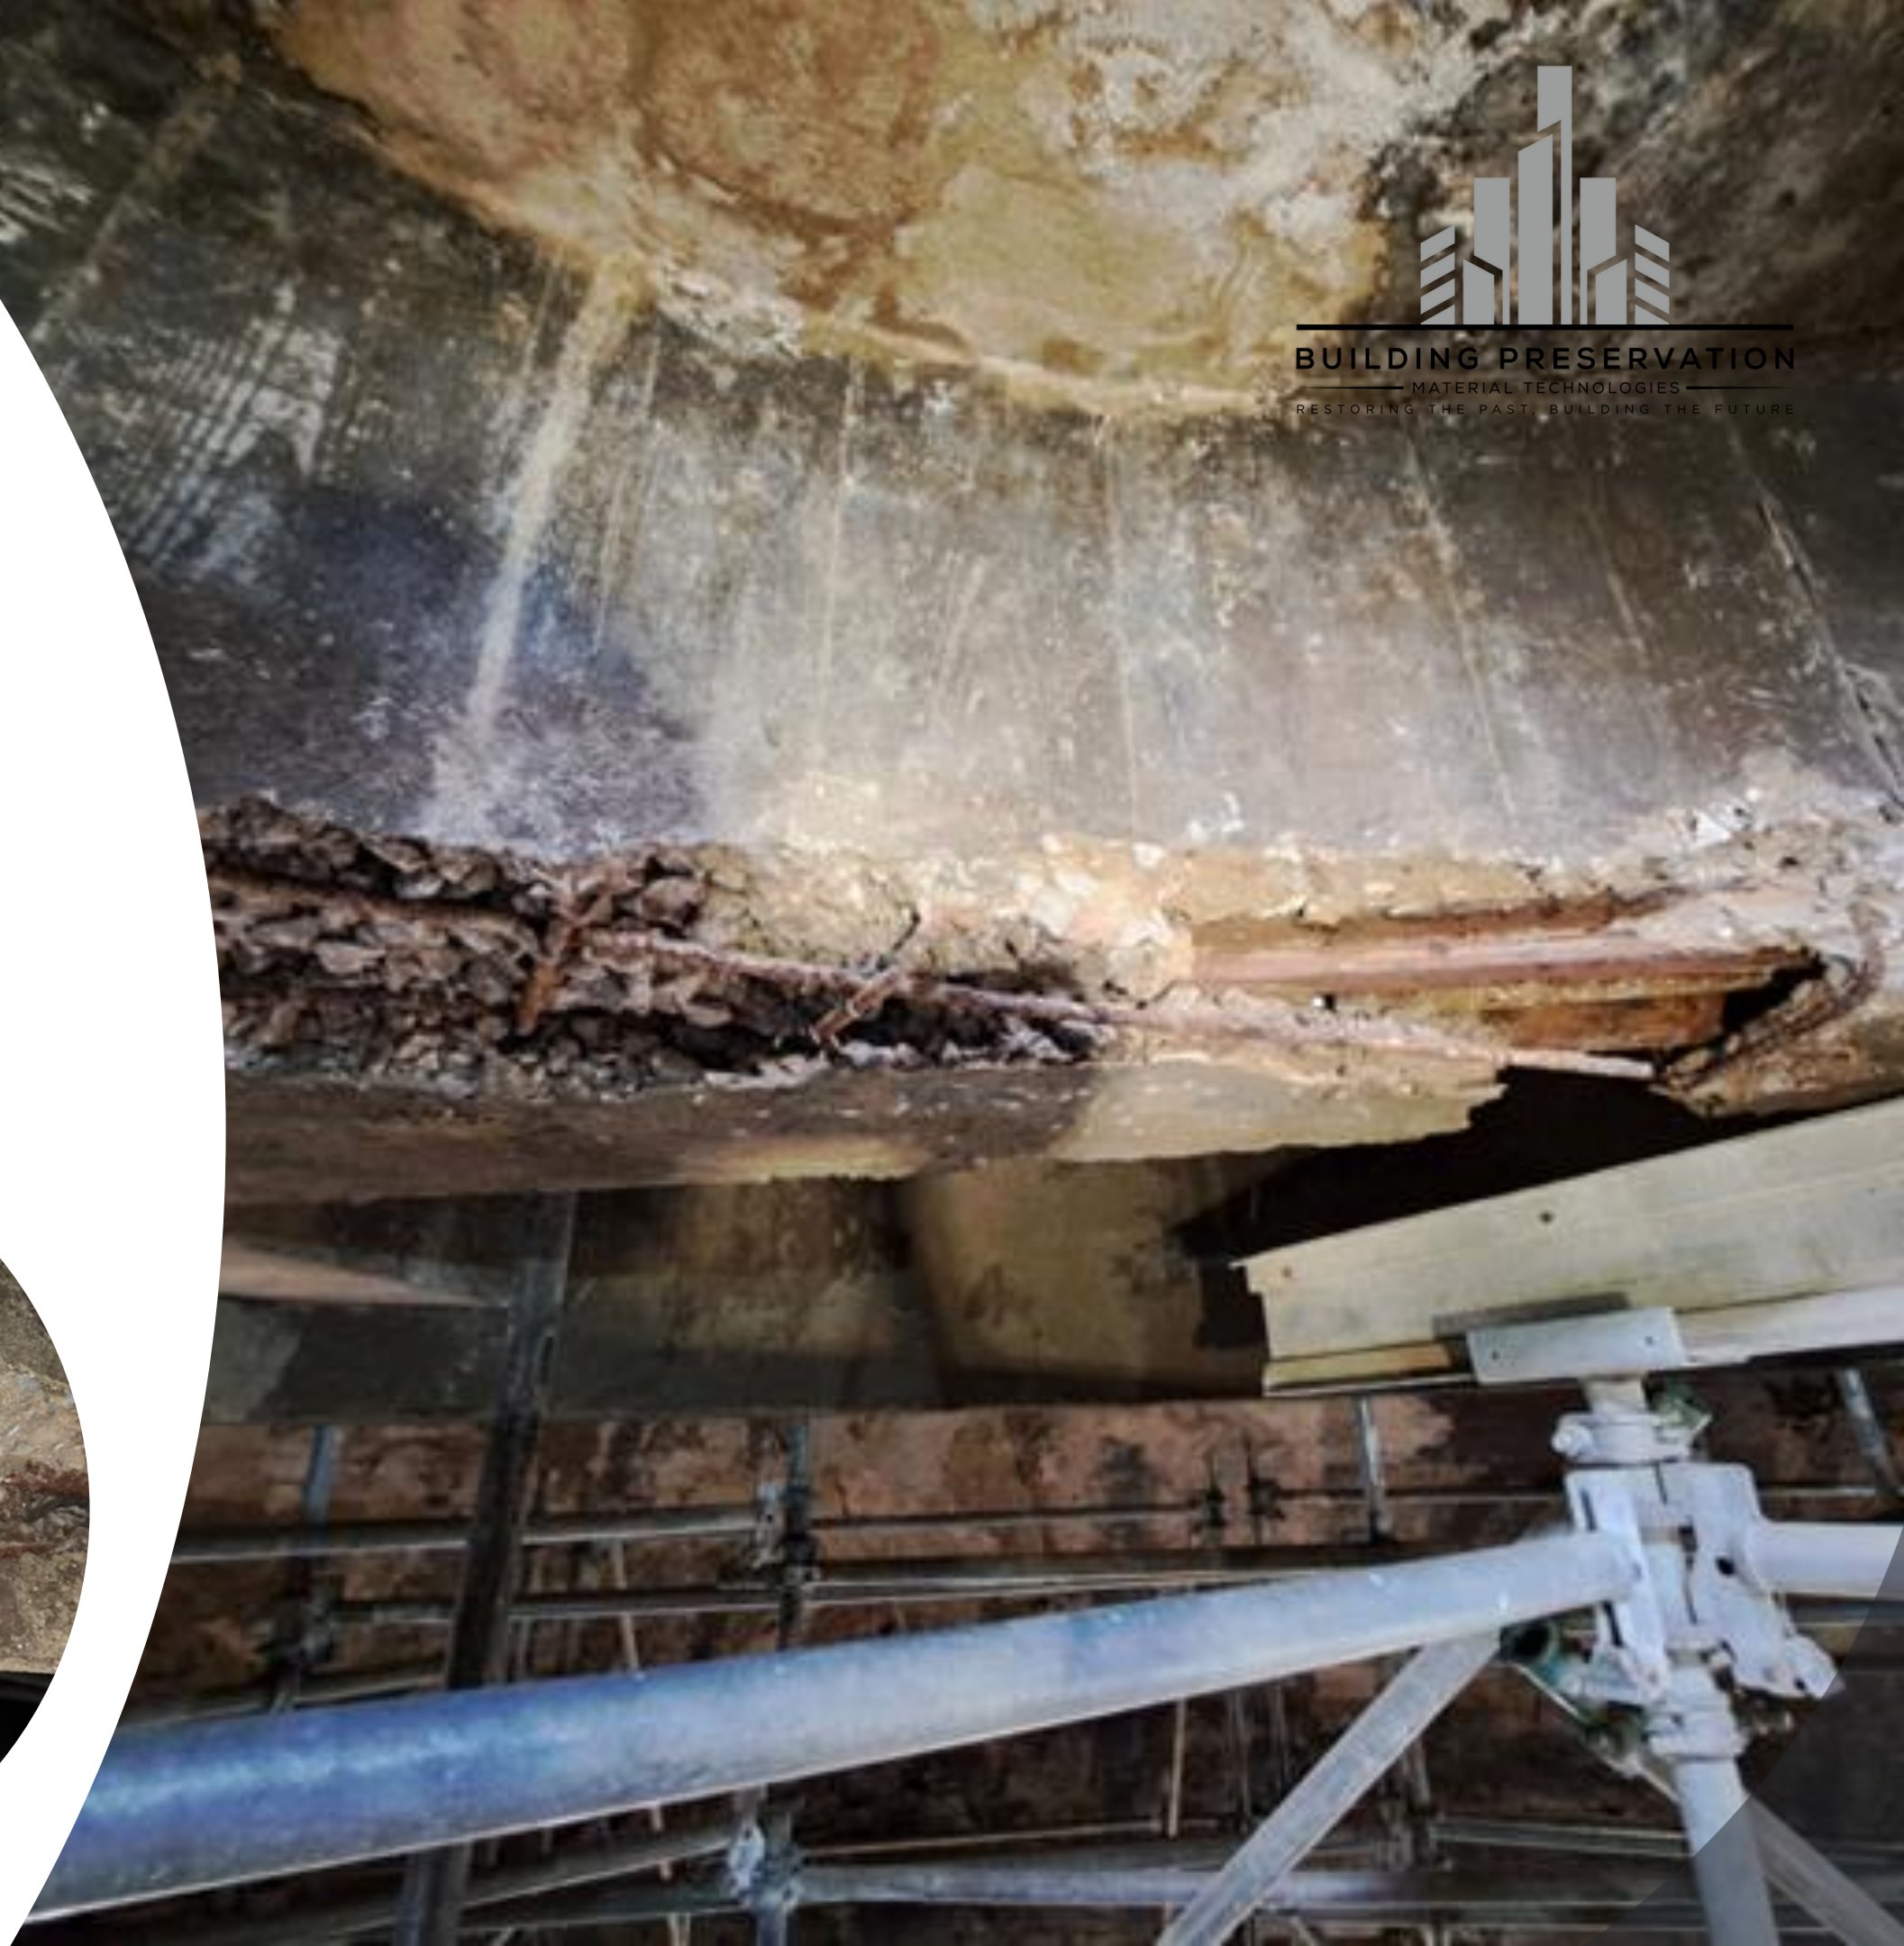
Existing Conditions of Interior

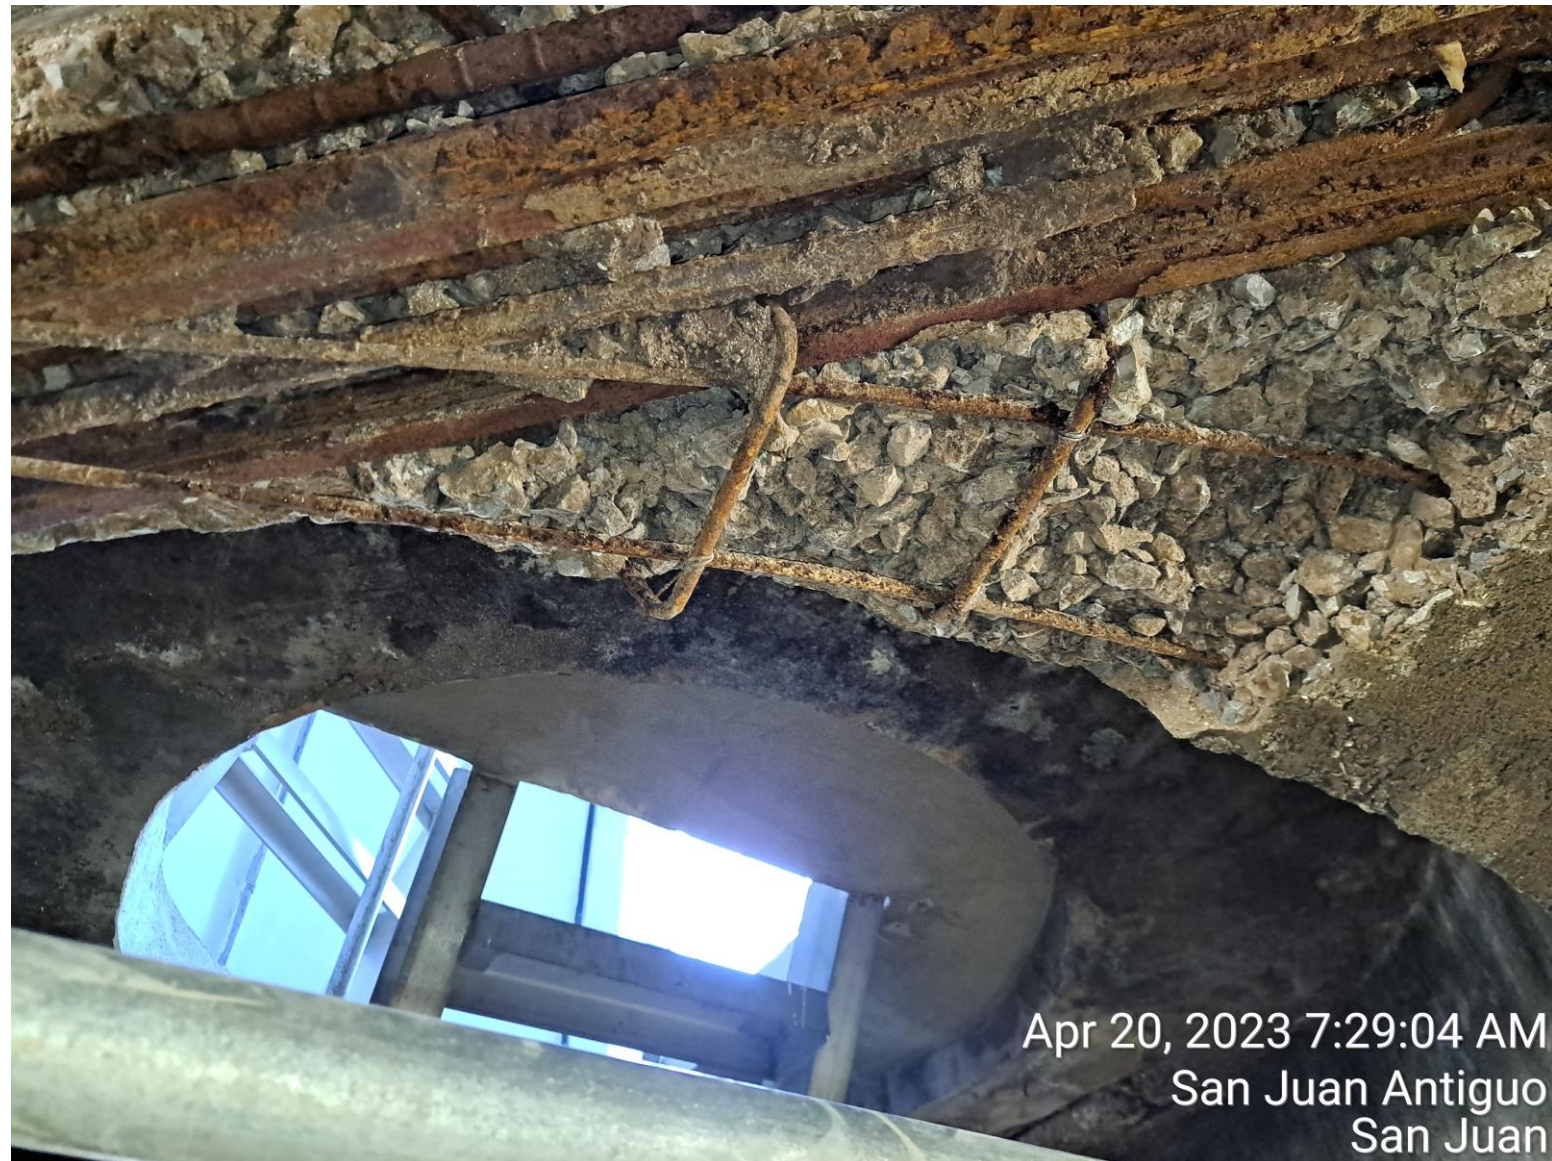
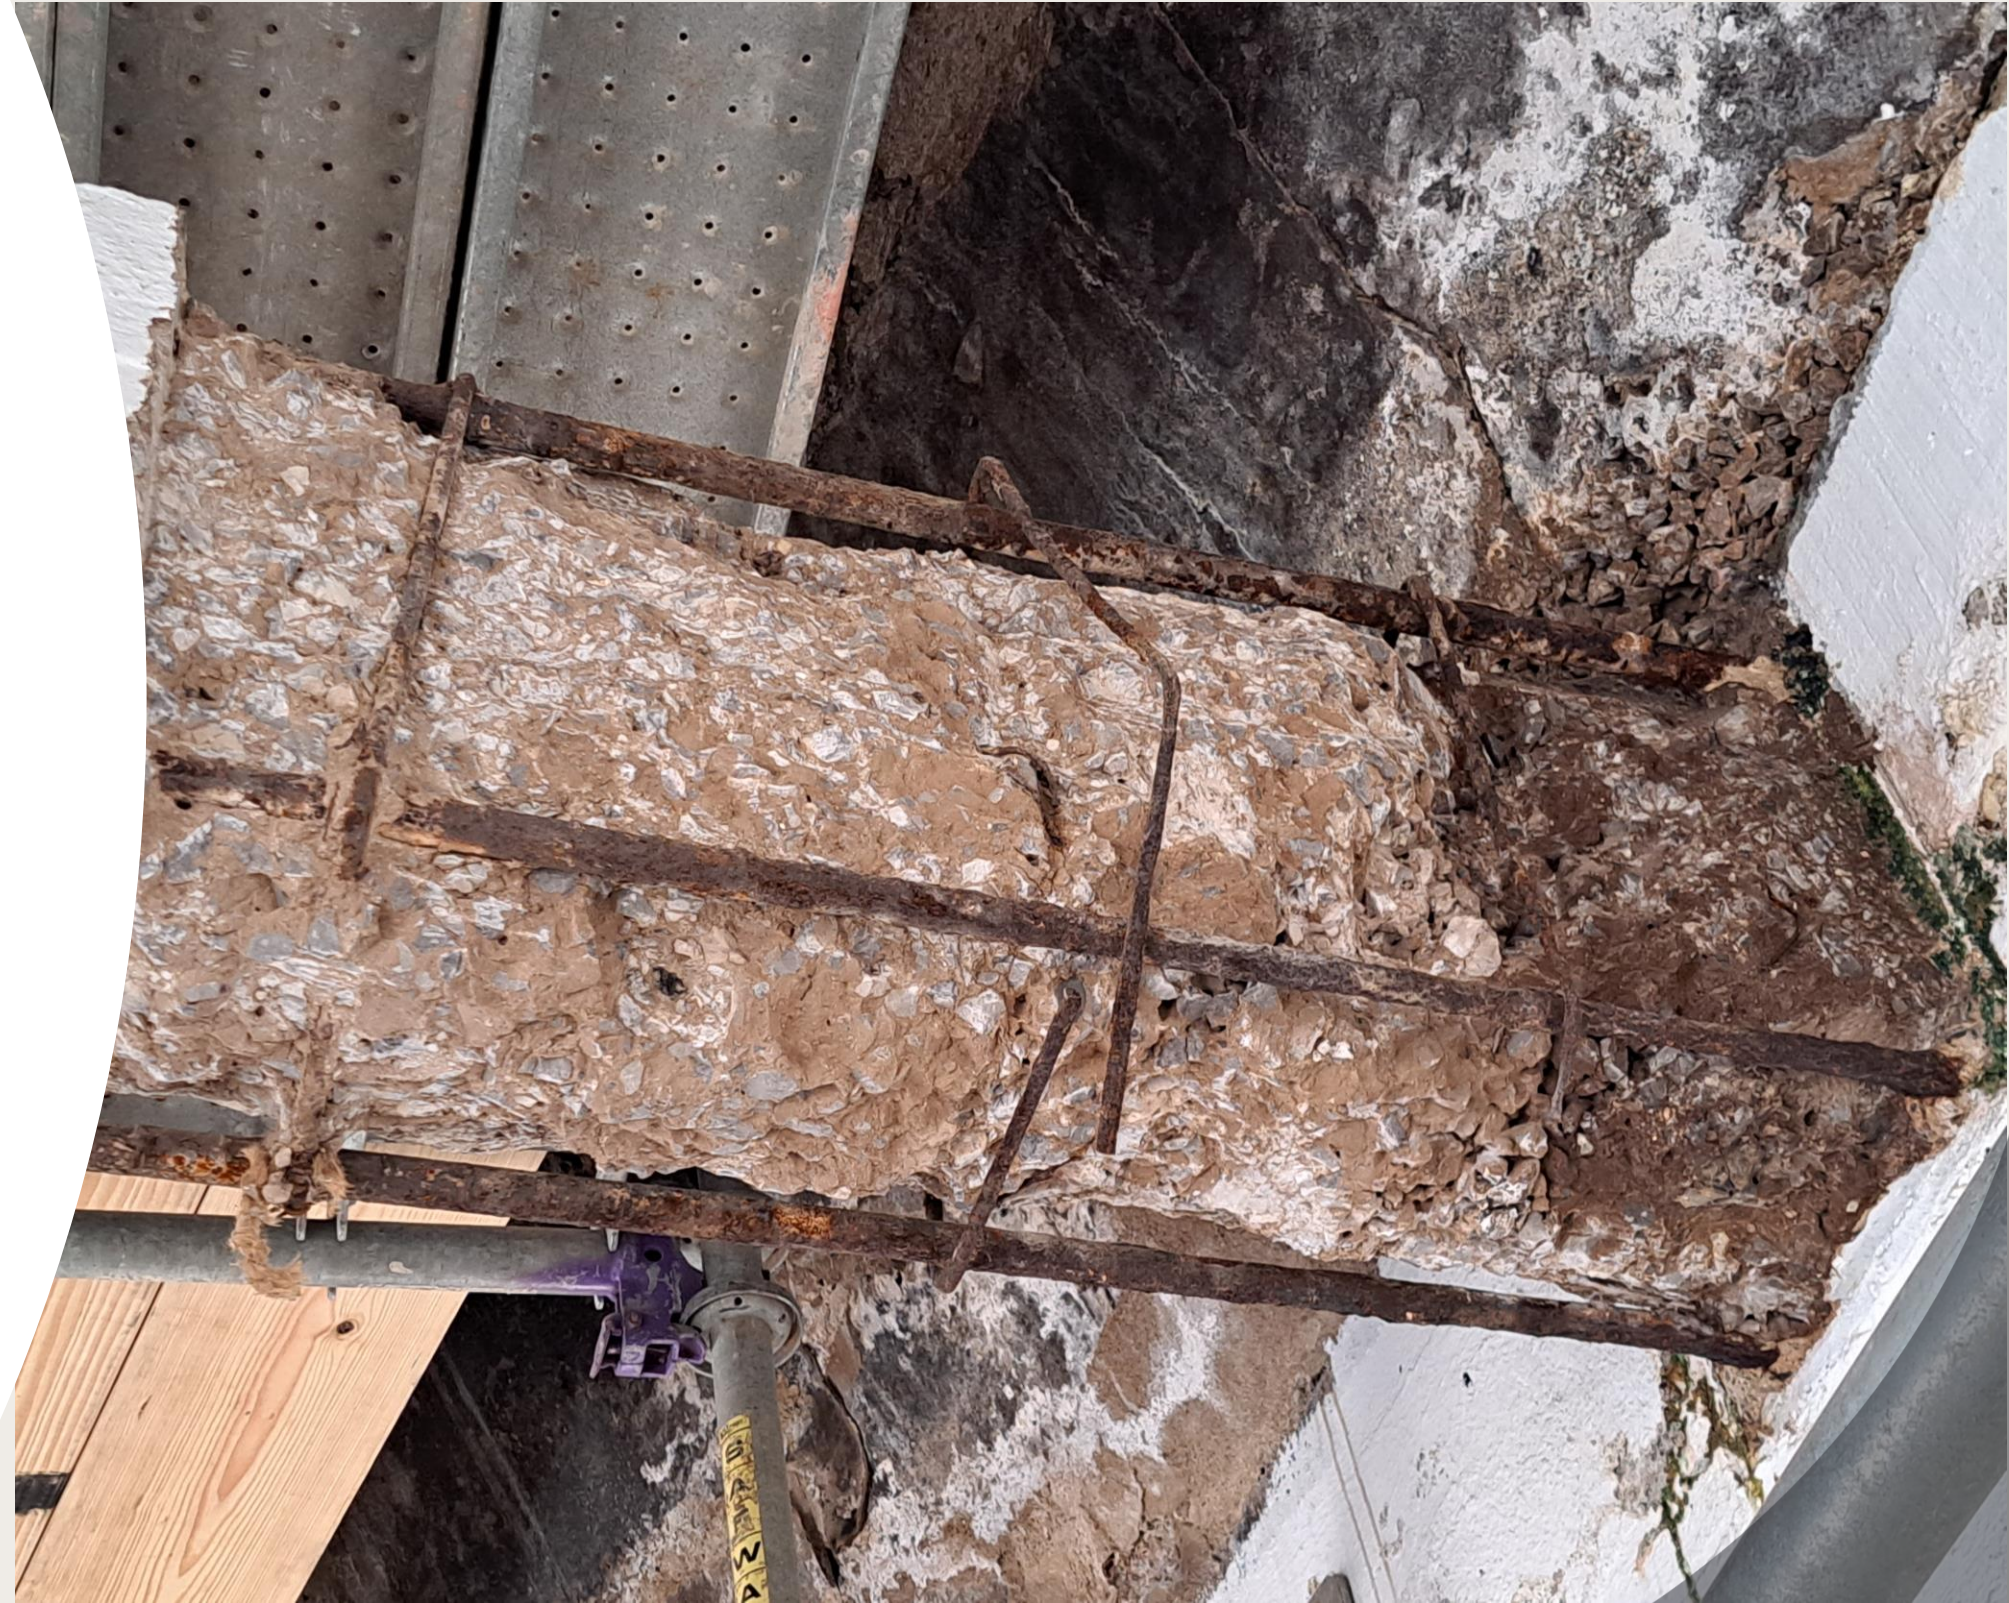
Existing Conditions of Interior
