BUILDING PRESERVATION
— MATERIAL TECHNOLOGIES —
RESTORING THE PAST, BUILDING THE FUTURE

***Structural and Architectural Restoration of the
Puerto Rico Capital Dome***

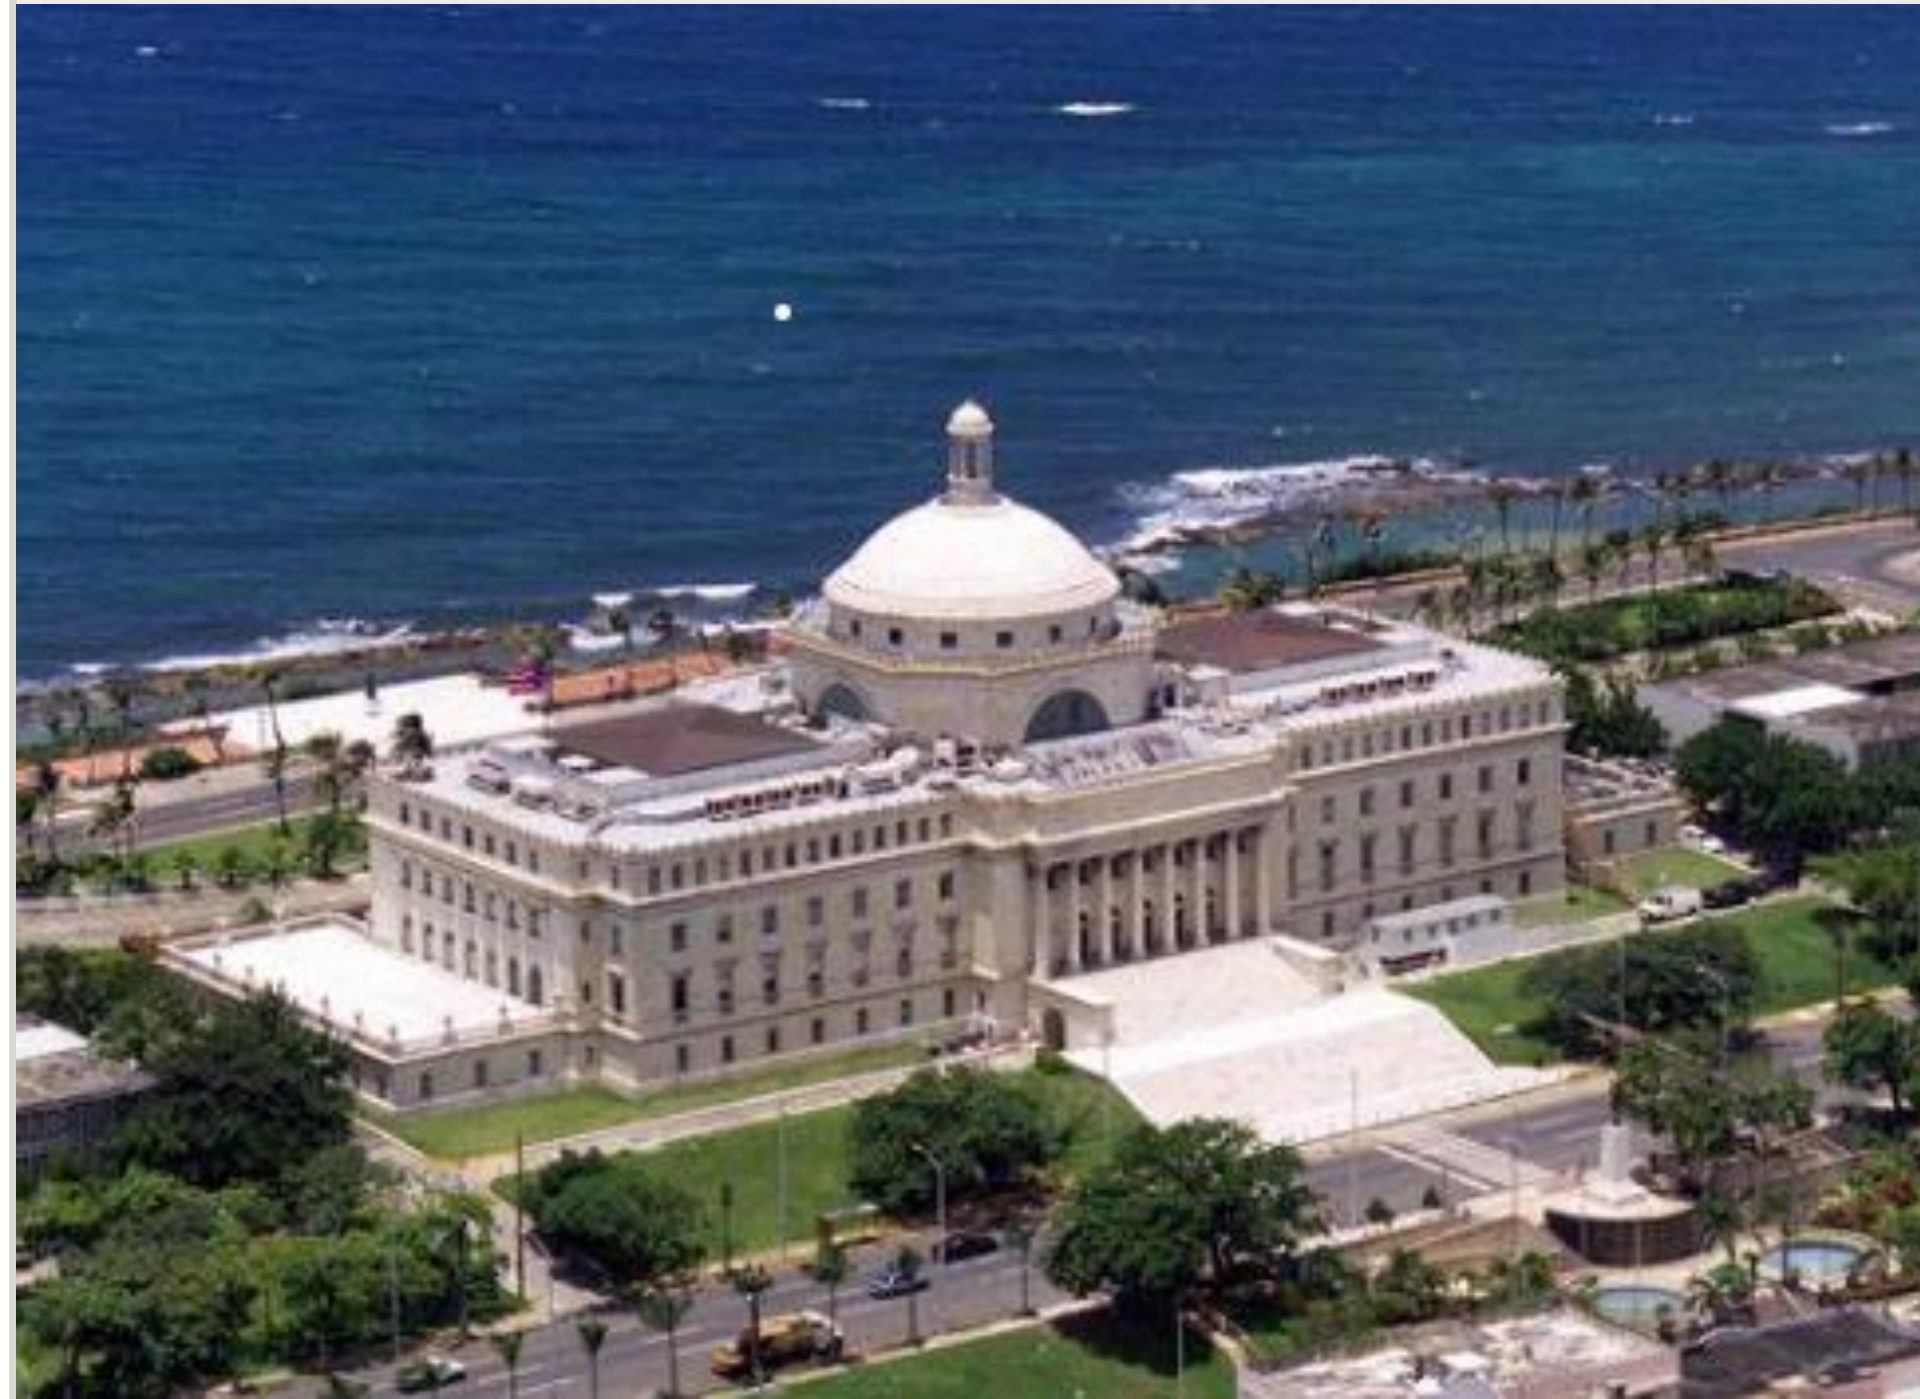
TERRACOTA FACADE - CHALLENGES

- Coastal zone
- Tropical Environment
- High Winds
- Hurricane Zones
- Maintenance Issues

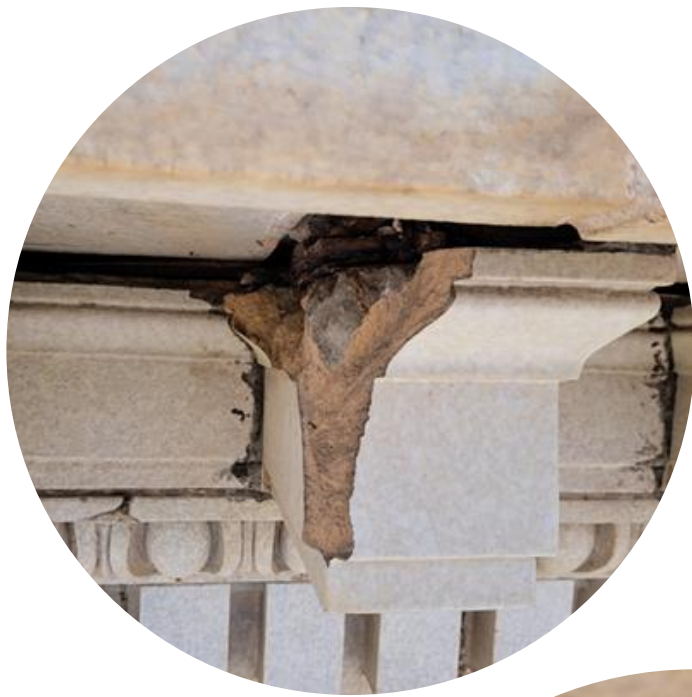
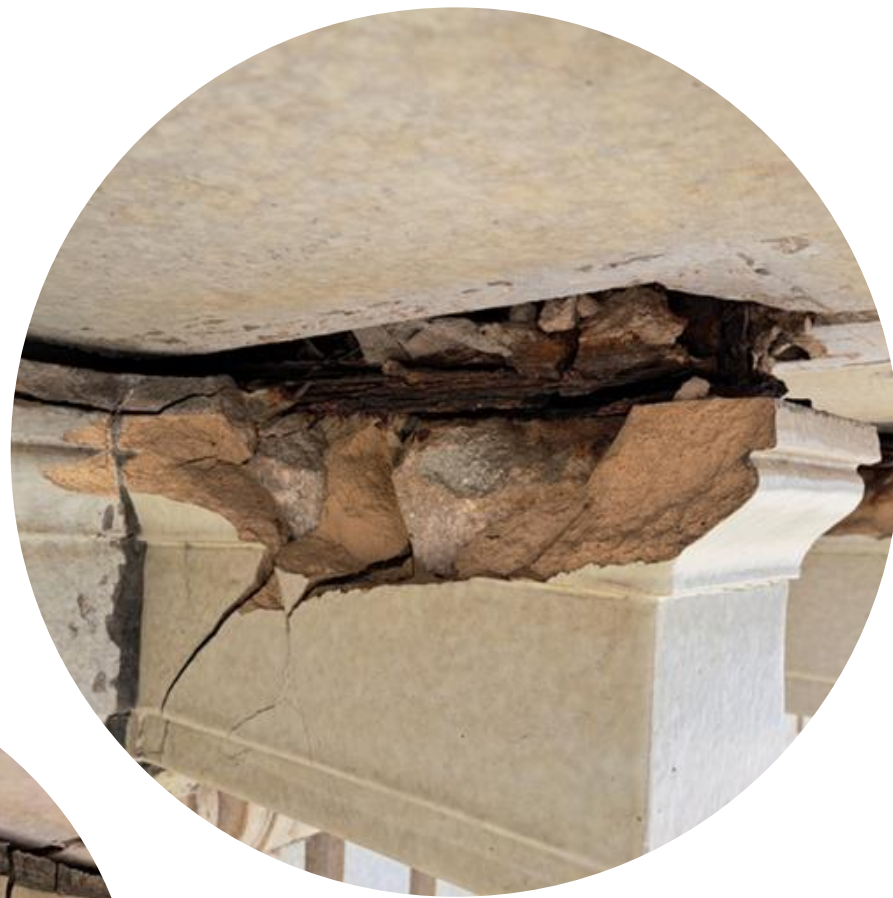
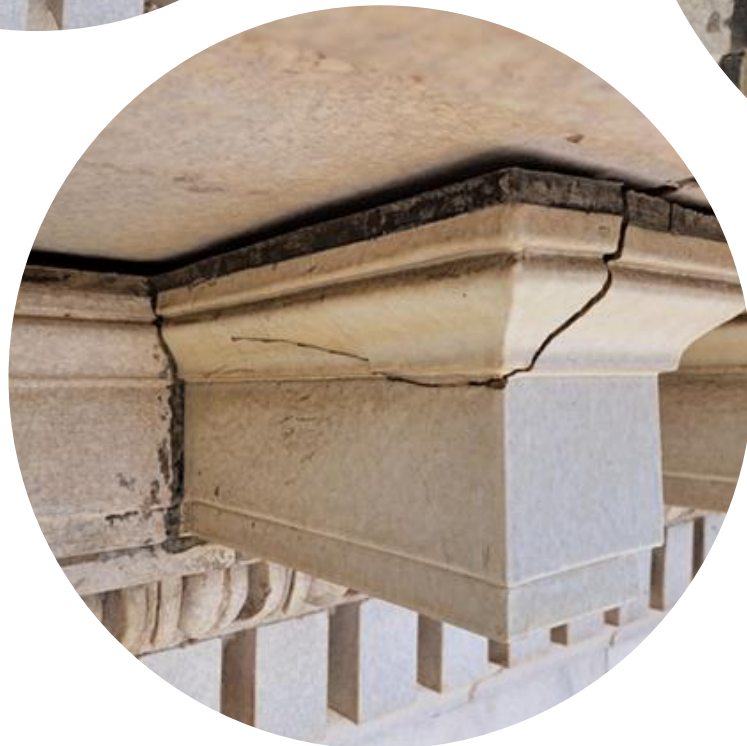
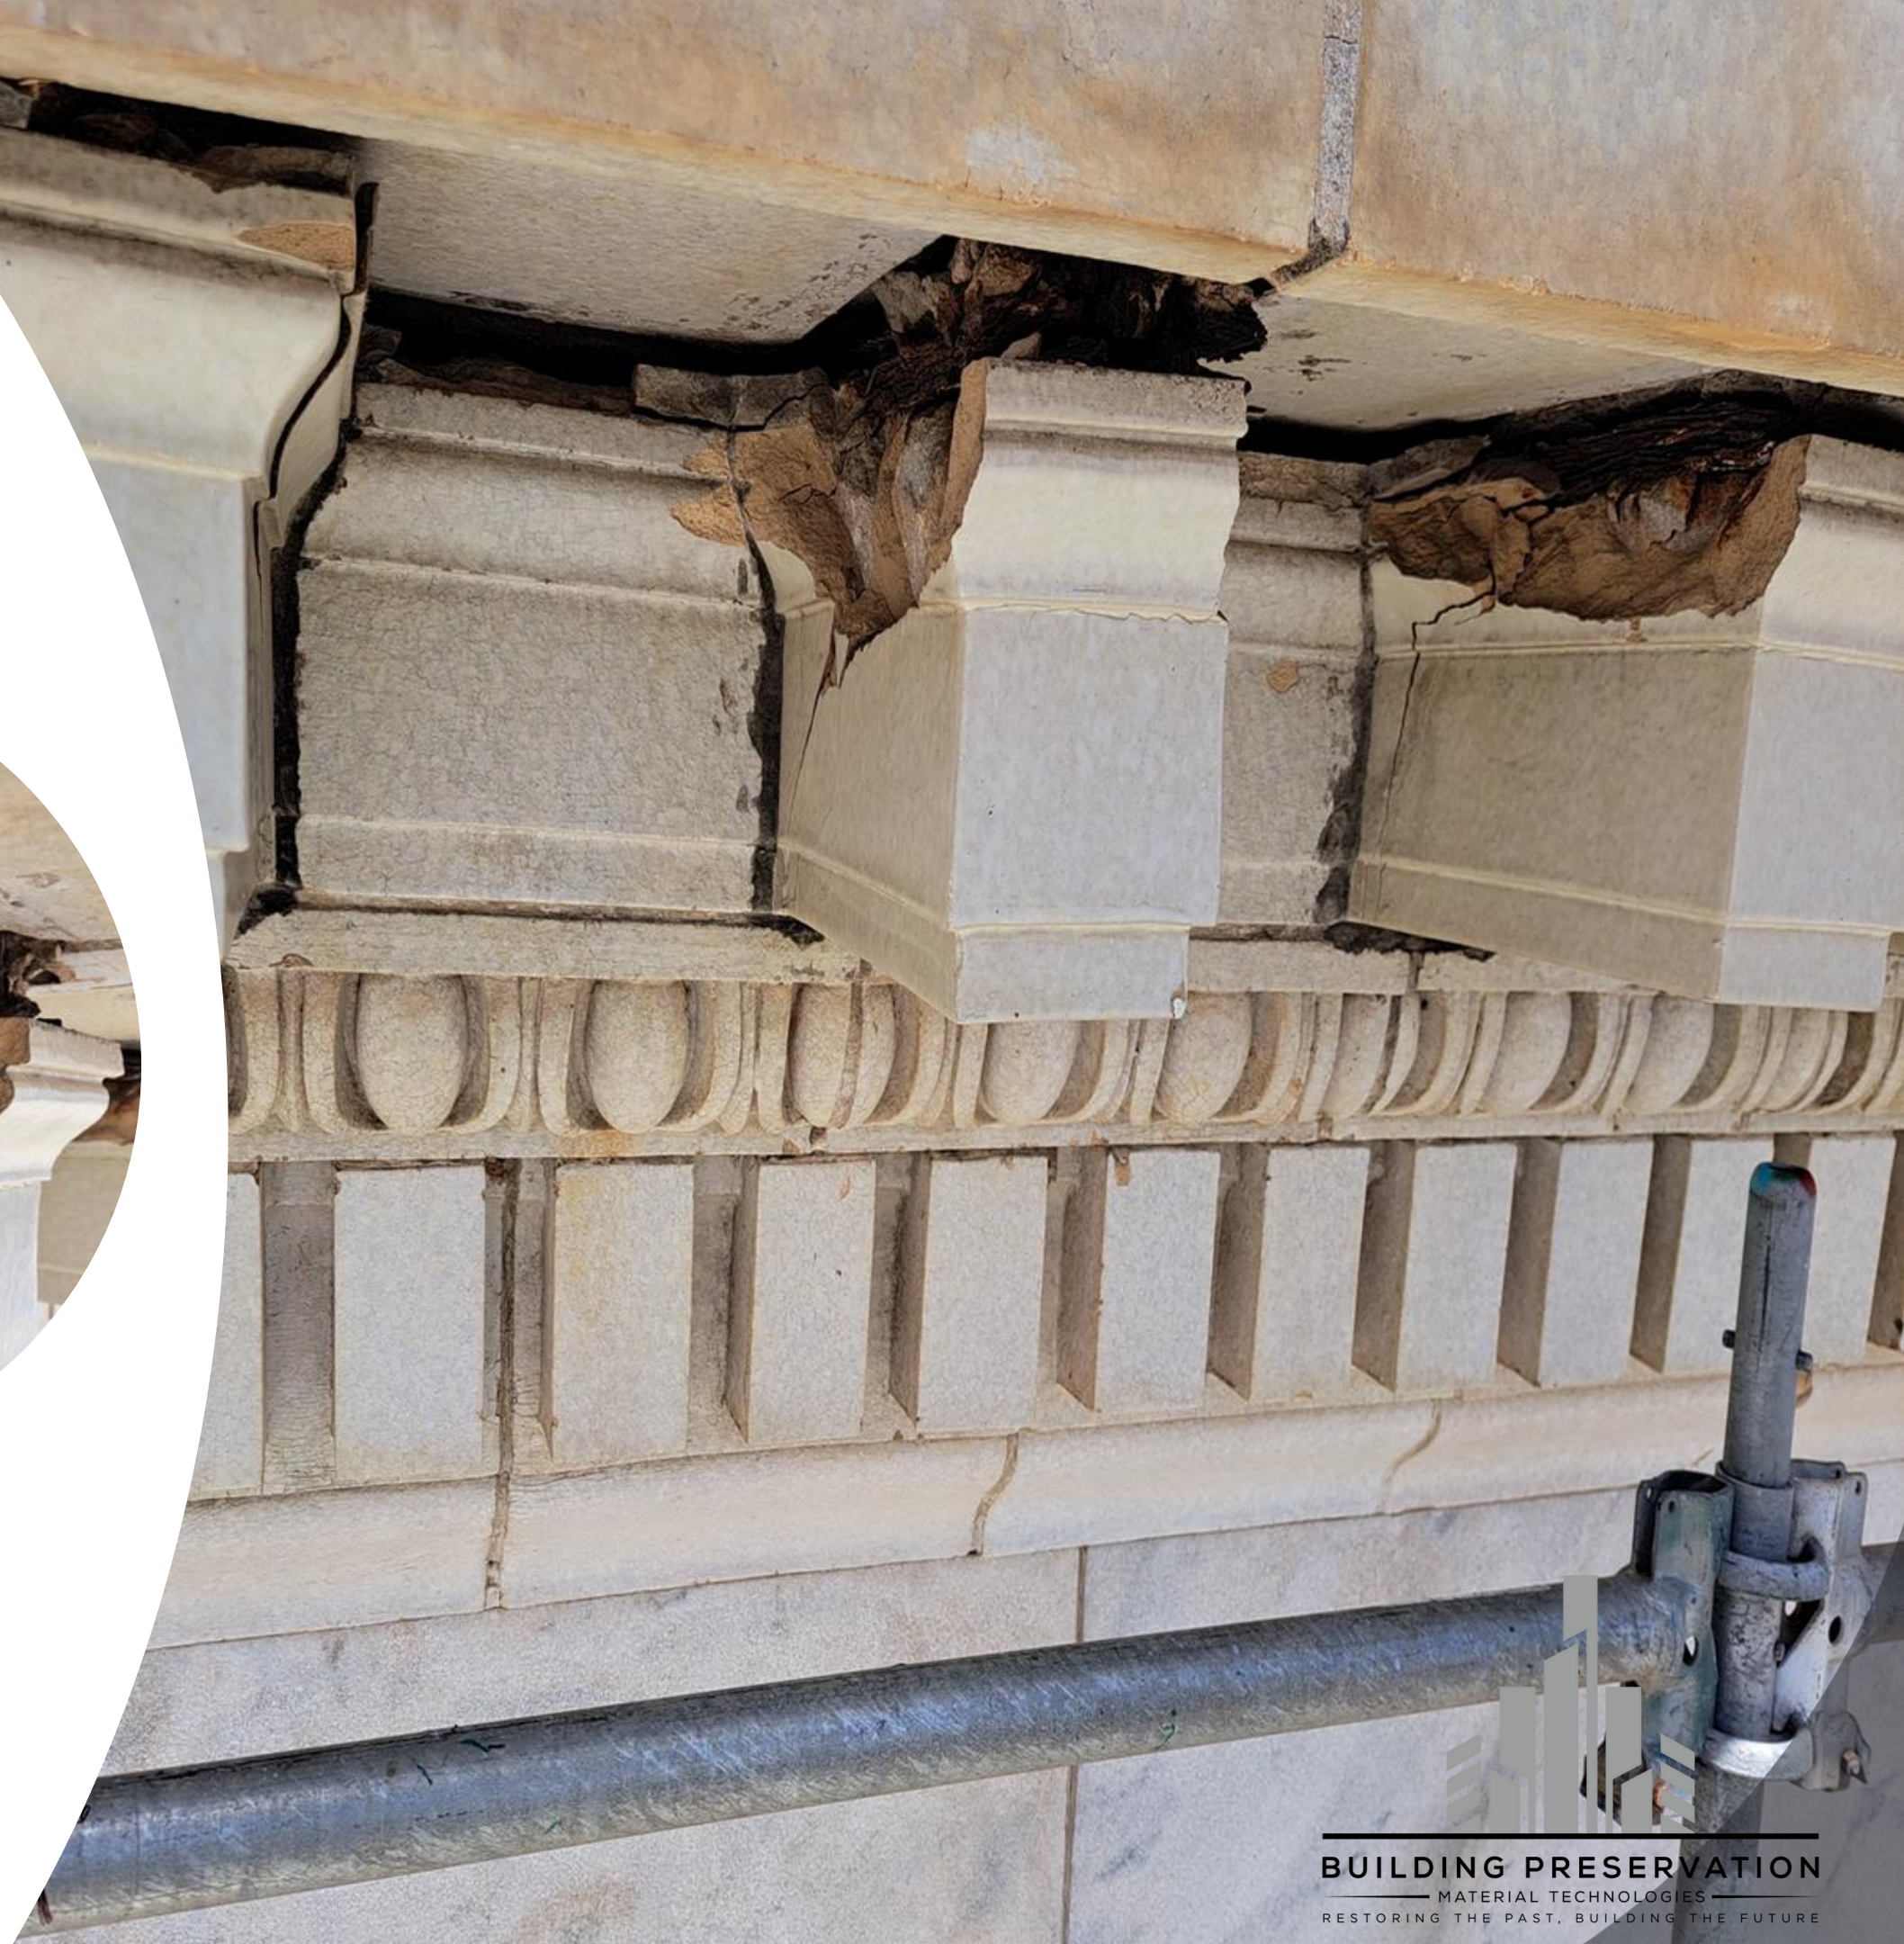
- Corroded Support System
- Collapsed Individual Pieces
- Grout Filled Terracotta individual Pieces
- Previous Repair Attempts

Existing Conditions

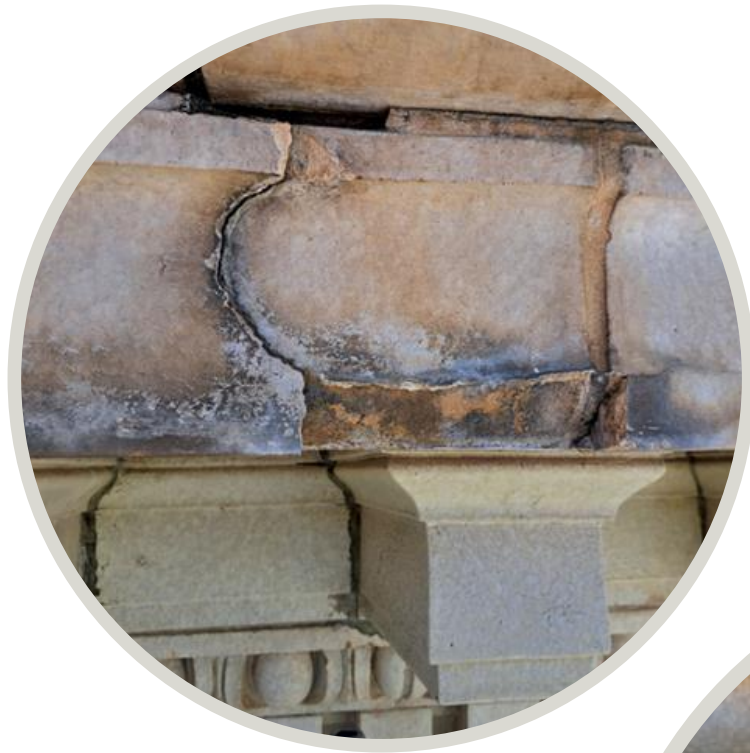
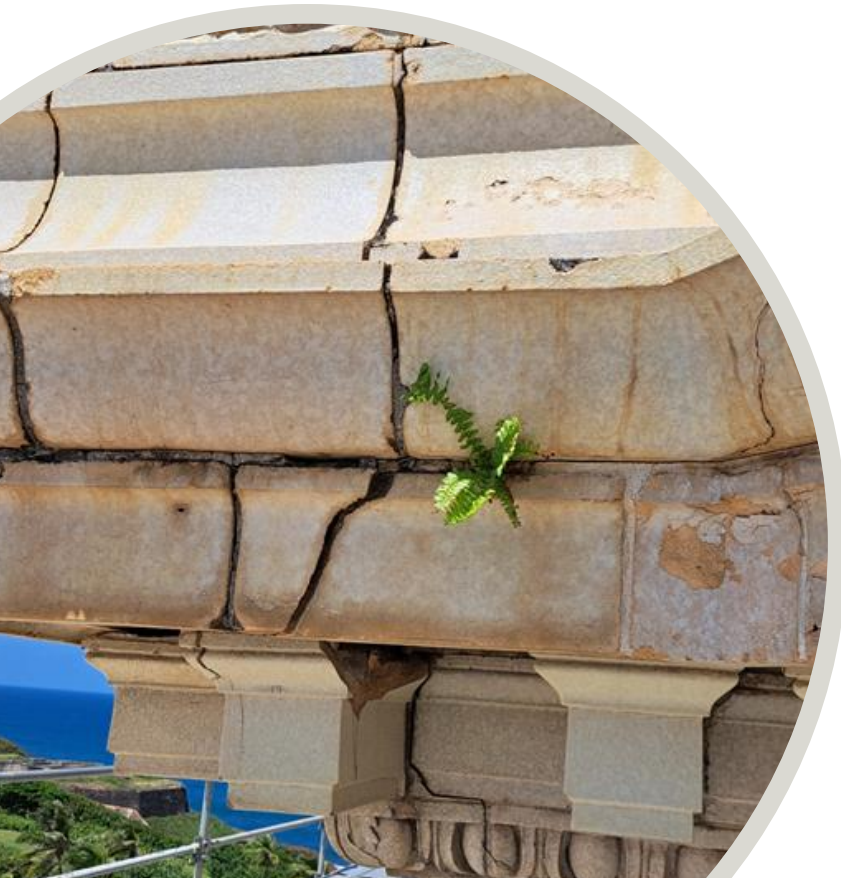
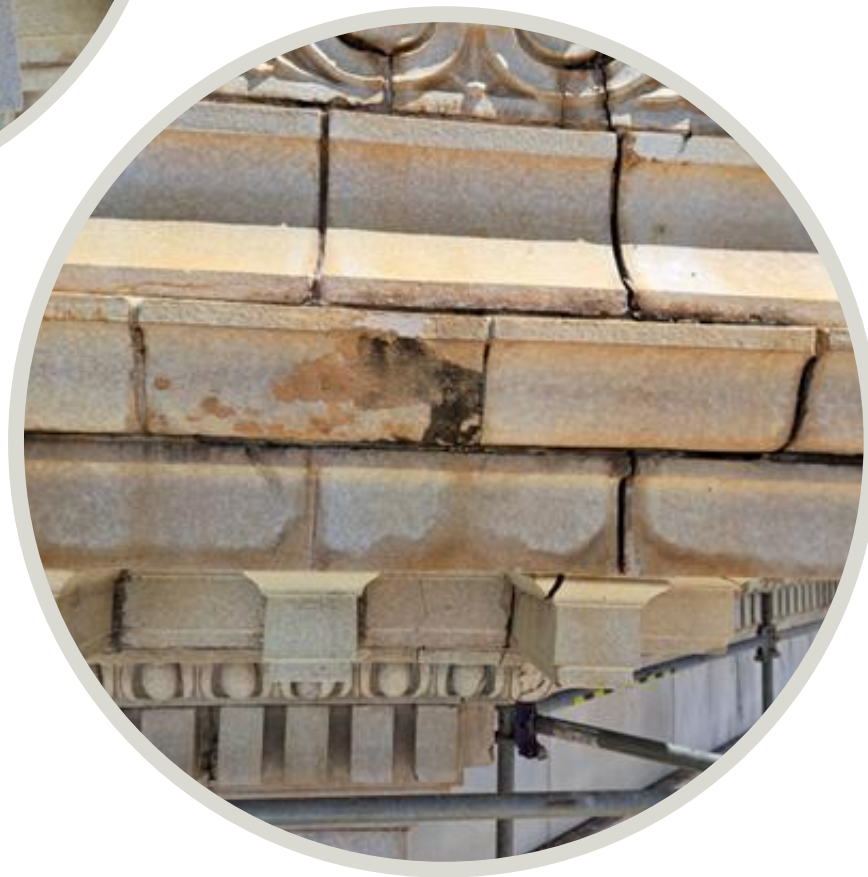
Existing Conditions

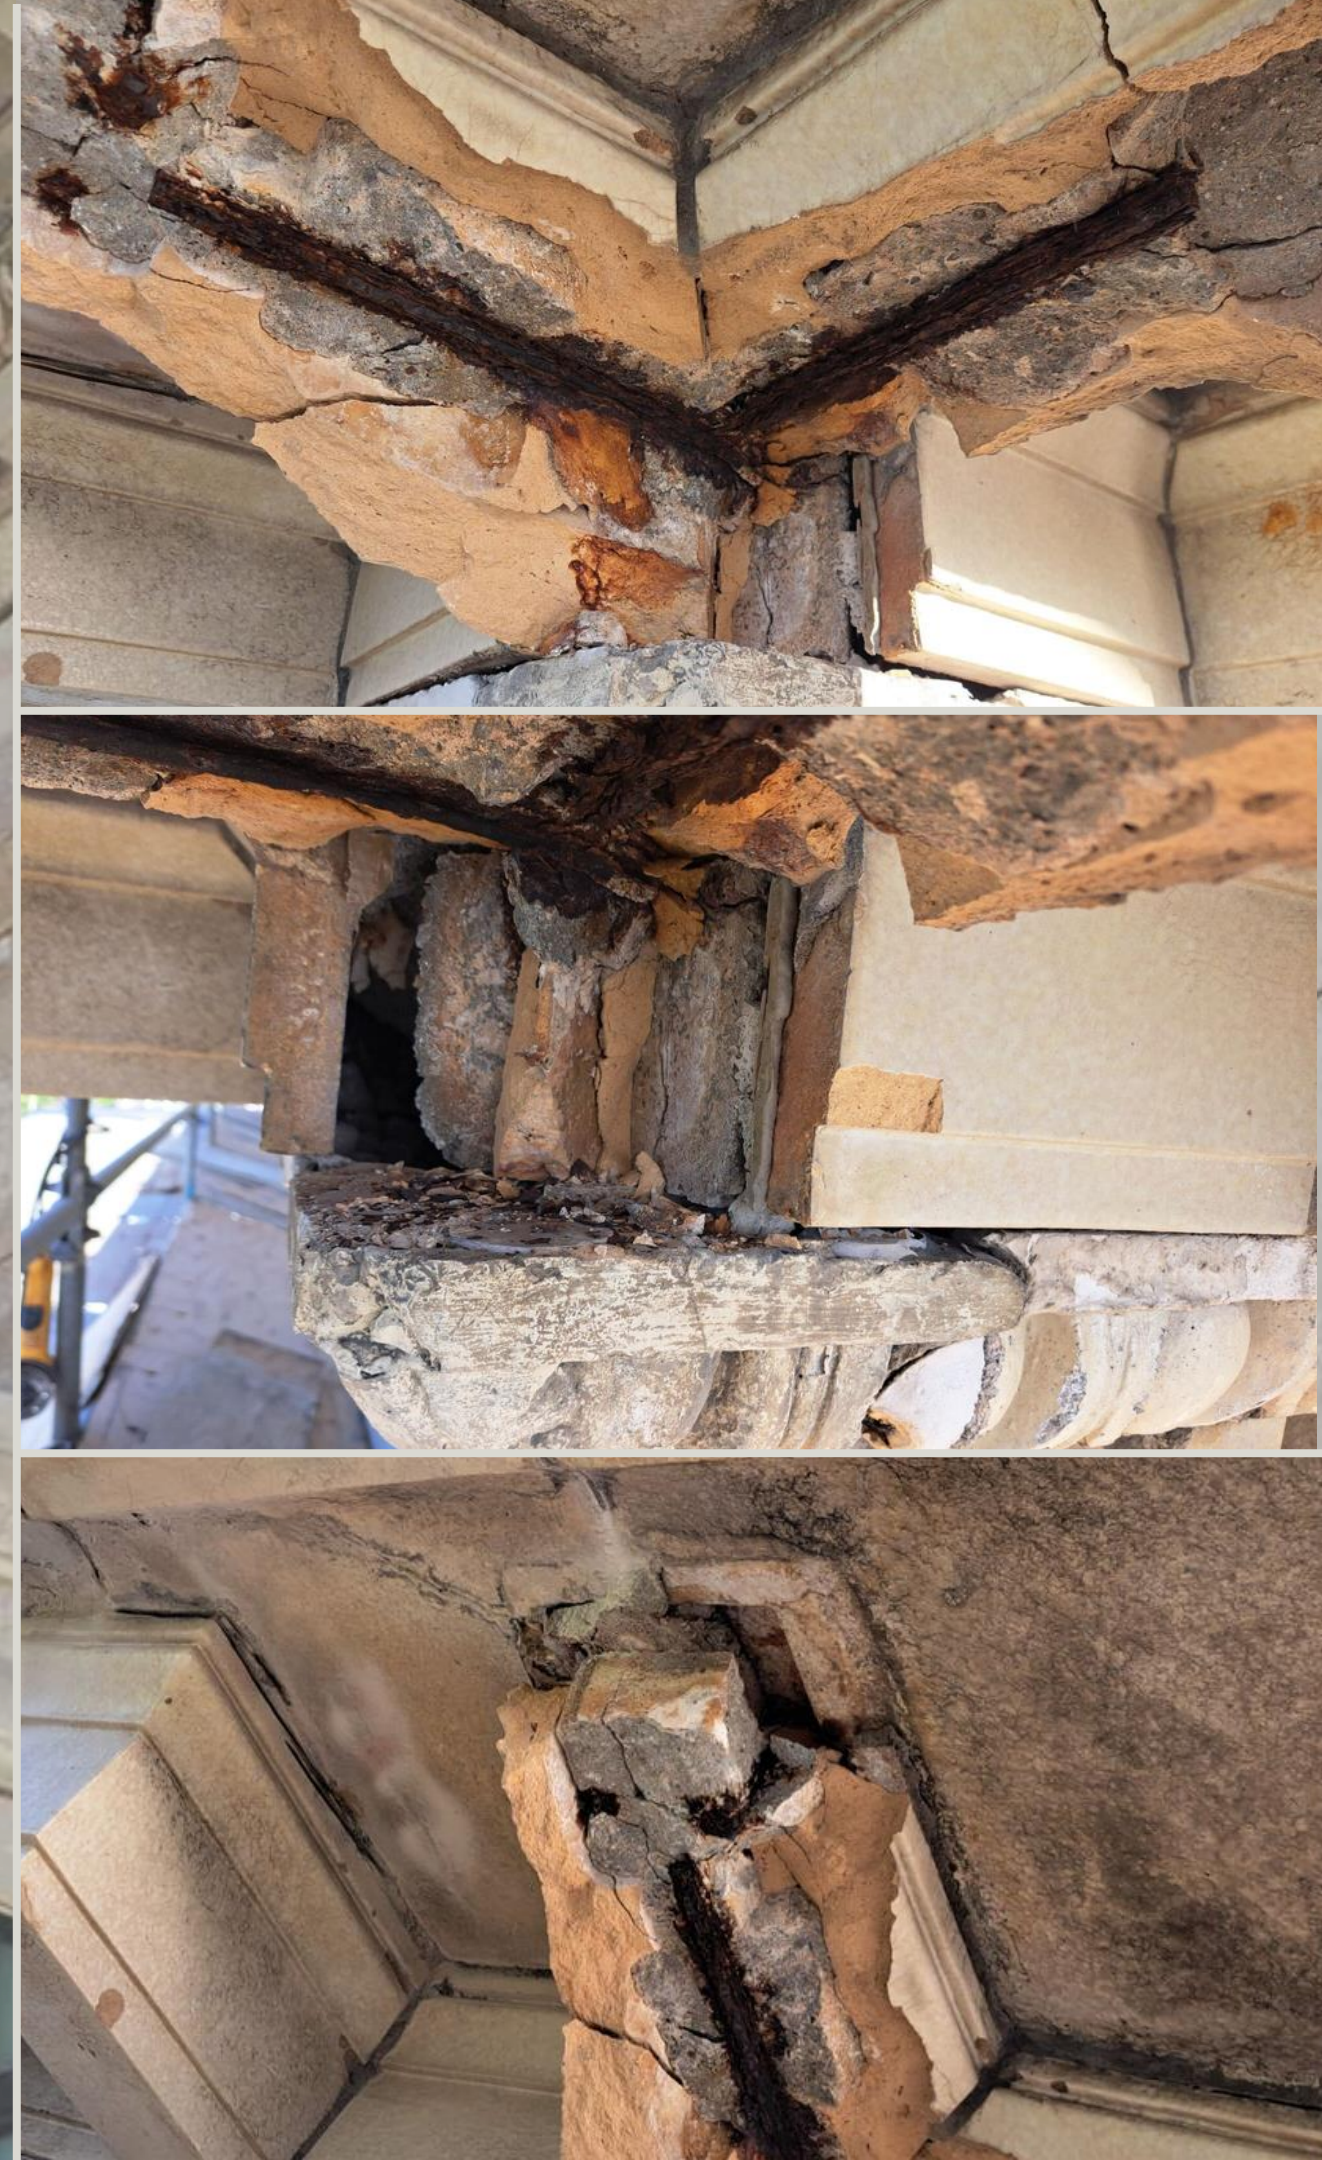
Existing Conditions

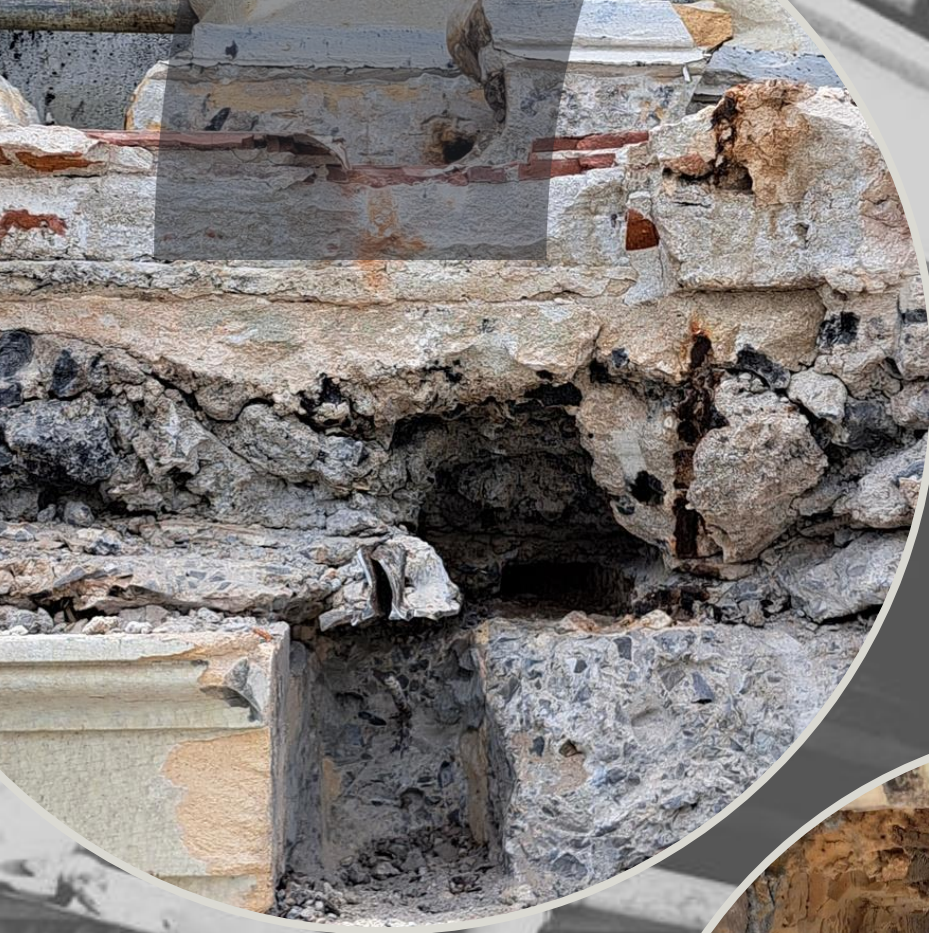
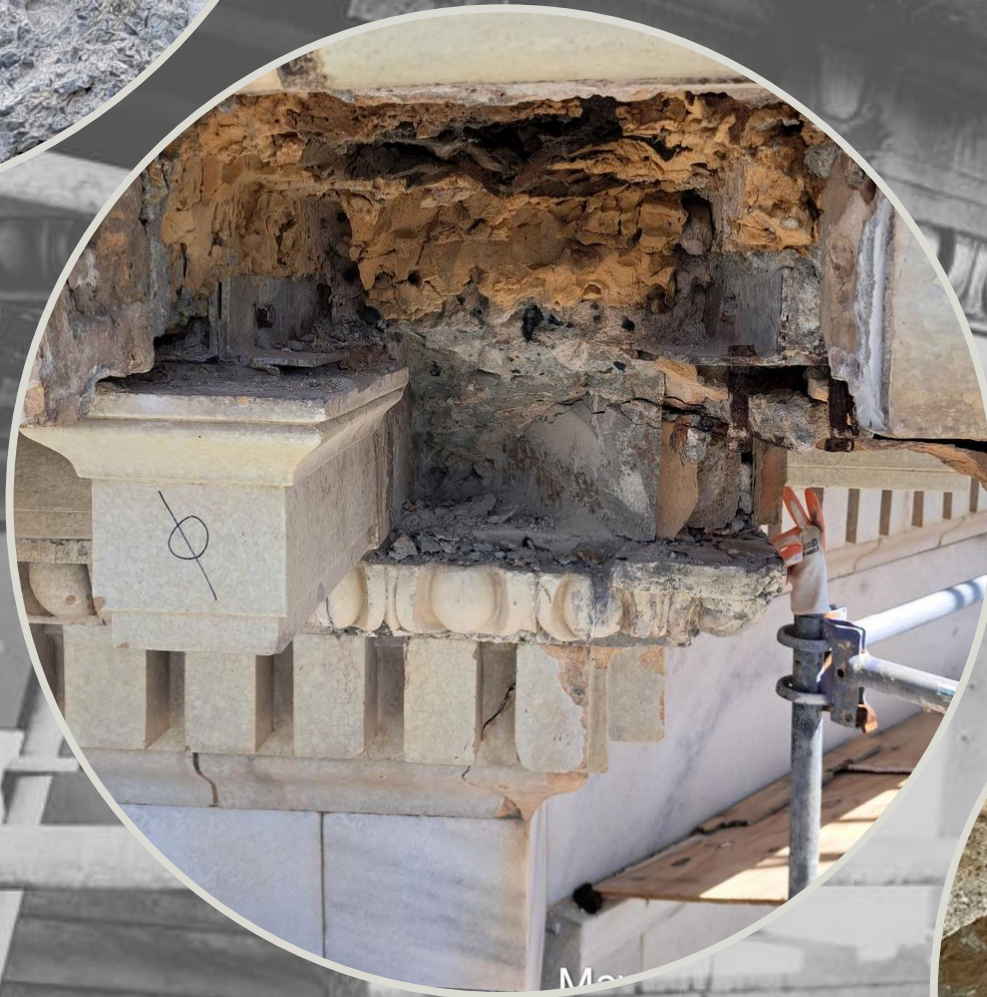
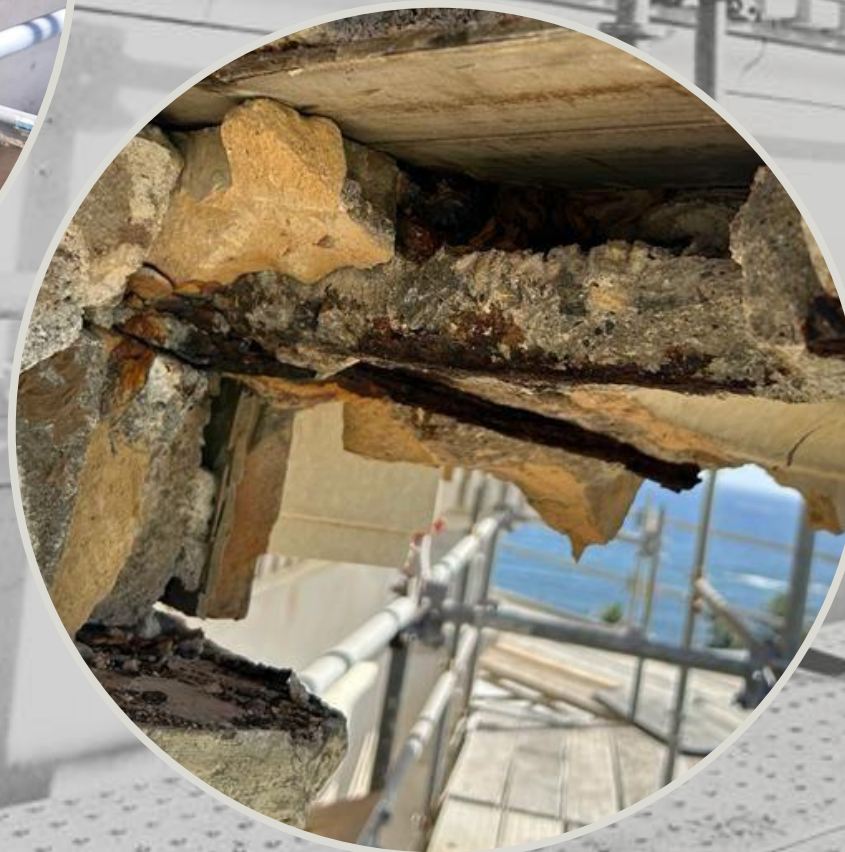
Existing Conditions
